Asbestos Management Survey 1 Southview Close Crowborough, Wealden, East Sussex, TN6 1HH

Executive Summary

A Management Survey has been carried out at 1 Southview Close, Crowborough, Wealden, East Sussex, TN6 1HH.

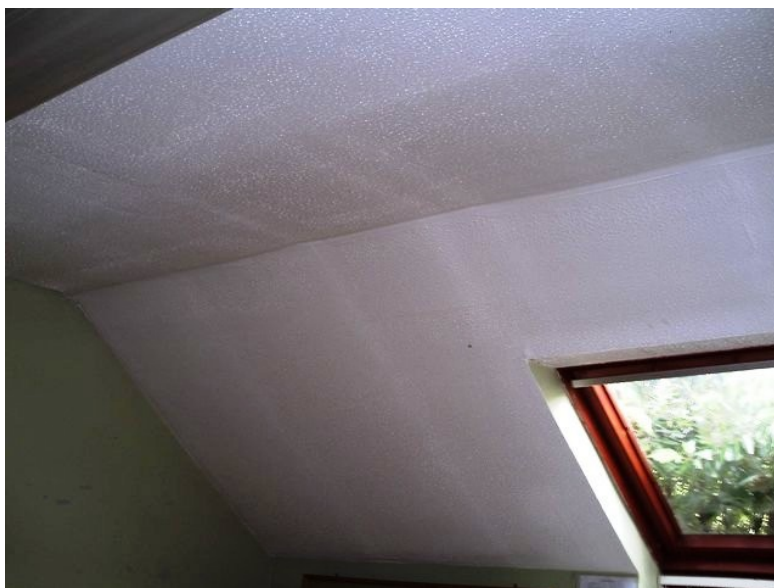
Sample No.	51849-001	Product Type	Textured Coating	1
	Photo 51849-001.jpg	Condition	Good Condition	-
Building	1 Southview Close	Surface Treatment	Sealed	-
Floor	First	Asbestos Type	Chrysotile	1
Room	043 - Driver / Handy Mans Office	Material Risk Assessment		2
Item	Textured Coating	Item Risk Classification	Very Low Risk	
Extent & Location	15sqm - Ceiling	Highest Risk Classification for Room	Very Low Risk

Main Recommendations: **Manage risk using appropriate controls and training.
 Inspect materials at least annually for further damage**

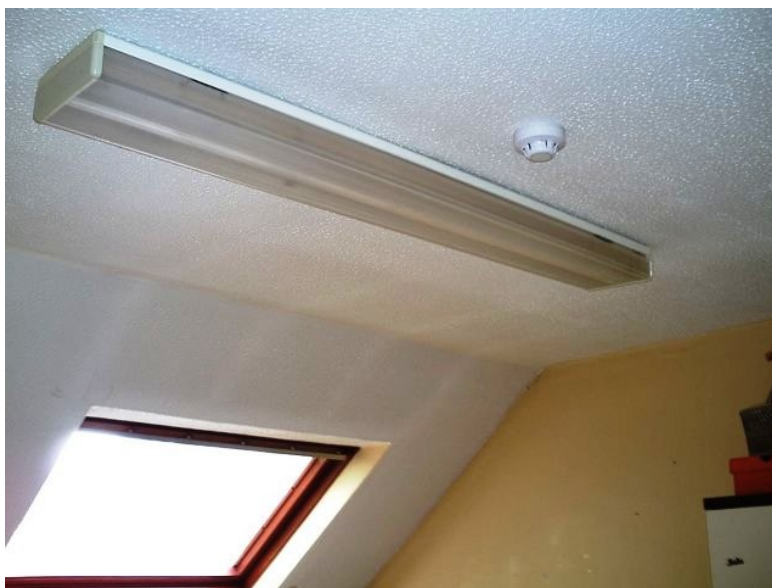
Sample No.	51849-002	Product Type	Textured Coating	1
	Photo 51849-002.jpg	Condition	Good Condition	-
Building	1 Southview Close	Surface Treatment	Sealed	-
Floor	First	Asbestos Type	Chrysotile	1
Room	041 - Conservation Group Room	Material Risk Assessment		2
Item	Textured Coating	Item Risk Classification	Very Low Risk	
Extent & Location	15sqm - Ceiling	Highest Risk Classification for Room	Very Low Risk

Main Recommendations: **Manage risk using appropriate controls and training.
 Inspect materials at least annually for further damage**

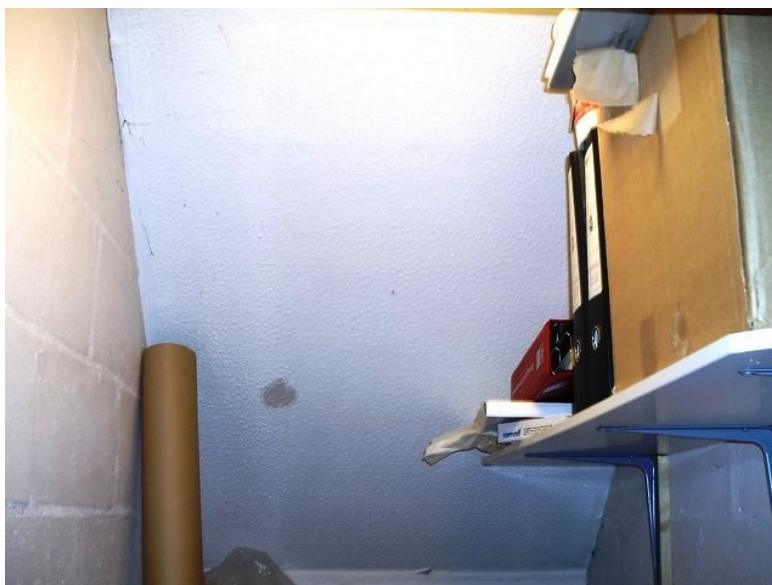
Sample No.	51849-003	Product Type	Textured Coating	1
	Photo 51849-008.jpg	Condition	Good Condition	-
Building	1 Southview Close	Surface Treatment	Sealed	-
Floor	First	Asbestos Type	Chrysotile	1
Room	035 - Store	Material Risk Assessment		2
Item	Textured Coating	Item Risk Classification	Very Low Risk	
Extent & Location	2sqm - Ceiling	Highest Risk Classification for Room	Very Low Risk

Main Recommendations: **Manage risk using appropriate controls and training.
 Inspect materials at least annually for further damage**

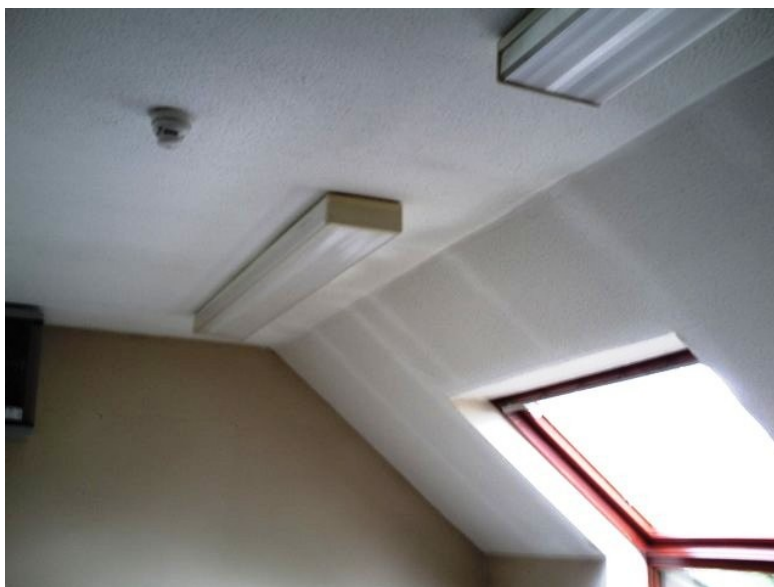
Sample No.	51849-004	Product Type	Textured Coating	1
	Photo 51849-009.jpg	Condition	Good Condition	-
Building	1 Southview Close	Surface Treatment	Sealed	-
Floor	First	Asbestos Type	Chrysotile	1
Room	034 - Equipment Store	Material Risk Assessment		2
Item	Textured Coating	Item Risk Classification	Very Low Risk	
Extent & Location	15sqm - Ceiling	Highest Risk Classification for Room	Very Low Risk

Main Recommendations: **Manage risk using appropriate controls and training.
 Inspect materials at least annually for further damage**

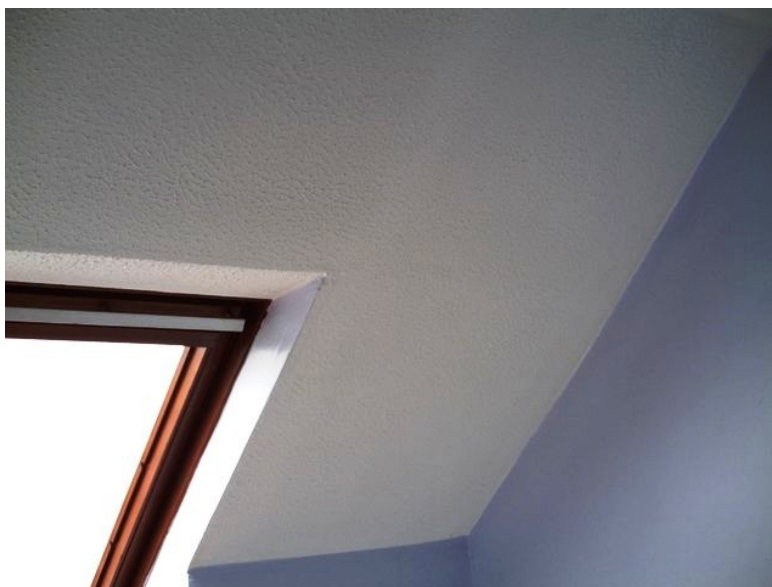
Sample No.	51849-006	Product Type	Textured Coating	1
	Photo 51849-021.jpg	Condition	Good Condition	-
Building	1 Southview Close	Surface Treatment	Sealed	-
Floor	First	Asbestos Type	Chrysotile	1
Room	022 - Ladies' WC	Material Risk Assessment		2
Item	Textured Coating	Item Risk Classification	Very Low Risk	
Extent & Location	10sqm - Ceiling	Highest Risk Classification for Room	Very Low Risk

Main Recommendations: **Manage risk using appropriate controls and training.
 Inspect materials at least annually for further damage**

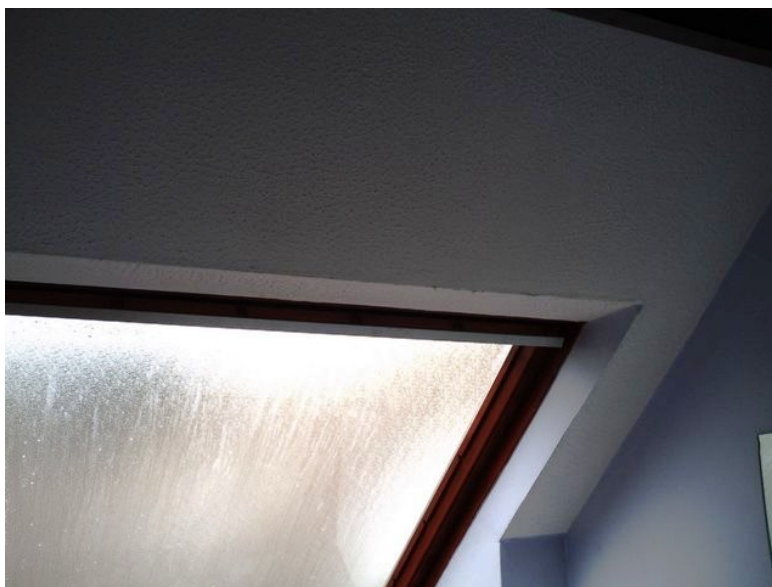
Sample No.	51849-007	Product Type	Textured Coating	1
	Photo 51849-022.jpg	Condition	Good Condition	-
Building	1 Southview Close	Surface Treatment	Sealed	-
Floor	First	Asbestos Type	Chrysotile	1
Room	021 - Ladies' WC	Material Risk Assessment		2
Item	Textured Coating	Item Risk Classification	Very Low Risk	
Extent & Location	10sqm - Ceiling	Highest Risk Classification for Room	Very Low Risk

Main Recommendations: **Manage risk using appropriate controls and training.
 Inspect materials at least annually for further damage**

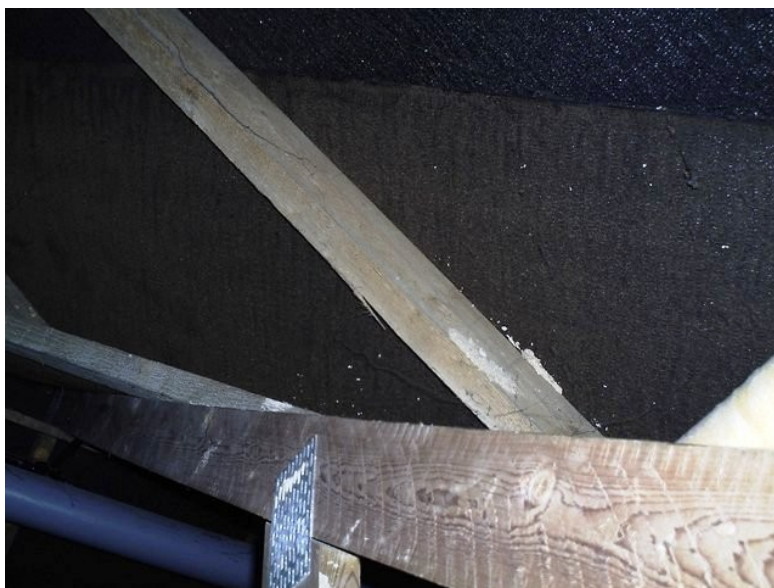
Sample No.	26615-VISUAL	Product Type	Asbestos Reinforced Composite	1
	Photo 51849-032.jpg	Condition	Minor Damage	1
Building	1 Southview Close	Surface Treatment	Sealed	-
Floor	Second	Asbestos Type	Chrysotile, Presumed	1
Room	090 - Loft	Material Risk Assessment		3
Item	Bitumen Felt	Item Risk Classification	Very Low Risk	
Extent & Location	Throughout - Roof	Highest Risk Classification for Room	Very Low Risk

Main Recommendations: Further investigation required. Assume asbestos present until proven otherwise

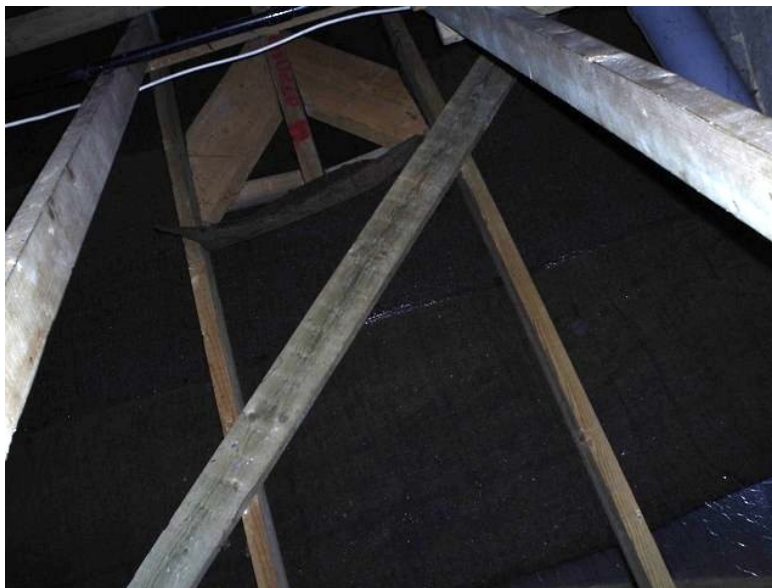
Sample No.	26615-VISUAL	Product Type	Asbestos Reinforced Composite	1
	Photo 51849-033.jpg	Condition	Extensive Damage	3
Building	1 Southview Close	Surface Treatment	Sealed	-
Floor	Second	Asbestos Type	Chrysotile, Presumed	1
Room	012 - Loft	Material Risk Assessment		5
Item	Bitumen Felt	Item Risk Classification	Low Risk	
Extent & Location	Throughout - Roof	Highest Risk Classification for Room	Low Risk

Main Recommendations: Further investigation required. Assume asbestos present until proven otherwise

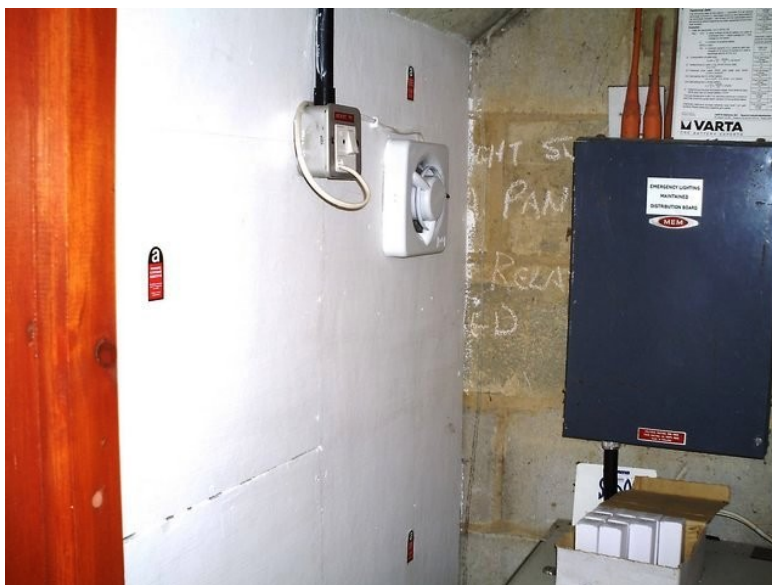
Sample No.	26615-0312/2025/B33/05	Product Type	Insulating Board	2
	Photo 51849-034.jpg	Condition	Good Condition	-
Building	1 Southview Close	Surface Treatment	Sealed	1
Floor	Ground	Asbestos Type	Amosite	2
Room	054 - Battery Room	Material Risk Assessment		5
Item	Insulating Board Lining Panels	Item Risk Classification	Low Risk	
Extent & Location	4sqm - Walls	Highest Risk Classification for Room	Low Risk

Main Recommendations: **Manage risk using appropriate controls and training.
 Inspect materials at least annually for further damage**

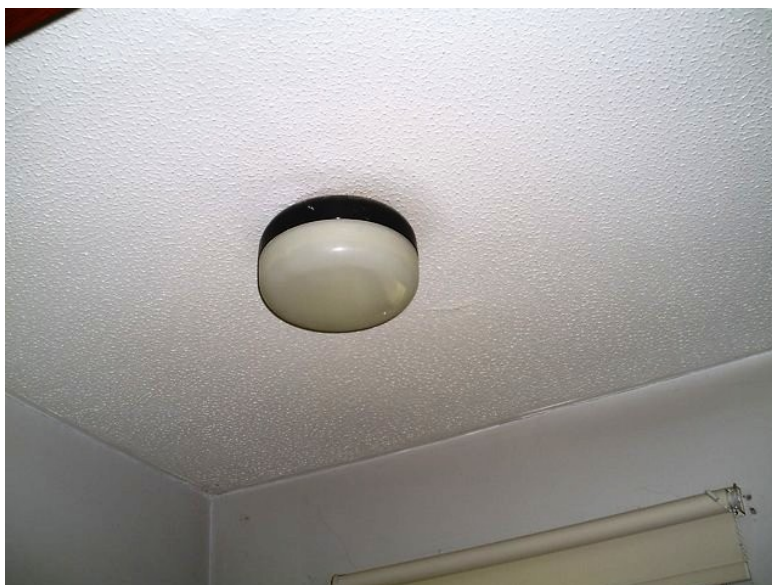
Sample No.	51849-009	Product Type	Textured Coating	1
	Photo 51849-039.jpg	Condition	Good Condition	-
Building	1 Southview Close	Surface Treatment	Sealed	-
Floor	Ground	Asbestos Type	Chrysotile	1
Room	051 - WC	Material Risk Assessment		2
Item	Textured Coating	Item Risk Classification	Very Low Risk	
Extent & Location	6sqm - Ceiling	Highest Risk Classification for Room	Very Low Risk

Main Recommendations: **Manage risk using appropriate controls and training.
Inspect materials at least annually for further damage**

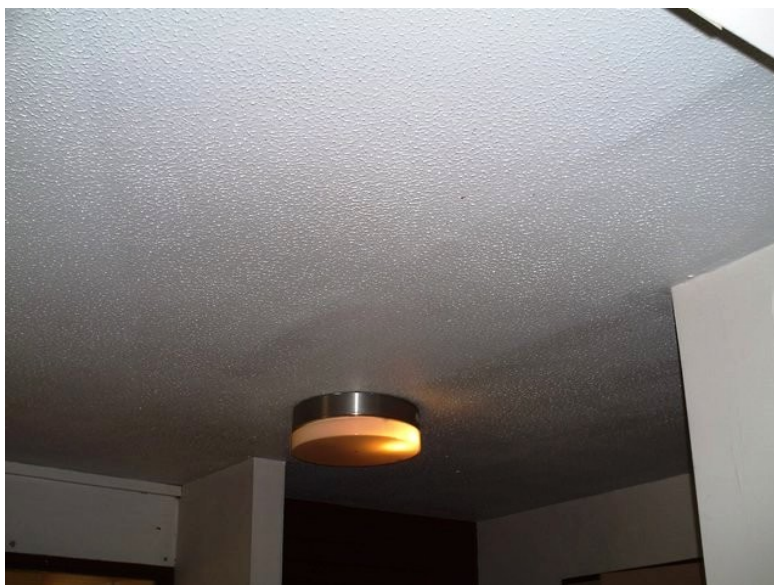
Sample No.	51849-010	Product Type	Textured Coating	1
	Photo 51849-042.jpg	Condition	Good Condition	-
Building	1 Southview Close	Surface Treatment	Sealed	-
Floor	Ground	Asbestos Type	Chrysotile	1
Room	045 - Lobby	Material Risk Assessment		2
Item	Textured Coating	Item Risk Classification	Very Low Risk	
Extent & Location	8sqm - Ceiling	Highest Risk Classification for Room	Very Low Risk

Main Recommendations: **Manage risk using appropriate controls and training.
 Inspect materials at least annually for further damage**

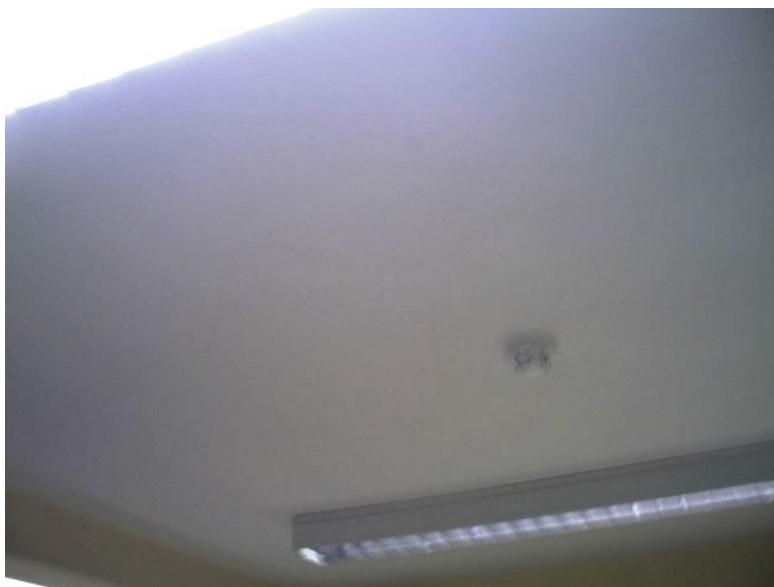
Sample No.	51849-011	Product Type	Textured Coating	1
	Photo 51849-048.jpg	Condition	Good Condition	-
Building	1 Southview Close	Surface Treatment	Sealed	-
Floor	Ground	Asbestos Type	Chrysotile	1
Room	060 - Resource Office	Material Risk Assessment		2
Item	Textured Coating	Item Risk Classification	Very Low Risk	
Extent & Location	14sqm - Ceiling	Highest Risk Classification for Room	Very Low Risk

Main Recommendations: **Manage risk using appropriate controls and training.
 Inspect materials at least annually for further damage**

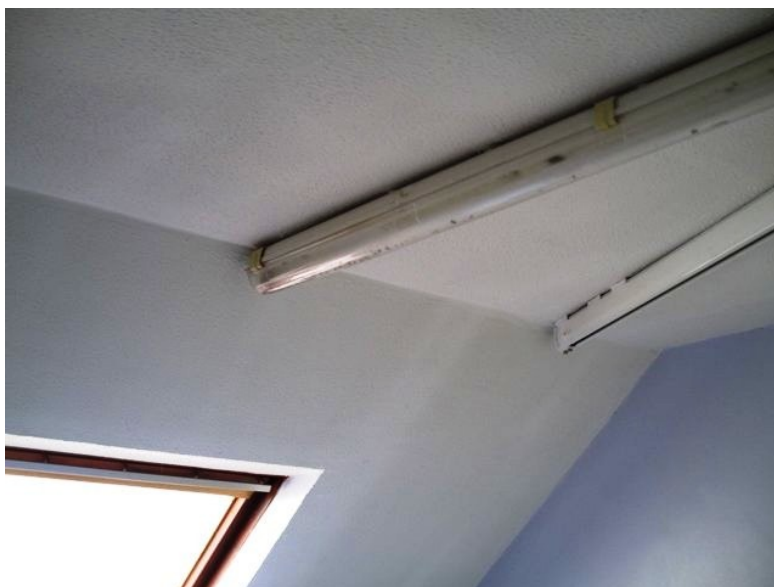
Sample No.	51849-012	Product Type	Textured Coating	1
	Photo 51849-062.jpg	Condition	Good Condition	-
Building	1 Southview Close	Surface Treatment	Sealed	-
Floor	First	Asbestos Type	Chrysotile	1
Room	009 - WC	Material Risk Assessment		2
Item	Textured Coating	Item Risk Classification	Very Low Risk	
Extent & Location	15sqm - Ceiling	Highest Risk Classification for Room	Very Low Risk

Main Recommendations: **Manage risk using appropriate controls and training.
 Inspect materials at least annually for further damage**

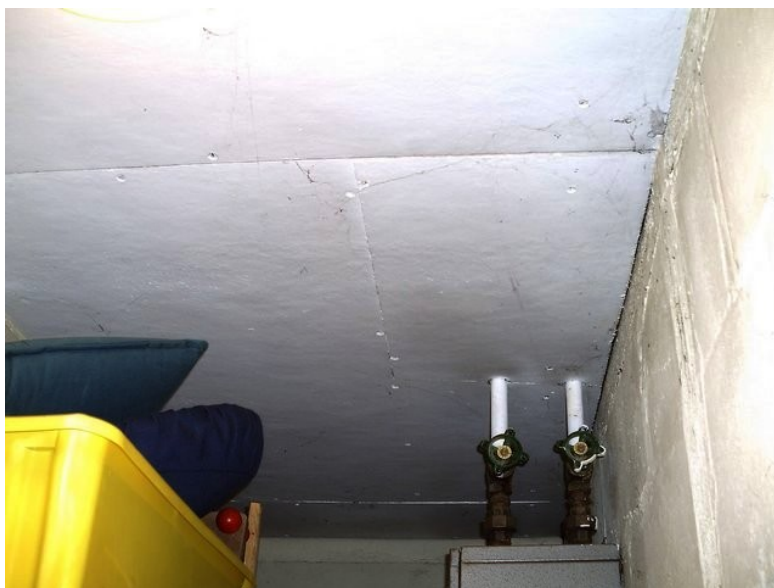
Sample No.	26615-0312/2025/B33/11	Product Type	Insulating Board	2
	Photo 51849-075.jpg	Condition	Good Condition	-
Building	1 Southview Close	Surface Treatment	Sealed	1
Floor	Ground	Asbestos Type	Amosite	2
Room	066 - High Dependency Unit Store	Material Risk Assessment		5
Item	Insulating Board	Item Risk Classification	Low Risk	
Extent & Location	8sqm - Ceiling	Highest Risk Classification for Room	Low Risk

Main Recommendations: **Manage risk using appropriate controls and training.
 Inspect materials at least annually for further damage**

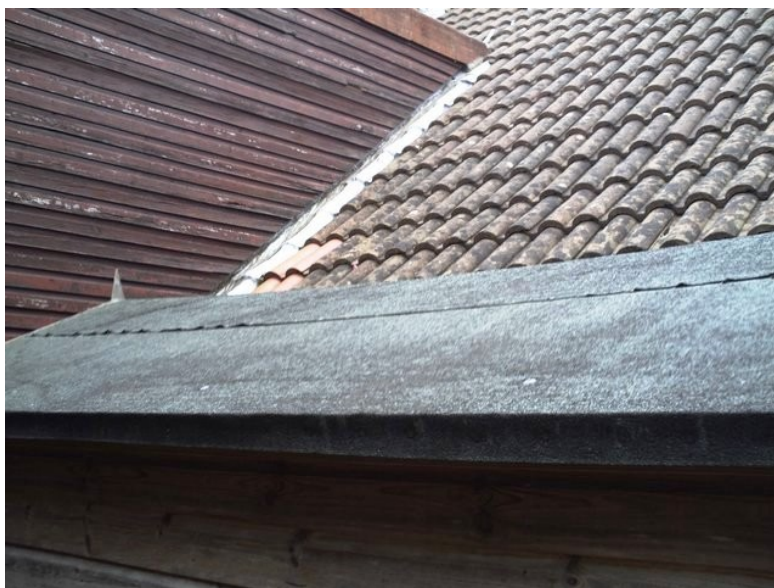
Sample No.	26615-VISUAL	Product Type	Asbestos Reinforced Composite	1
	Photo 51849-077.jpg	Condition	Good Condition	-
Building	1 Southview Close	Surface Treatment	Sealed	-
Floor	External	Asbestos Type	Chrysotile, Presumed	1
Room	Ext - External	Material Risk Assessment		2
Item	Bitumen Felt	Item Risk Classification	Very Low Risk	
Extent & Location	Throughout - Roof Sheds	Highest Risk Classification for Room	Very Low Risk

Main Recommendations: Further investigation required. Assume asbestos present until proven otherwise

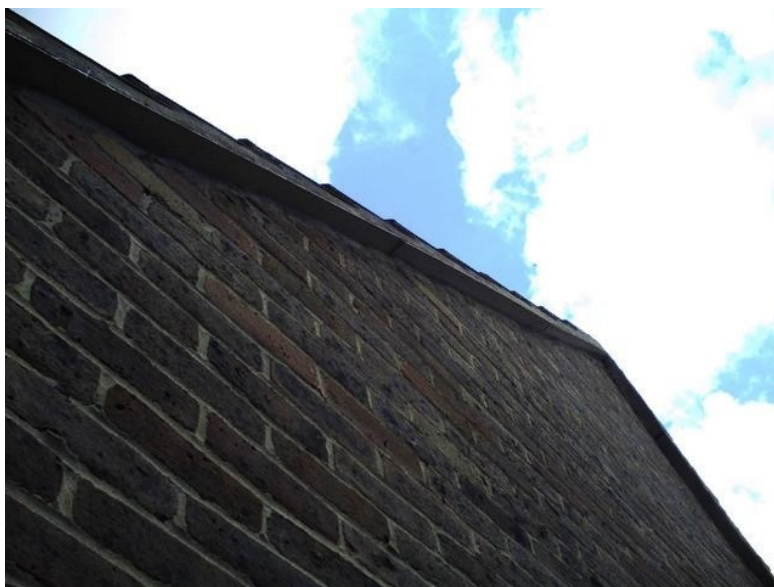
Sample No.	26615-0312/2025/B33/12	Product Type	Asbestos Cement	1
	Photo 51849-078.jpg	Condition	Good Condition	-
Building	1 Southview Close	Surface Treatment	Unsealed	1
Floor	External	Asbestos Type	Chrysotile	1
Room	Ext - External	Material Risk Assessment		3
Item	Cement Undercloak	Item Risk Classification	Very Low Risk	
Extent & Location	25sqm - Roof Verge	Highest Risk Classification for Room	Very Low Risk

Main Recommendations: **Manage risk using appropriate controls and training.
 Inspect materials at least annually for further damage**

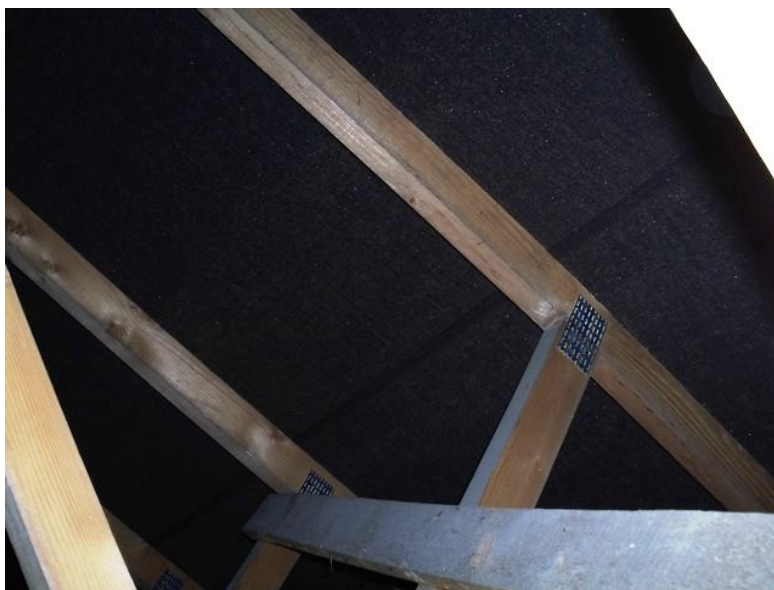
Sample No.	26615-VISUAL	Product Type	Asbestos Reinforced Composite	1
	Photo 51849-079.jpg	Condition	Good Condition	-
Building	1 Southview Close	Surface Treatment	Sealed	-
Floor	Second	Asbestos Type	Chrysotile, Presumed	1
Room	011 - Loft	Material Risk Assessment		2
Item	Bitumen Felt Lining	Item Risk Classification	Very Low Risk	
Extent & Location	Throughout - Roof	Highest Risk Classification for Room	Very Low Risk

Main Recommendations: Further investigation required. Assume asbestos present until proven otherwise
