**ARBORICULTURAL IMPLICATIONS ASSESSMENT
FOR
PROPOSED 12 UNIT RESIDENTIAL REDEVELOPMENT**

**ASHWOOD NURSING HOME
BURWASH COMMON
ETCHINGHAM
EAST SUSSEX
TN19 7LT**

**Tim Laddiman
BSc.(Hons) M.I.C.For. M.Arbor.A.
Chartered Arboriculturist**

**Our ref: J58.12
13th October 2020**

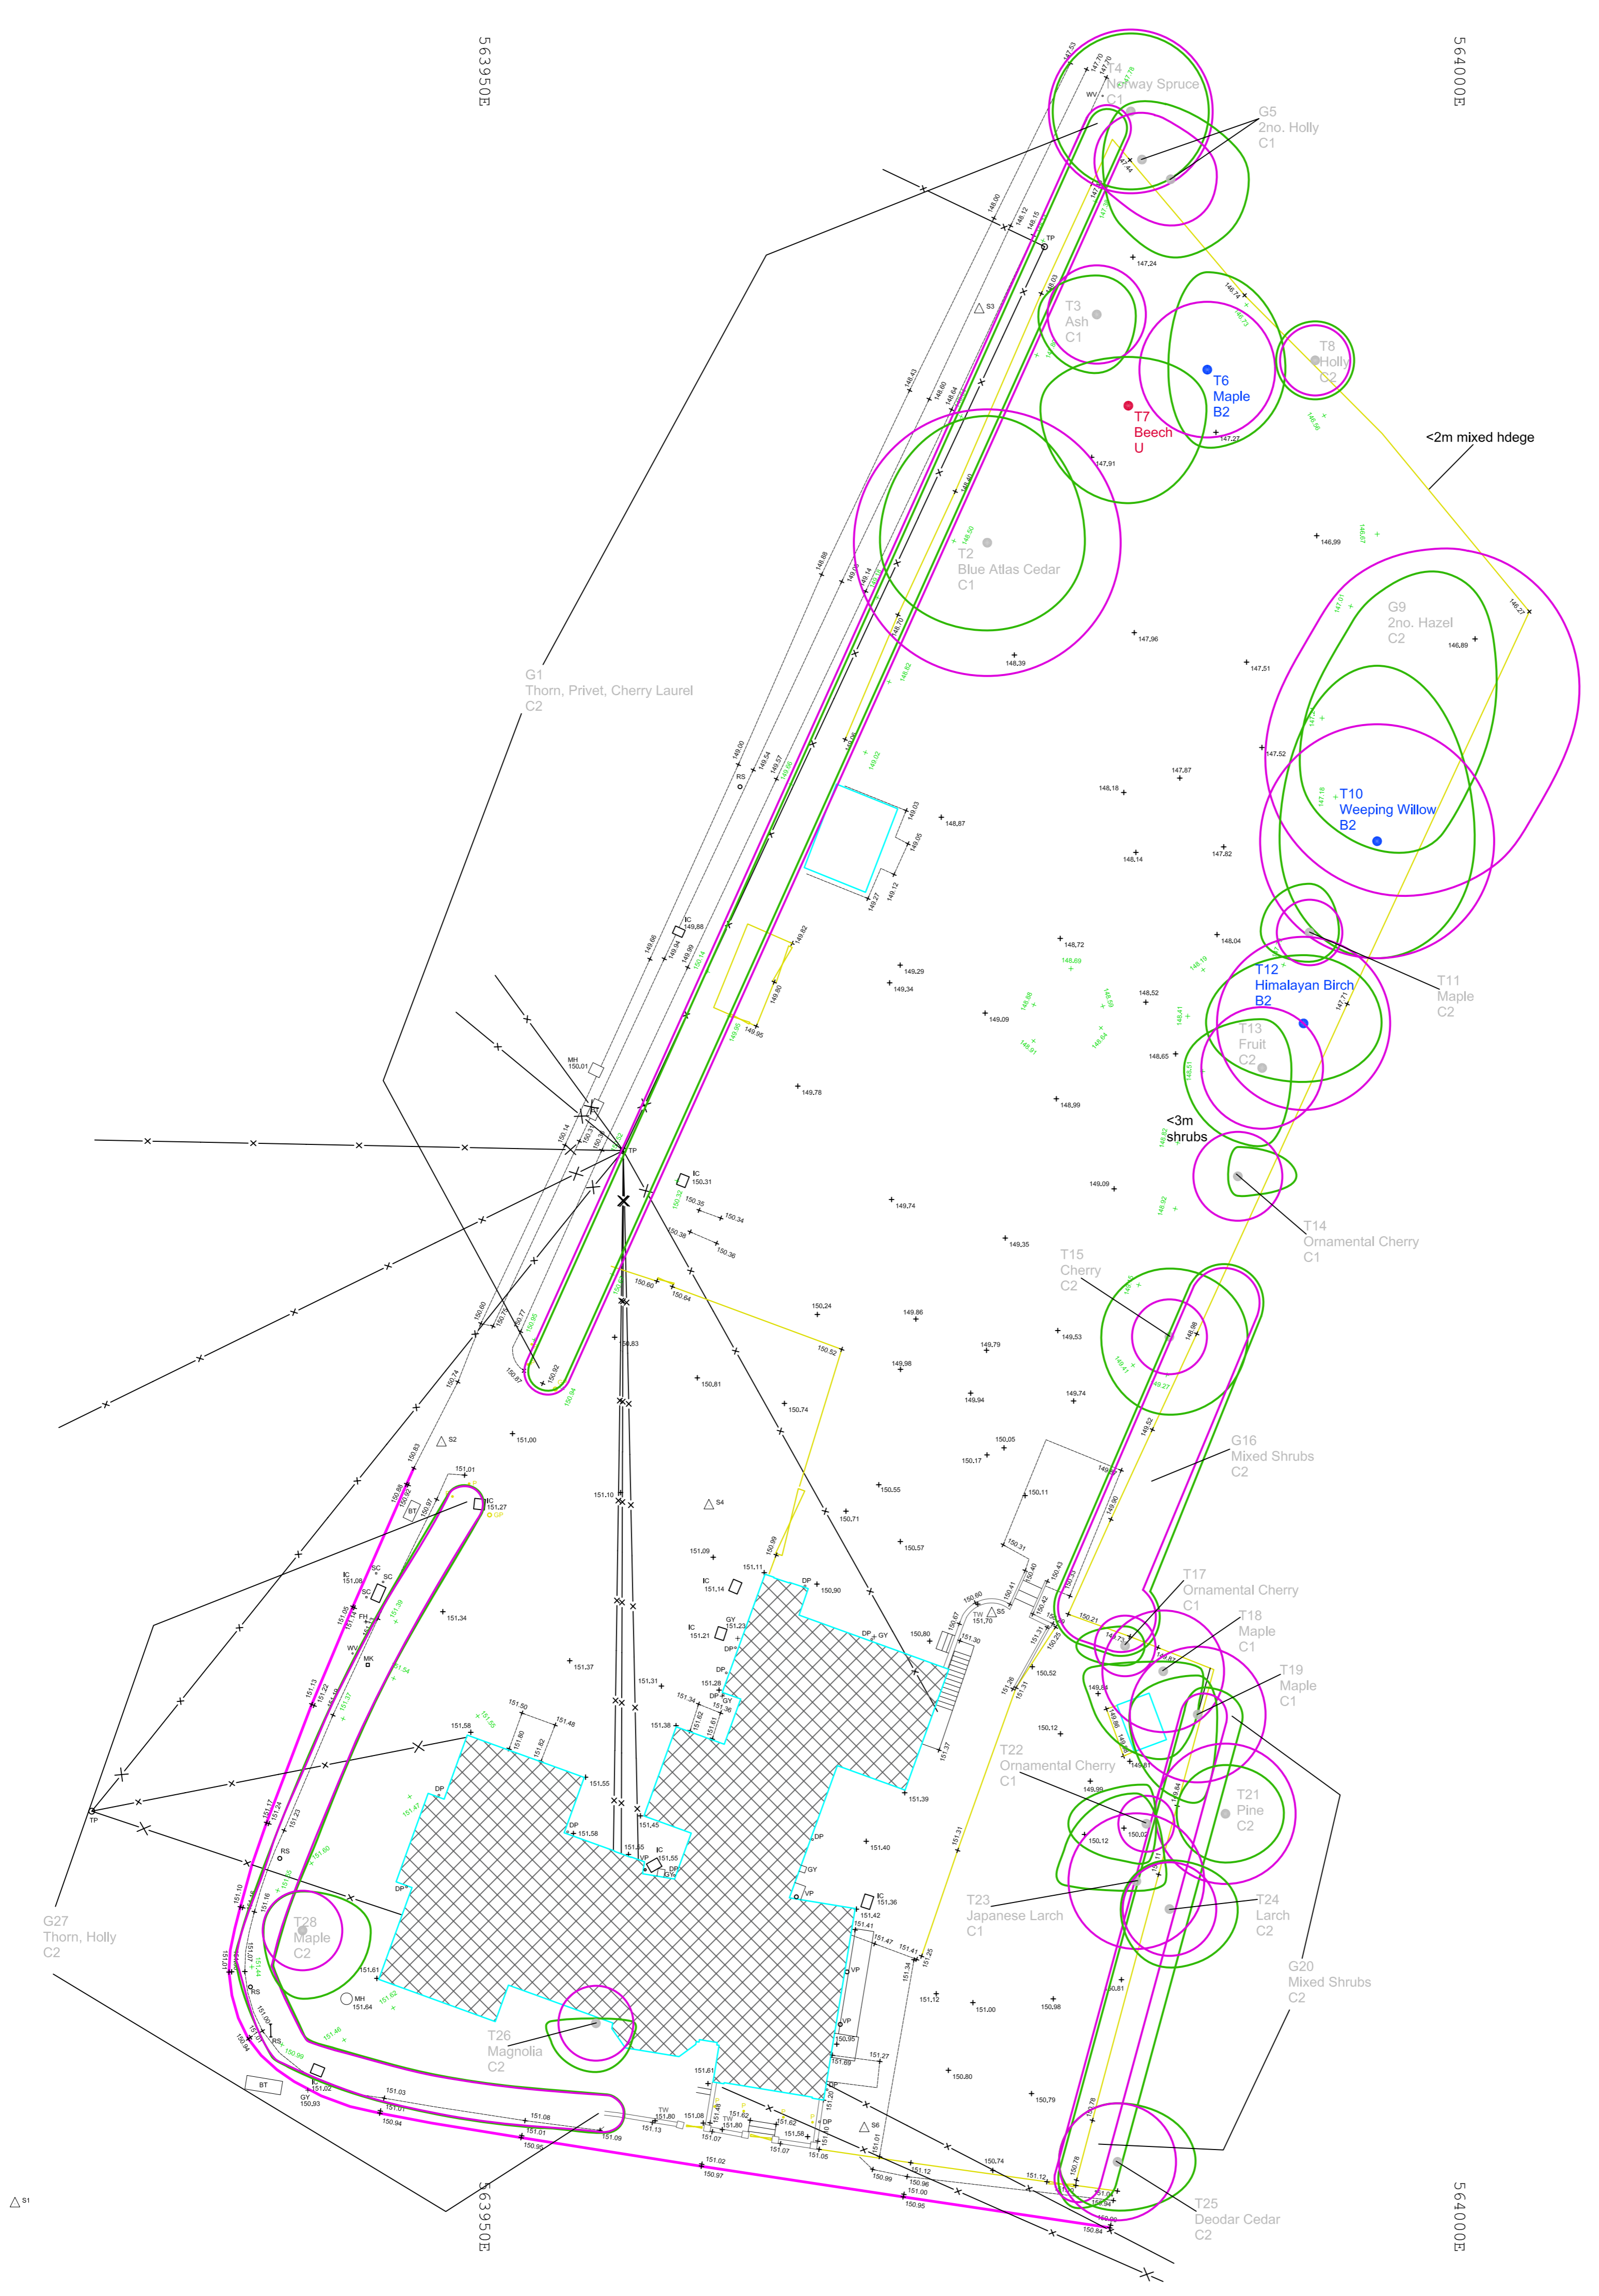
4.2 The tree survey followed the numbered sequence from G1 to T28 inclusive. Tree numbers, together with BS recommended colour coding of condition, have been added to the Tree Constraints Plan, our drawing no. J58.12/01 in Appendix 2. This drawing also includes crown spreads based on four compass points and BS calculated root protection areas.

- 7.2 The table in Appendix 3 been calculated using the measured stem diameters and the formula as described in Section 4.6 in BS 5837:2012. These are represented as basic circles on the Tree Constraints Plan. Where buildings, walls, services and hard surfacing exist within the indicated RPAs it is likely that the architecture of root systems will have been affected. Foundations to walls and buildings can completely obstruct root development, depending on their depth and the nature of the underlying soils. In the absence of detailed site investigations the indicated RPA circles should be used for guidance only within any redevelopment proposals.

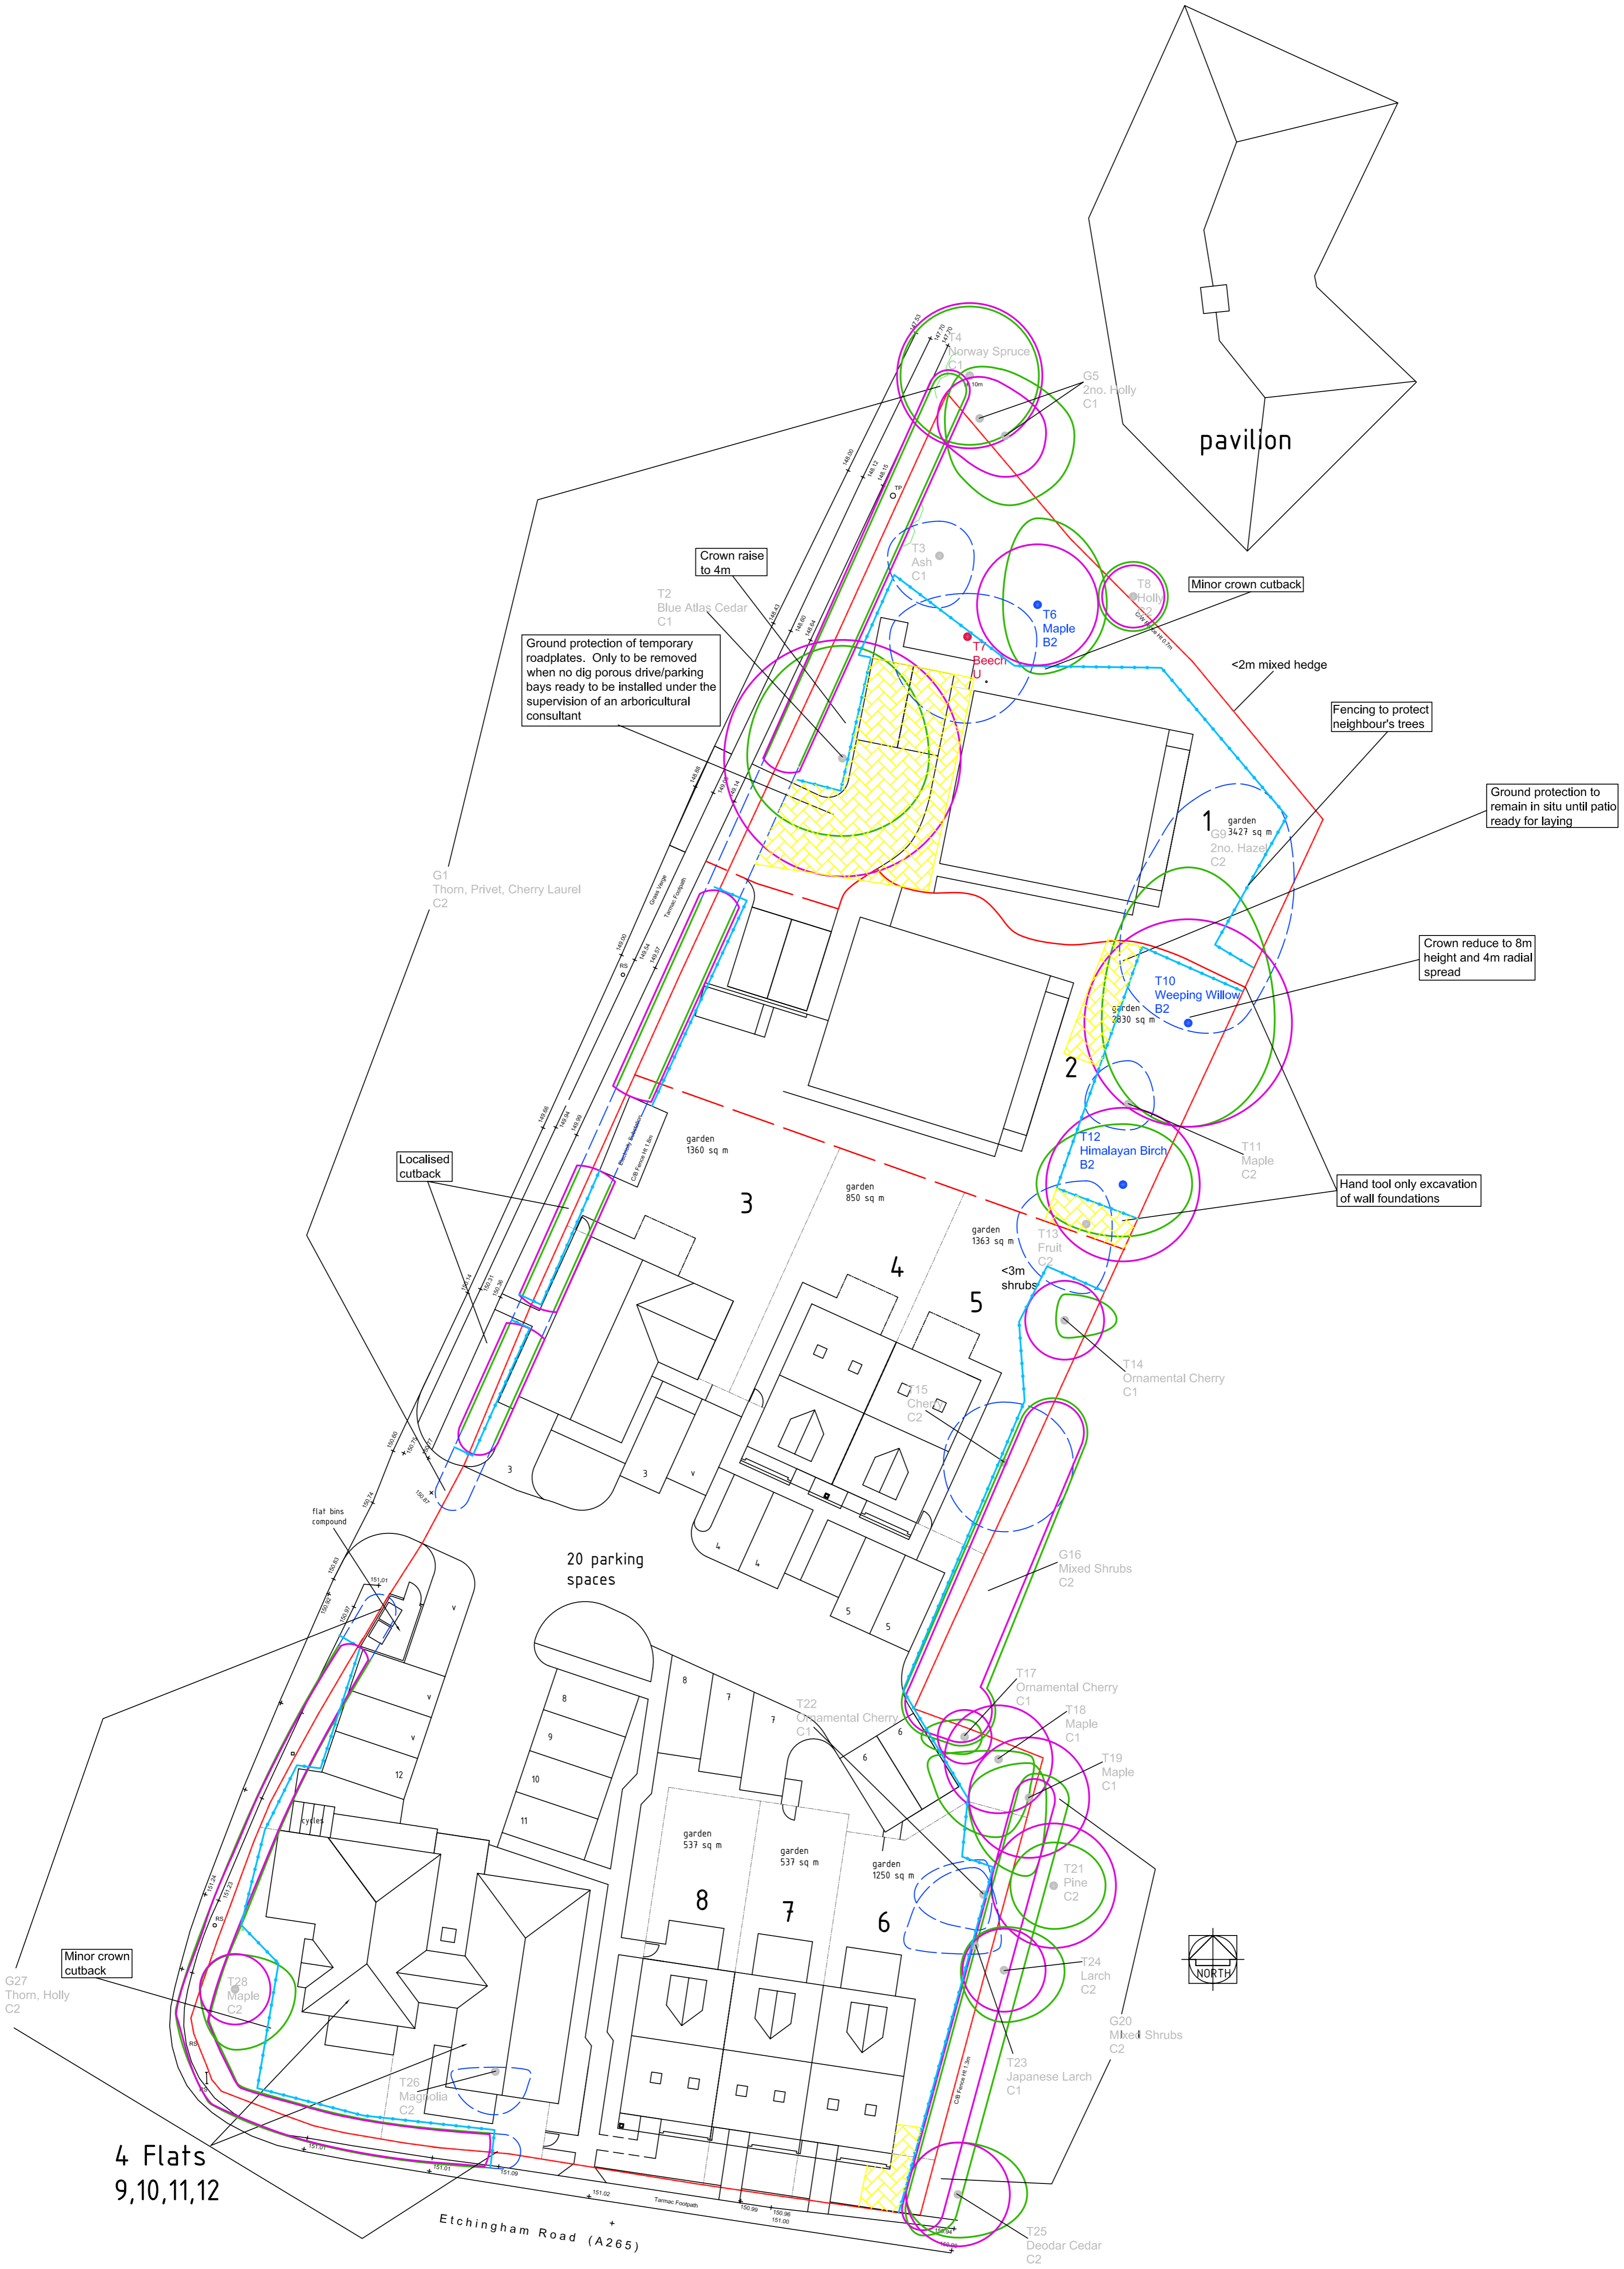
- Storage or disposal of any soil, building materials, machinery, fuel or waste residues of any description.
- Siting of any temporary structures of any description including site offices/sales buildings, temporary car parking facilities, porta-loos, storage compounds or temporary hard standing areas.
- Excavations, soil/turf stripping, raising/lowering of existing levels or alterations to the existing natural surfaces/ground conditions of any other description.
- Location of temporary drainage, water supplies or any other temporary underground services.
- No use, movement or parking of any machinery or vehicles of any description.
- Additionally, no fires shall be lit within 20m, of the trunks of any trees or the centre line of any hedgerow to be retained.

All services to be installed to the requirements of NUJG Volume 4 "Guidelines for the Planning, Installation and Maintenance of Utility Apparatus in Proximity to Trees". Any runs within retained tree root protection areas to either be bored/moled or any hand excavation to be supervised by the Arboricultural Consultant

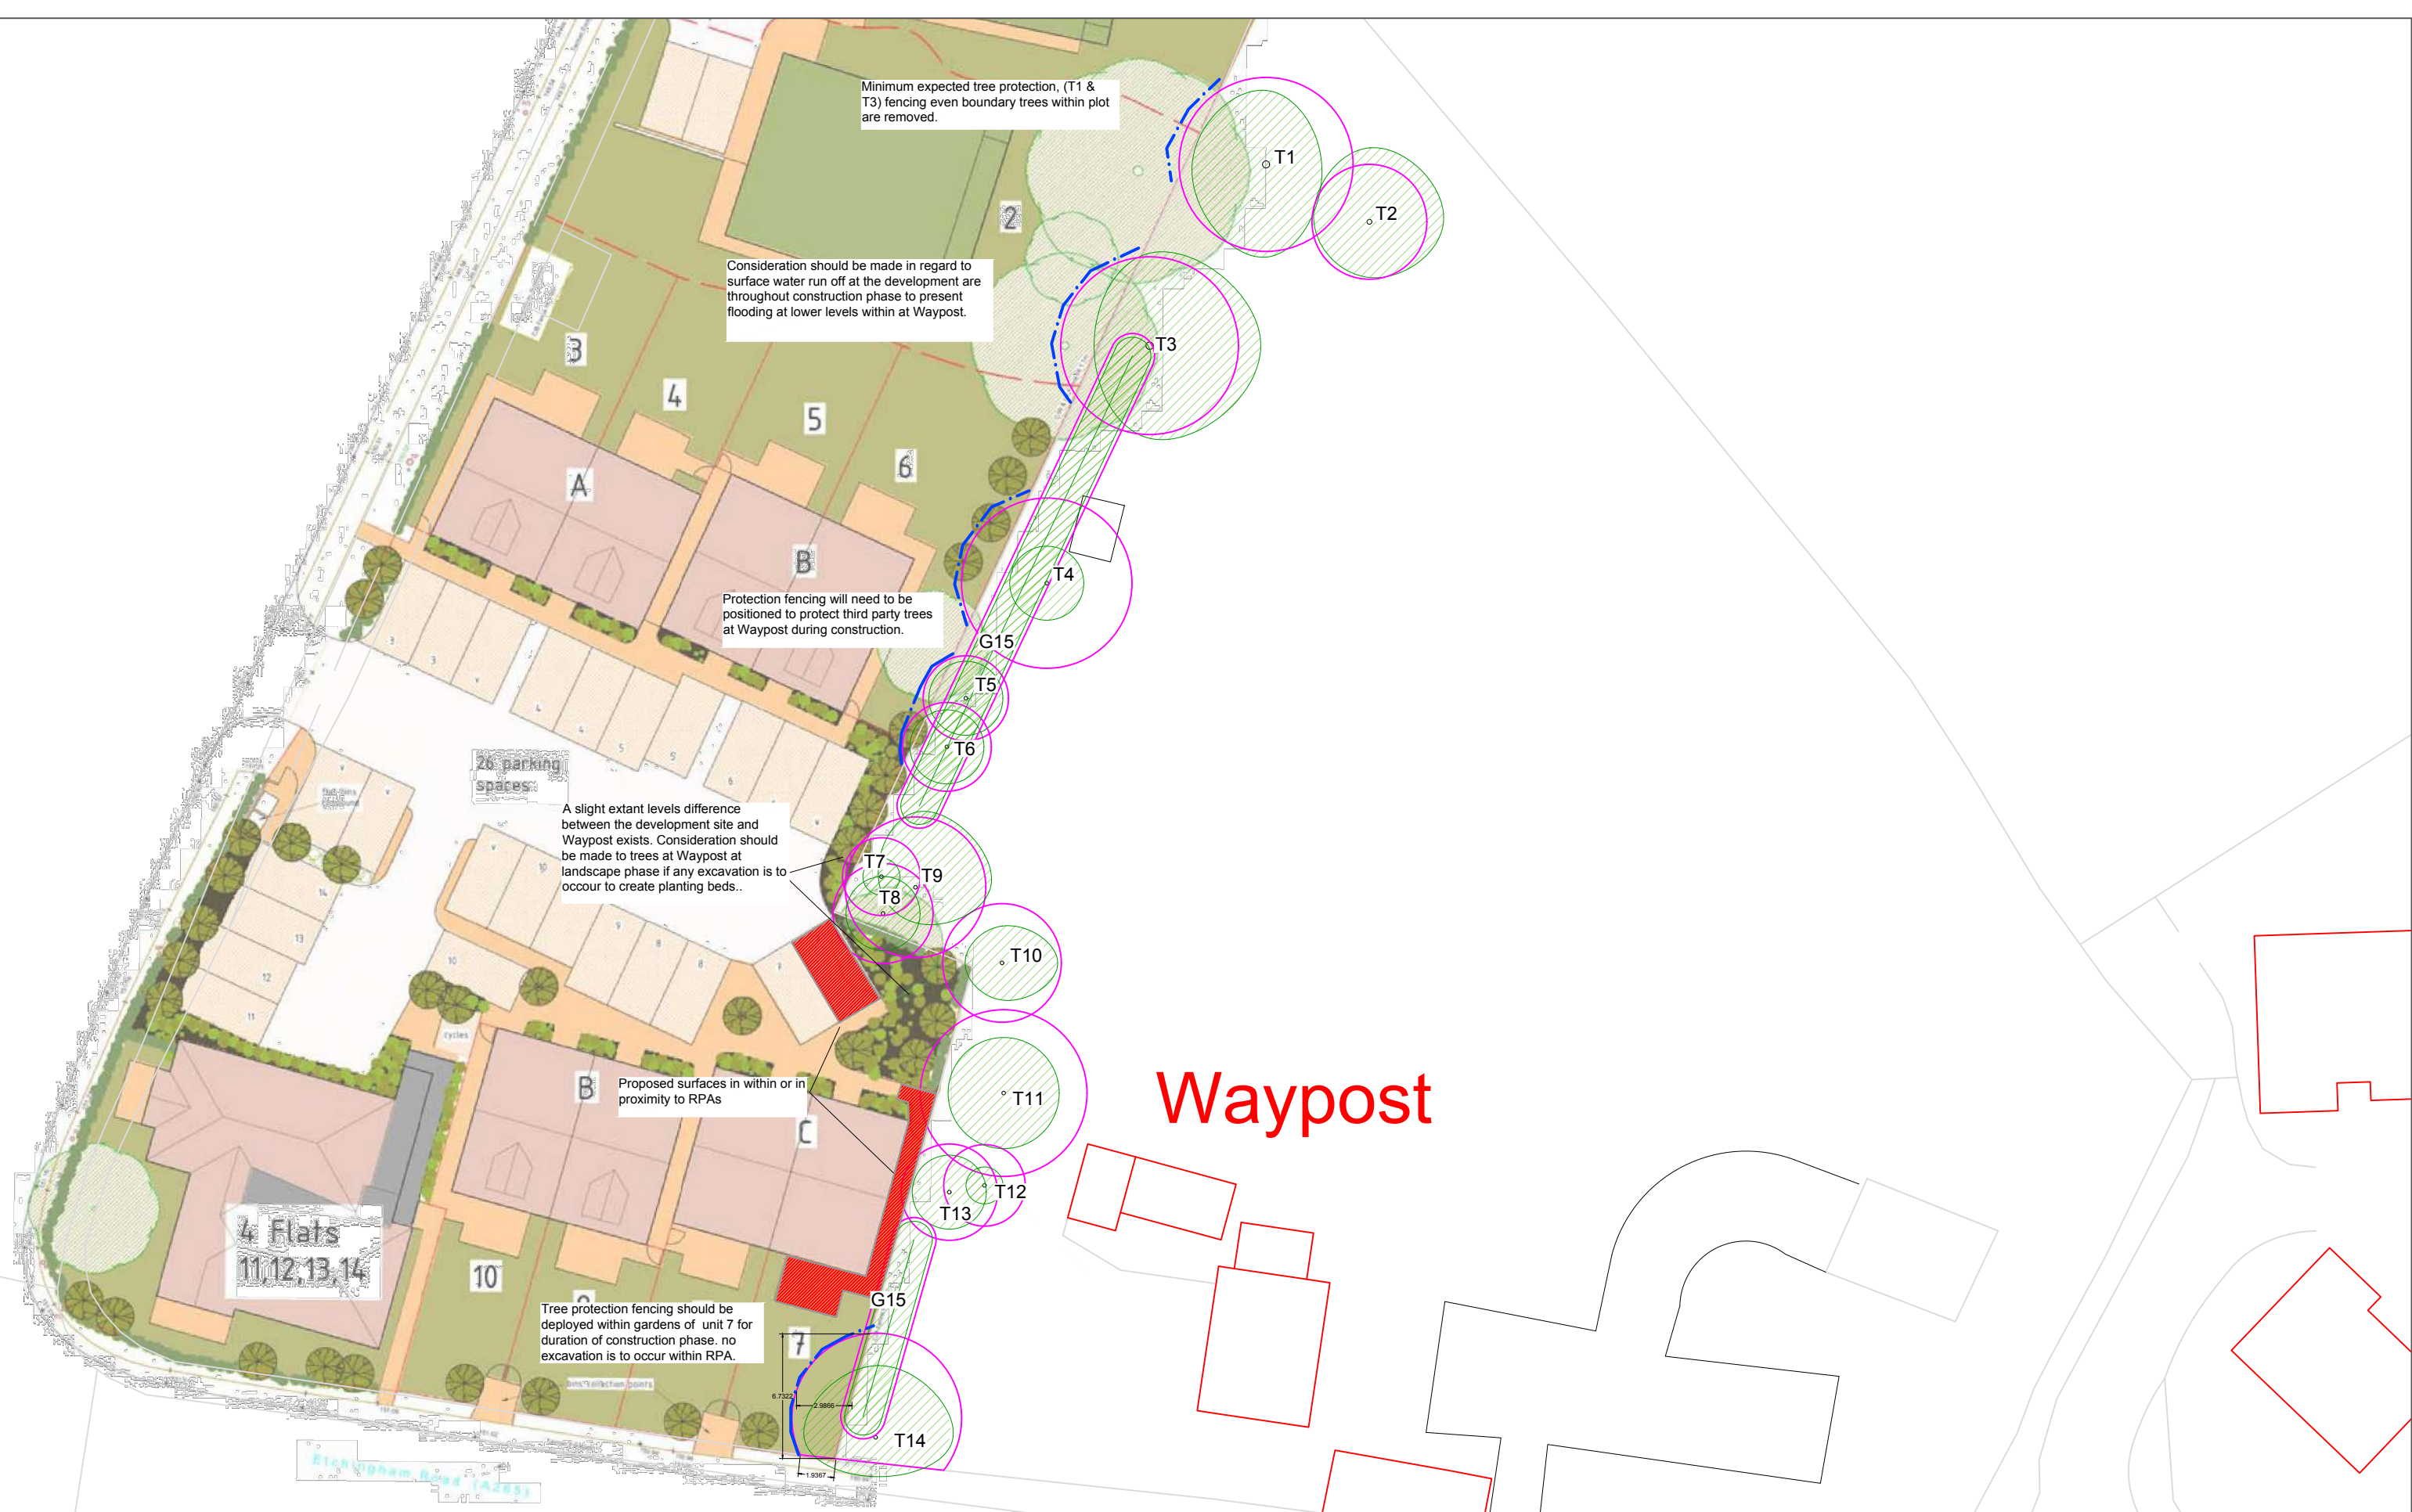
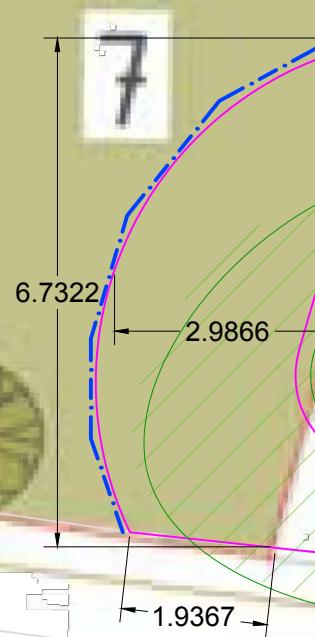
Proposed surfaces in within or in proximity to RPAs

Tree protection fencing should be deployed within gardens of unit 7 for duration of construction phase. no excavation is to occur within RPA.
