ASBESTOS DEMOLITION SURVEY

Ashwood Nursing Home, Burwash Common, TN19
7LT

1 Feb 2022

ASE-272

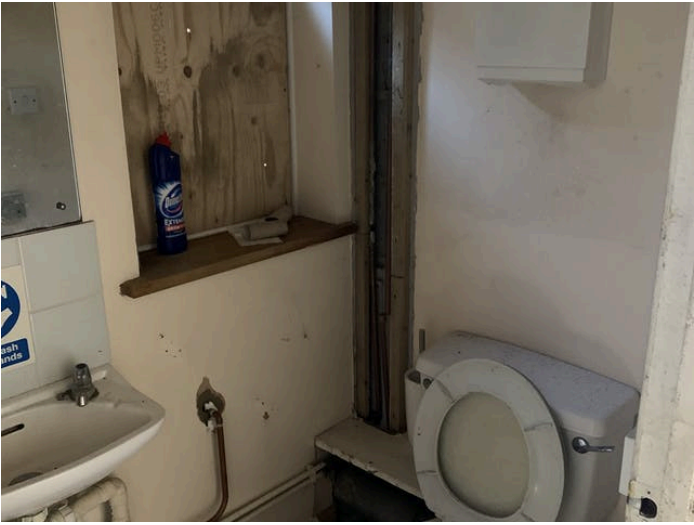
Building	Main Building	Level	0
Location	001 - Toilet	Item

Location Notes	Ceiling: Plasterboard, plaster. Walls: Brick, plaster. Floor: Concrete, carpet.

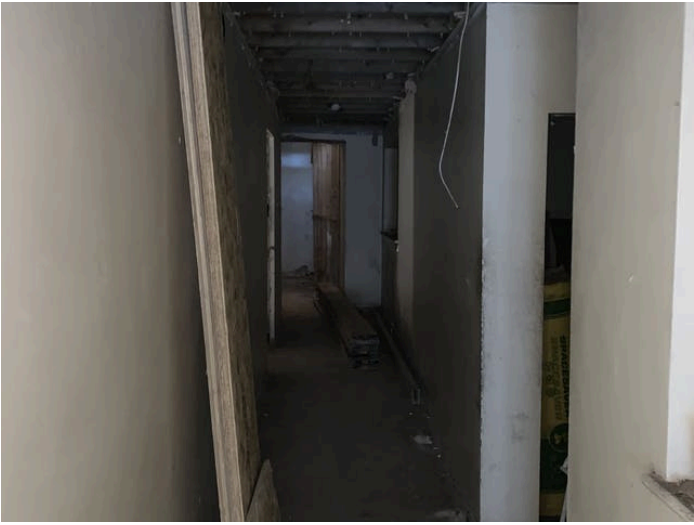
Building	Main Building	Level	0
Location	002 - Lobby / corridor	Item

Location Notes	Ceiling: Timber. Walls: Brick, plaster. Floor: Concrete.

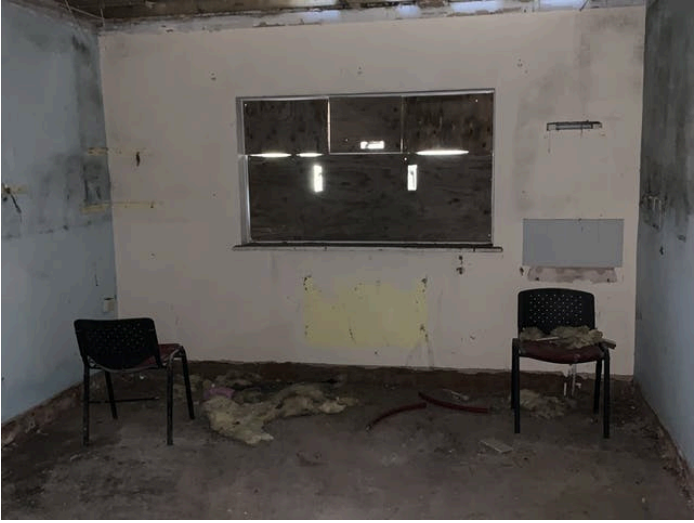
Building	Main Building	Level	0
Location	003 - Room 1	Item

Location Notes	Ceiling: Timber. Walls: Brick, plaster. Floor: Concrete.

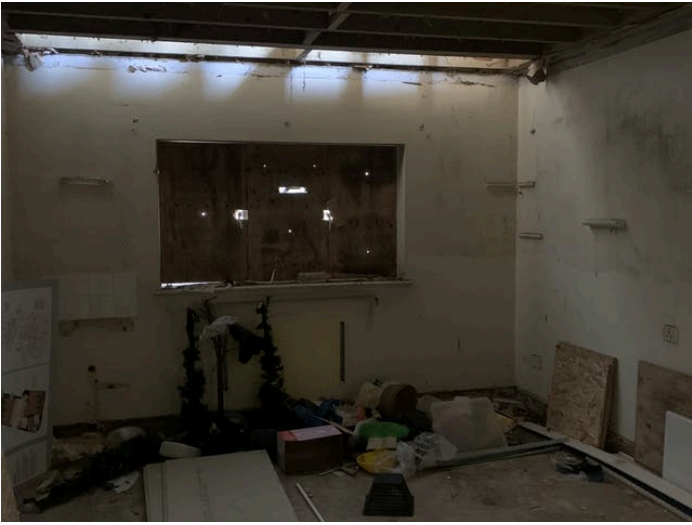
Building	Main Building	Level	0
Location	004 - Room 2	Item

Location Notes	Ceiling: Timber. Walls: Brick, plaster. Floor: Concrete.

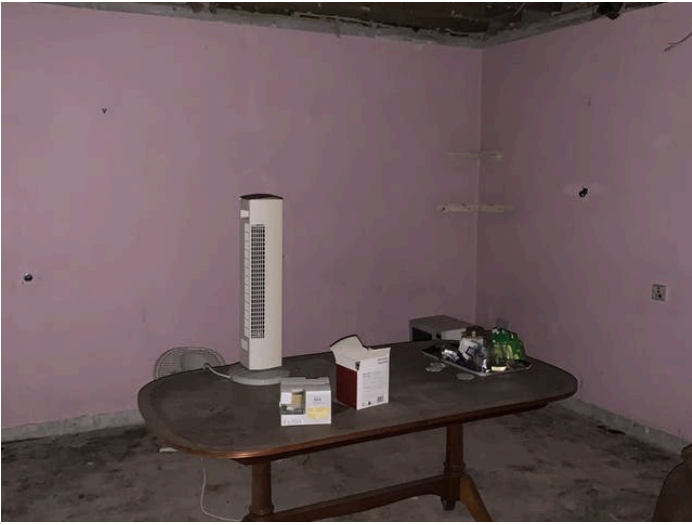
Building	Main Building	Level	0
Location	005 - Room 3	Item

Location Notes	Ceiling: Timber. Walls: Brick, plaster. Floor: Concrete.

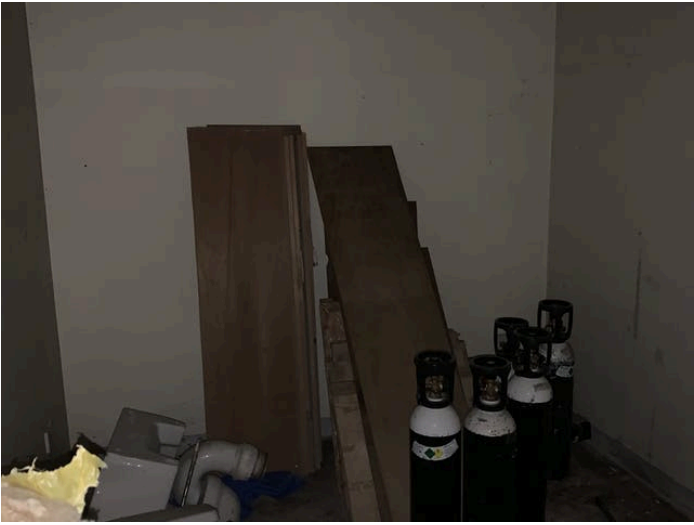
Building	Main Building	Level	0
Location	006 - Room 4	Item

Location Notes	Ceiling: Timber. Walls: Brick, plaster. Floor: Concrete.

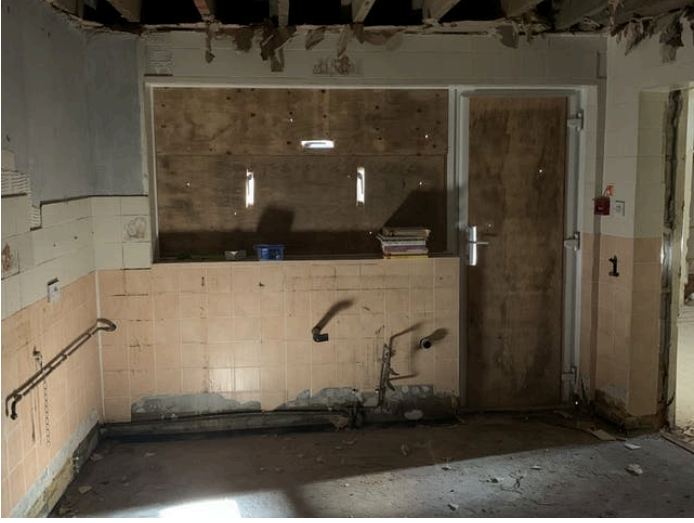
Building	Main Building	Level	0
Location	007 - Room 5	Item

Location Notes	Ceiling: Timber. Walls: Brick, plaster. Floor: Concrete.

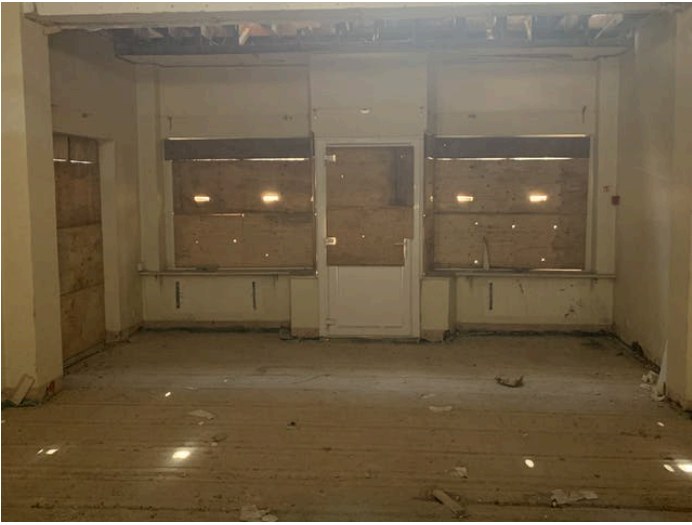
Building	Main Building	Level	0
Location	008 - Room 6	Item

Location Notes	Ceiling: Timber. Walls: Brick, plaster. Floor: Concrete.

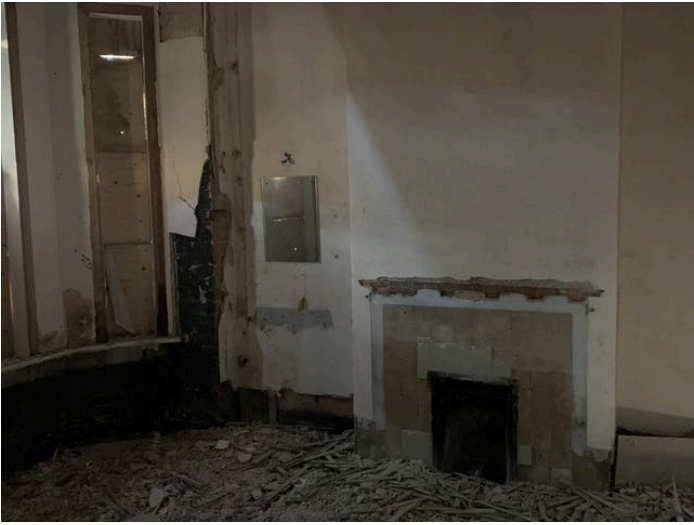
Building	Main Building	Level	0
Location	009 - Room 7	Item

Location Notes	Ceiling: Timber. Walls: Brick, plaster. Floor: Concrete.

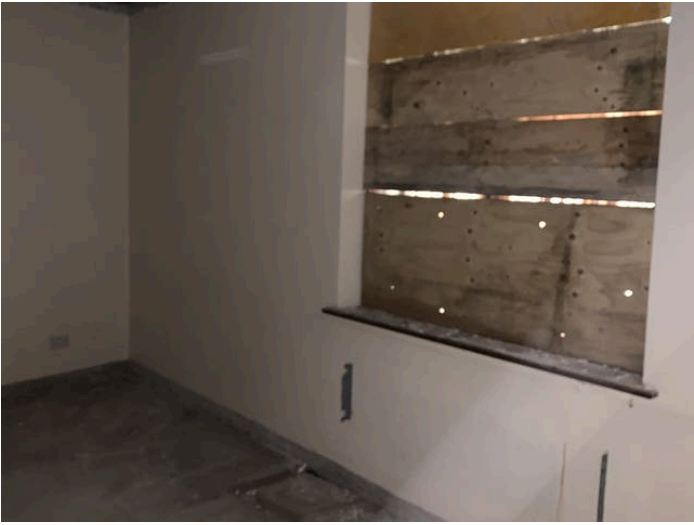
Building	Main Building	Level	0
Location	010 - Room 8	Item

Location Notes	Ceiling: Concrete. Walls: Brick, plaster. Floor: Concrete.

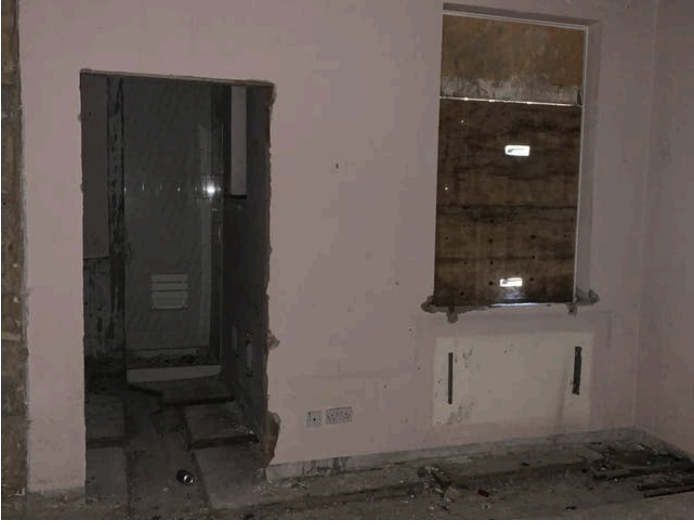
Building	Main Building	Level	0
Location	011 - Room 9	Item

Location Notes	Ceiling: Concrete. Walls: Brick, plaster. Floor: Concrete.

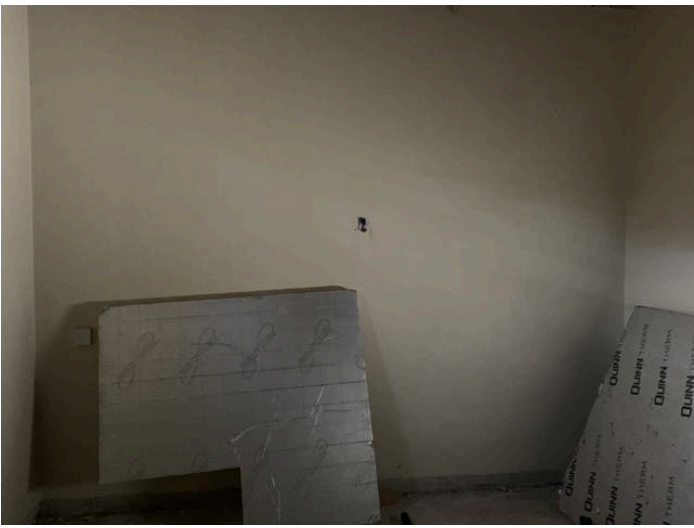
Building	Main Building	Level	0
Location	012 - Room 10	Item

Location Notes	Ceiling: Concrete. Walls: Brick, plaster. Floor: Concrete.

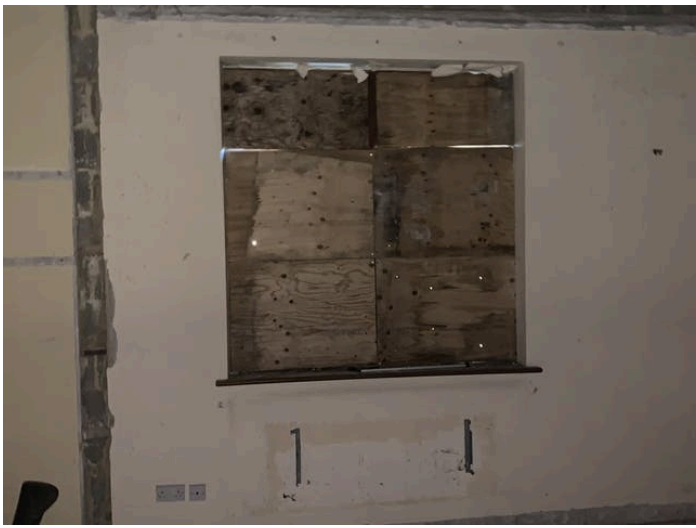
Building	Main Building	Level	0
Location	013 - Room 11	Item

Location Notes	Ceiling: Concrete. Walls: Brick, plaster. Floor: Concrete.

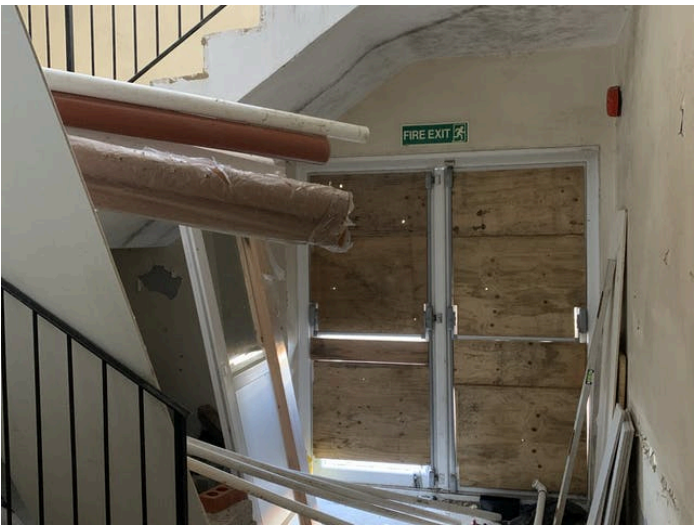
Building	Main Building	Level	0
Location	014 - Stair lobby	Item

Location Notes	Ceiling: Concrete. Walls: Brick, plaster. Floor: Concrete.

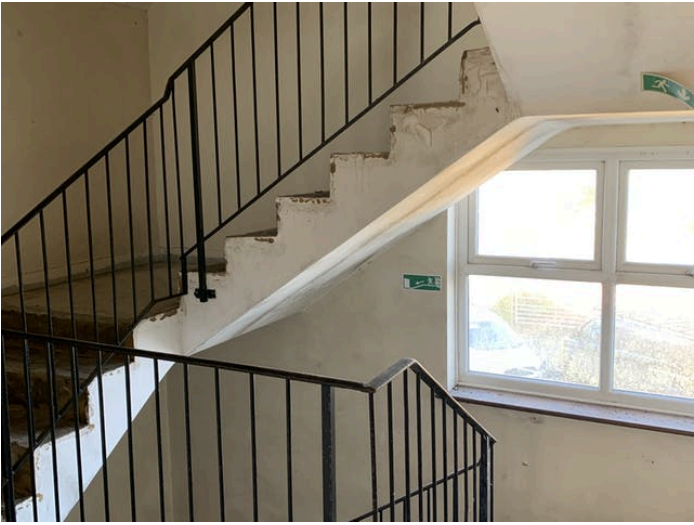
Building	Main Building	Level	1
Location	015 - Stair lobby	Item

Location Notes	Ceiling: Concrete. Walls: Brick, plaster. Floor: Concrete.

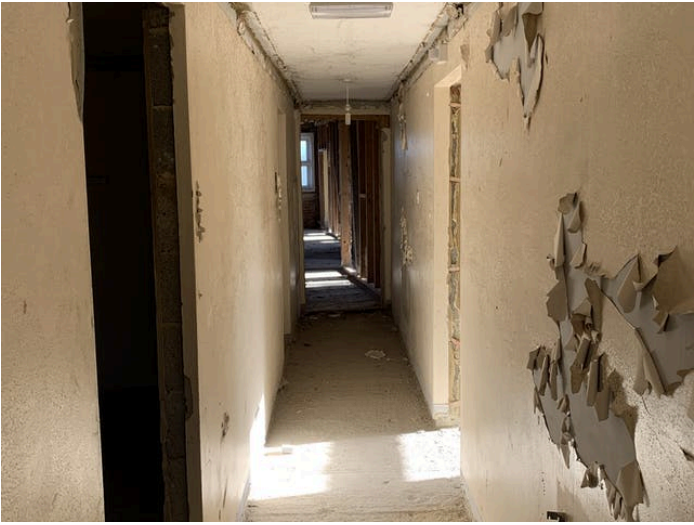
Building	Main Building	Level	1
Location	016 - Corridor	Item

Location Notes	Ceiling: Concrete. Walls: Brick, plaster. Floor: Concrete.

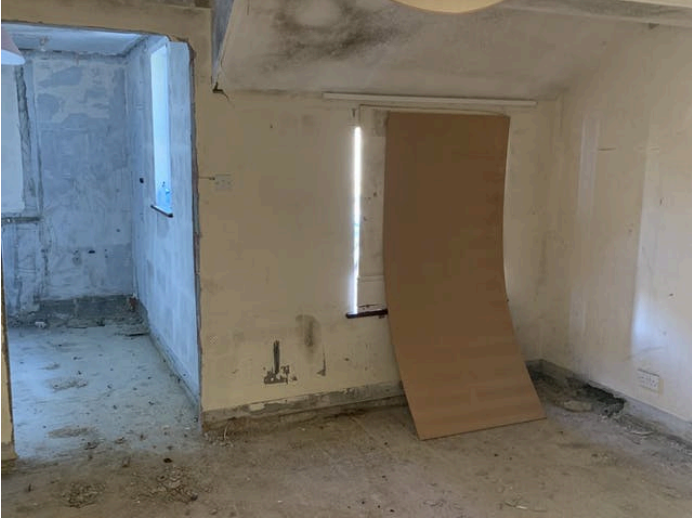
Building	Main Building	Level	1
Location	017 - Room 12	Item

Location Notes	Ceiling: Concrete. Walls: Brick, plaster. Floor: Concrete.

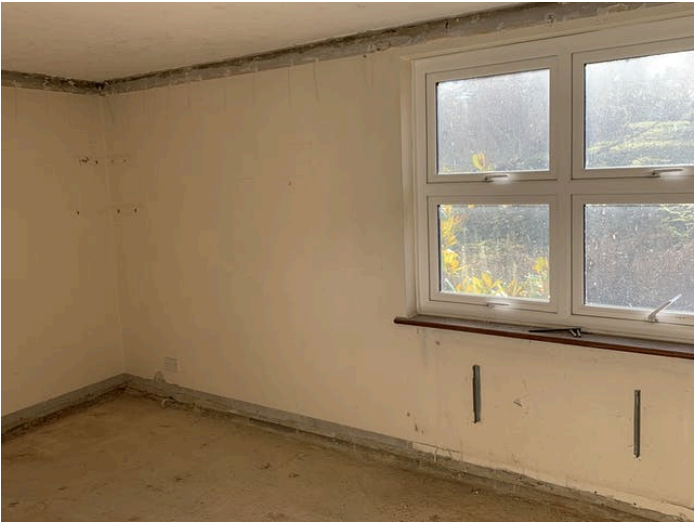
Building	Main Building	Level	1
Location	018 - Room 13	Item

Location Notes	Ceiling: Concrete. Walls: Brick, plaster. Floor: Concrete.

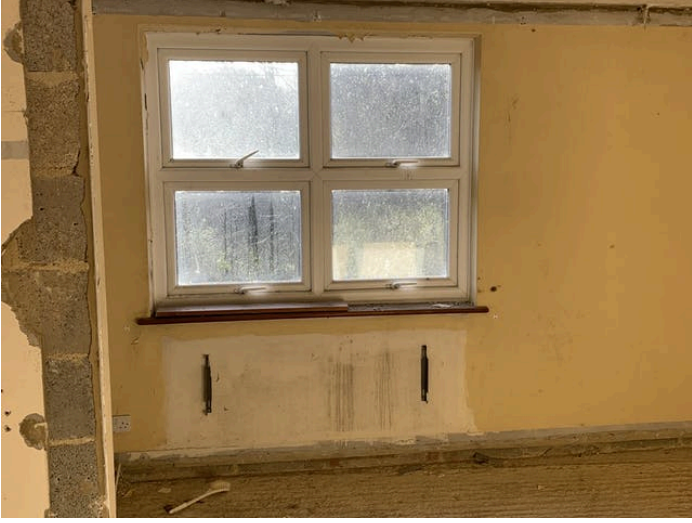
Building	Main Building	Level	1
Location	019 - Room 14	Item

Location Notes	Ceiling: Concrete. Walls: Brick, plaster. Floor: Concrete.

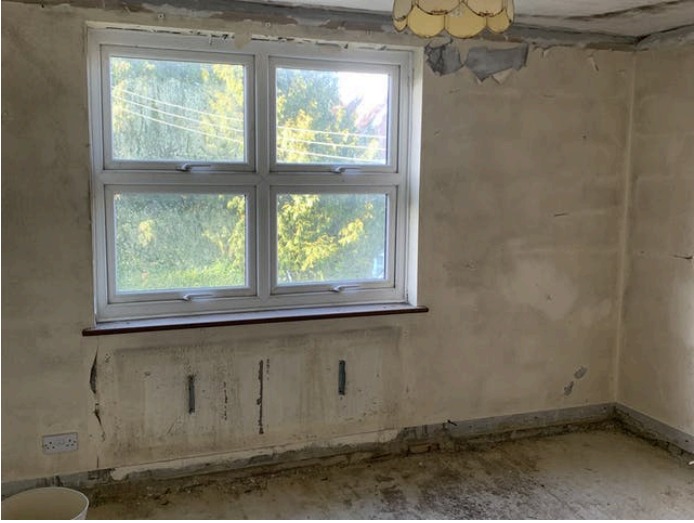
Building	Main Building	Level	1
Location	020 - Room 15	Item

Location Notes	Ceiling: Concrete. Walls: Brick, plaster. Floor: Concrete.

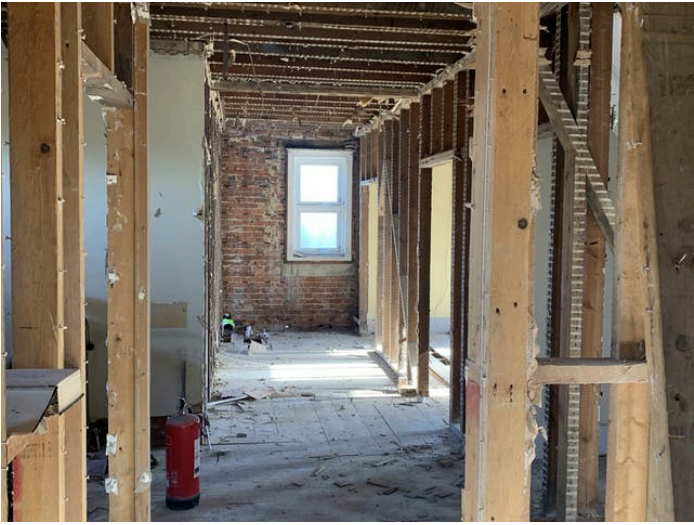
Building	Main Building	Level	1
Location	021 - Room 16	Item

Location Notes	Ceiling: Timber. Walls: Brick, plaster. Floor: Timber.

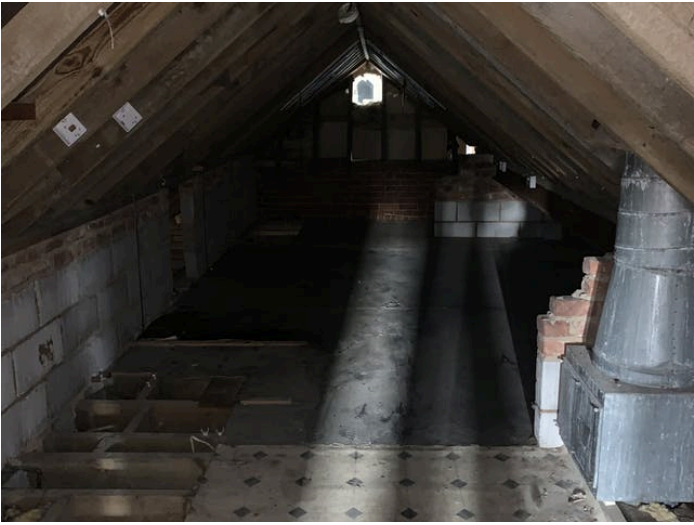
Building	Main Building	Level	1
Location	024 - Loft area	Item

Location Notes	Ceiling: Timber, modern felt. Walls: Brick, plaster. Floor: Timber, modern lino.

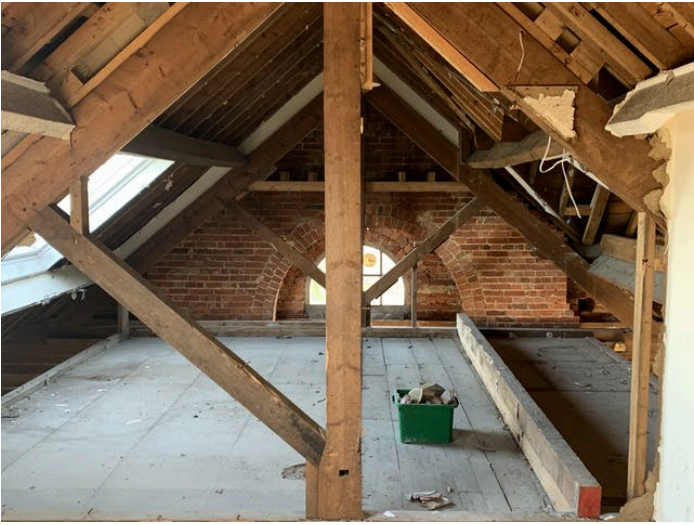
Building	Main Building	Level	2
Location	022 - Room 17	Item

Location Notes	Ceiling: Timber. Walls: Brick, plaster. Floor: Timber.

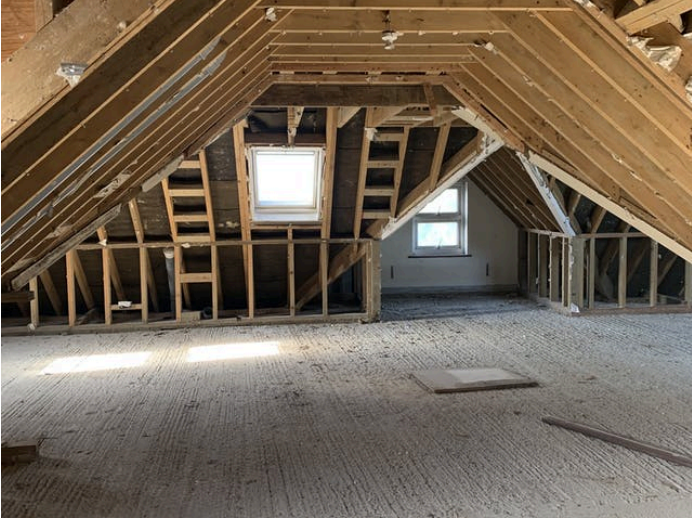
Building	Main Building	Level	2
Location	023 - Room 18	Item

Location Notes	Ceiling: Timber, modern felt. Walls: Brick, plaster. Floor: Concrete.

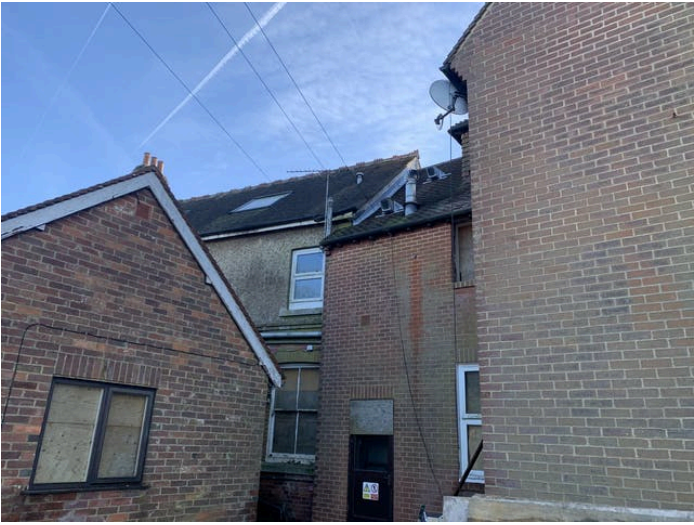
Building	Main Building	Level	External
Location	025 - All elevations	Item

Location Notes	Roof: Clay tiles. Walls: Brick. Rainwater goods: Plastic, metal.
