**Aspect Contracts Ltd**  
**Asbestos Survey for**  
**East Sussex County Council**

**Broad Oaks CPS**  
**Scotsford Road**  
**Heathfield**  
**TN21 8UD**

Project Number: ESCC3

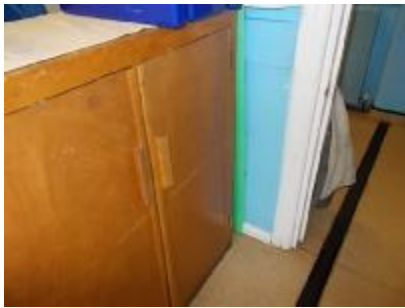
Location ID: 20619 Sample No: 1 Product Type: Asbestos Insulating Board

Material Comments:  
AIB low level wall panels as identified on original Type 2 report - 0212/309/B33/39 Visual Presumption

Damage: Low Damage

Action:  
Manage Monitor for Deterioration

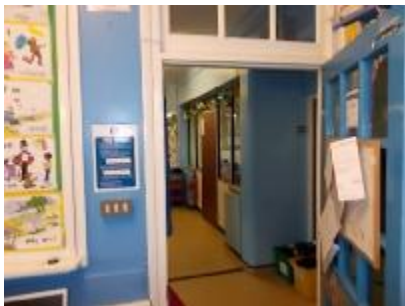
Location ID: 20620 Sample No: 2 Product Type: Asbestos Insulating Board

Material Comments:  
AIB low level wall panels as identified on original Type 2 report - 0212/309/B33/39 Visual Presumption

Damage: Low Damage

Action:  
Manage Monitor for Deterioration

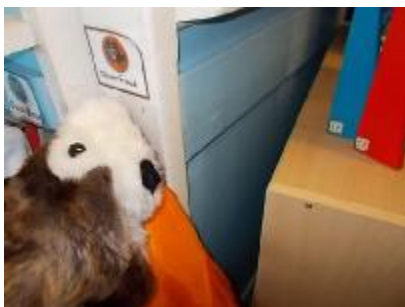
Location ID: 20621 Sample No: 3 Product Type: Asbestos Insulating Board

Material Comments:  
AIB low level wall panels as identified on original Type 2 report - 0212/309/B33/39 Visual Presumption

Damage: Low Damage

Action:  
Manage Monitor for Deterioration
