## **Condition Assessment of a 450mm DI Main at Cross Road, Deal**

**RP8737**

**Client:** Gladman

**Project:** 3142-005

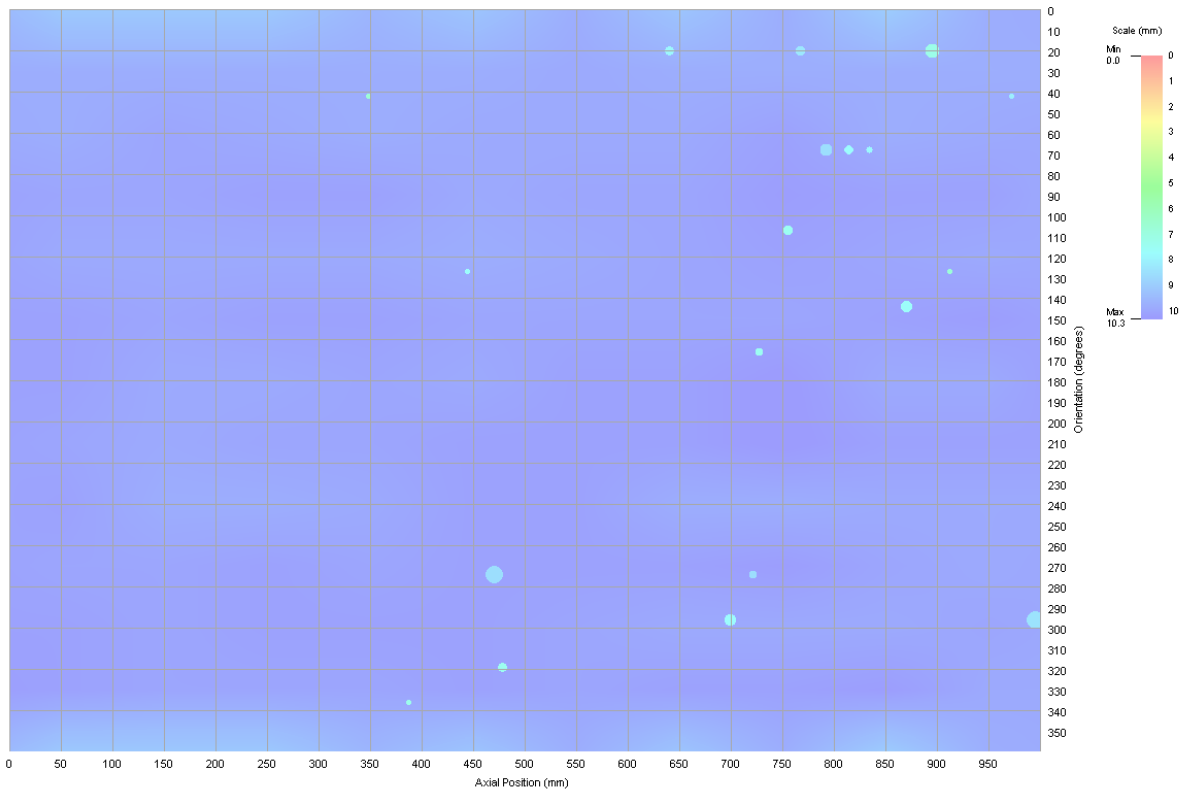
**FIGURE 4.1 REMAINING WALL THICKNESS PLOT**

Corrosion pitting at the inspected section was minimal with a loose cluster of shallow defects (up to around 30% of wall thickness in depth) appearing at the distal end of the scan between 20° and 150° from the pipe crown. The maximum defect was 3.2mm (32% wall thickness) in depth and originated from the internal pipe wall.

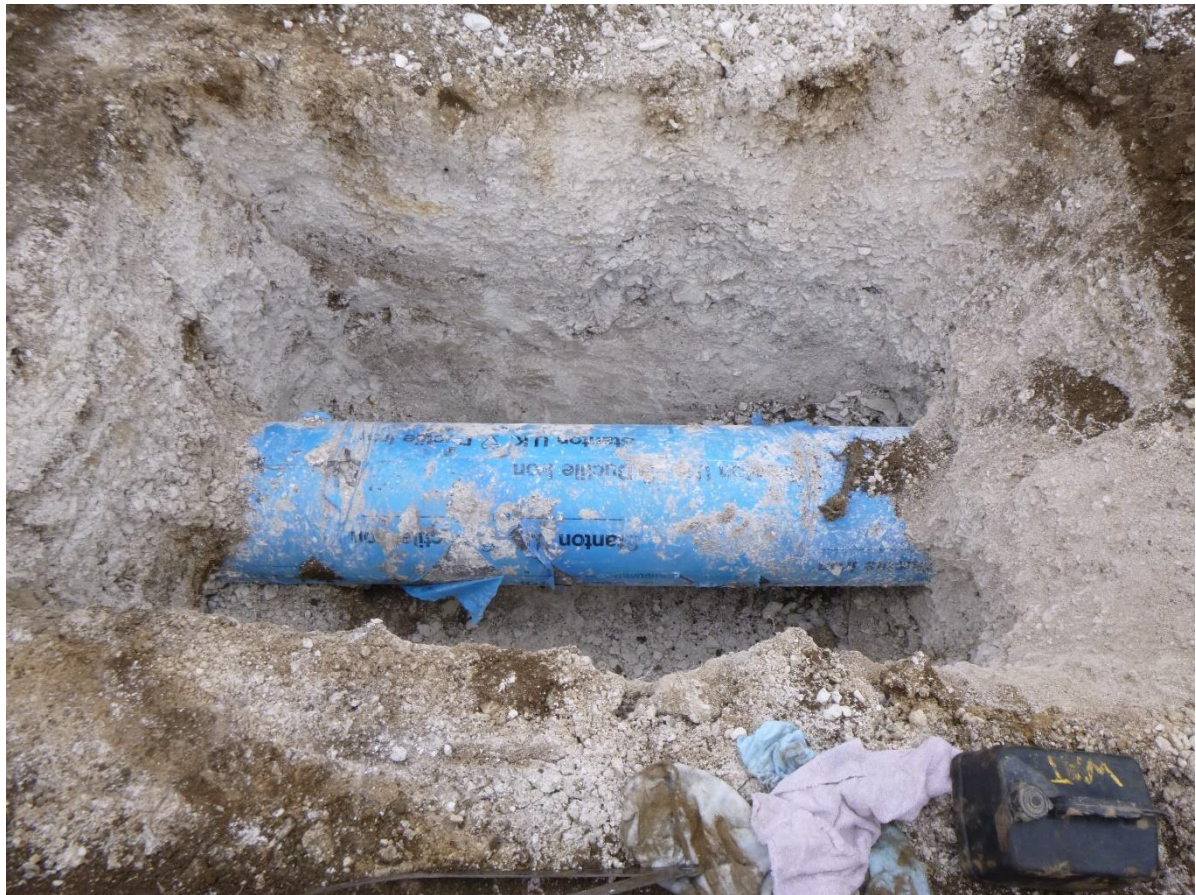
The pipe was protected by Stanguard wrapping and bitumen paint, both the wrap and bitumen paint displayed good overall condition and the pipe surface beneath the coating was also in good condition.

**FIGURE A1.3 – EXCAVATION AT INSPECTION SITE, STANGUARD WRAPPING IN GOOD CONDITION**

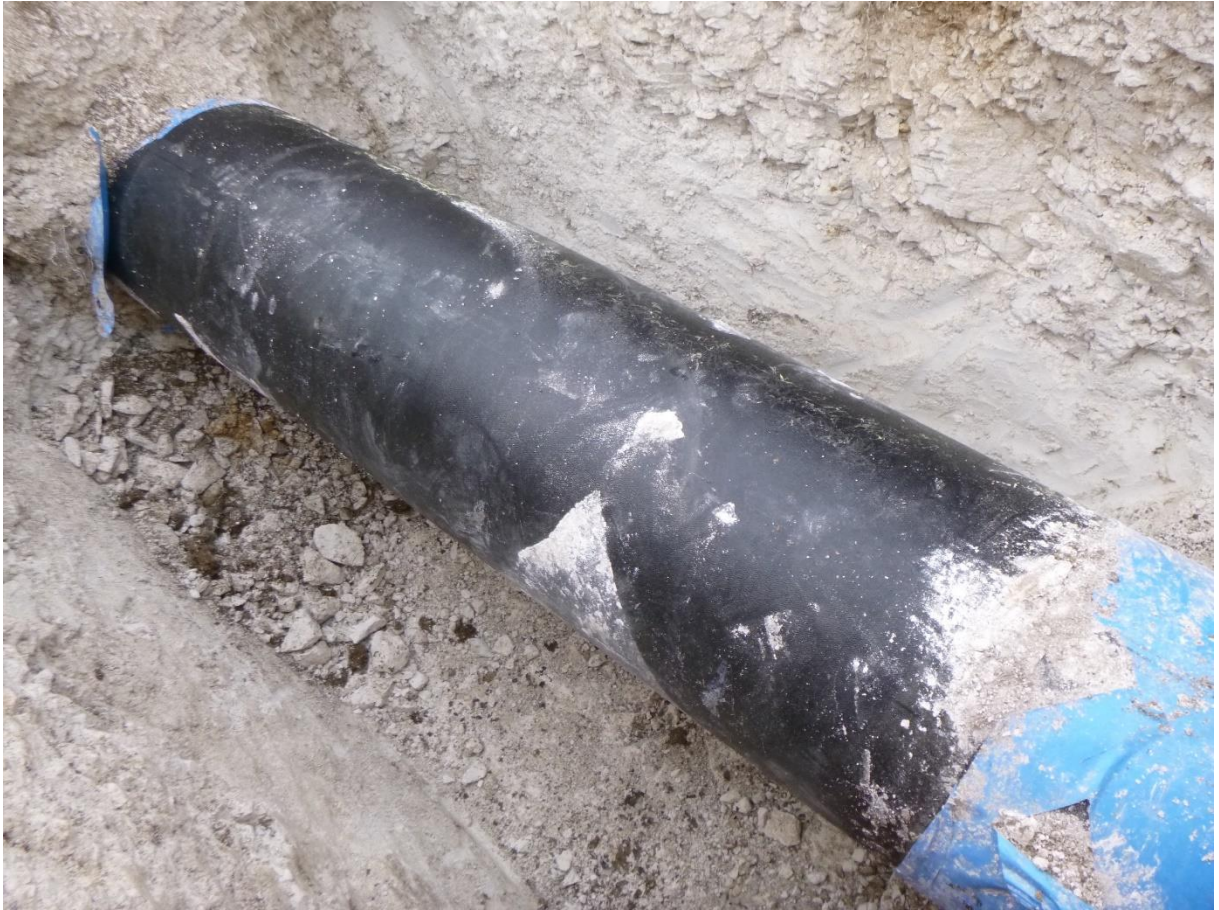
**FIGURE A1.4 – PIPE SURFACE BENEATH STANGUARD, GOOD CONDITION**

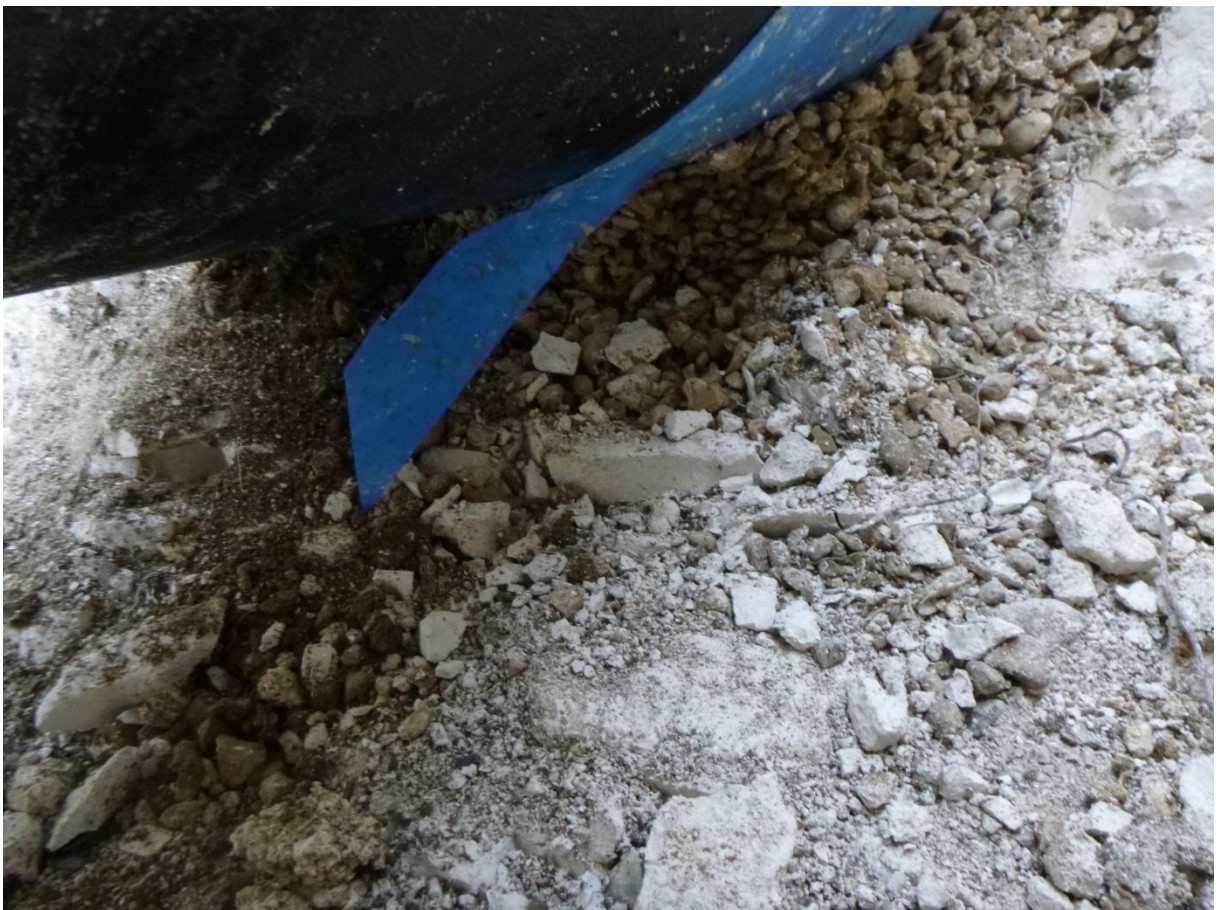
**FIGURE A1.5 – PEA GRAVEL BACKFILL IMMEDIATELY SURROUNDING PIPE**

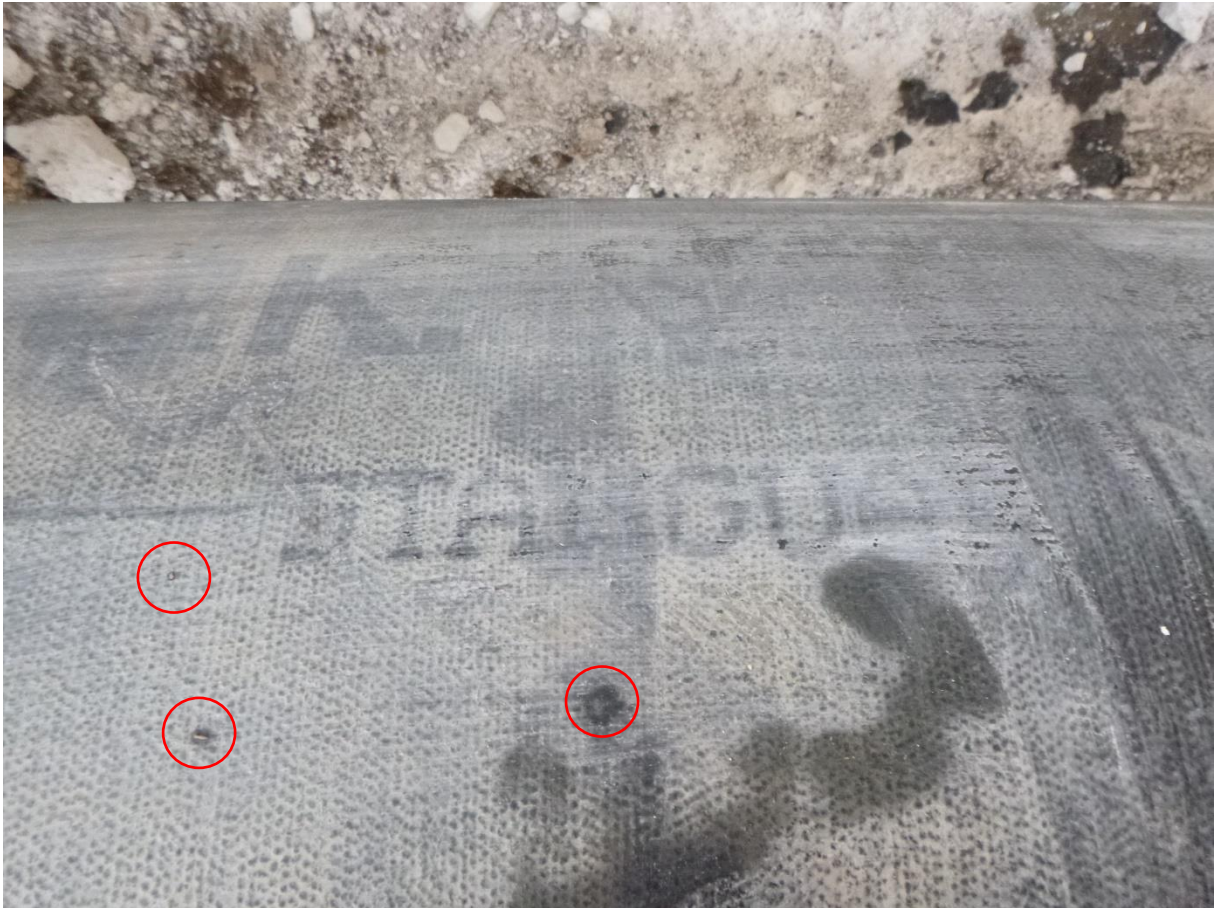
FIGURE A1.6 – CLOSE UP OF PIPE SURFACE, SUPERFICIAL EXTERNAL DEFECTS NOTED

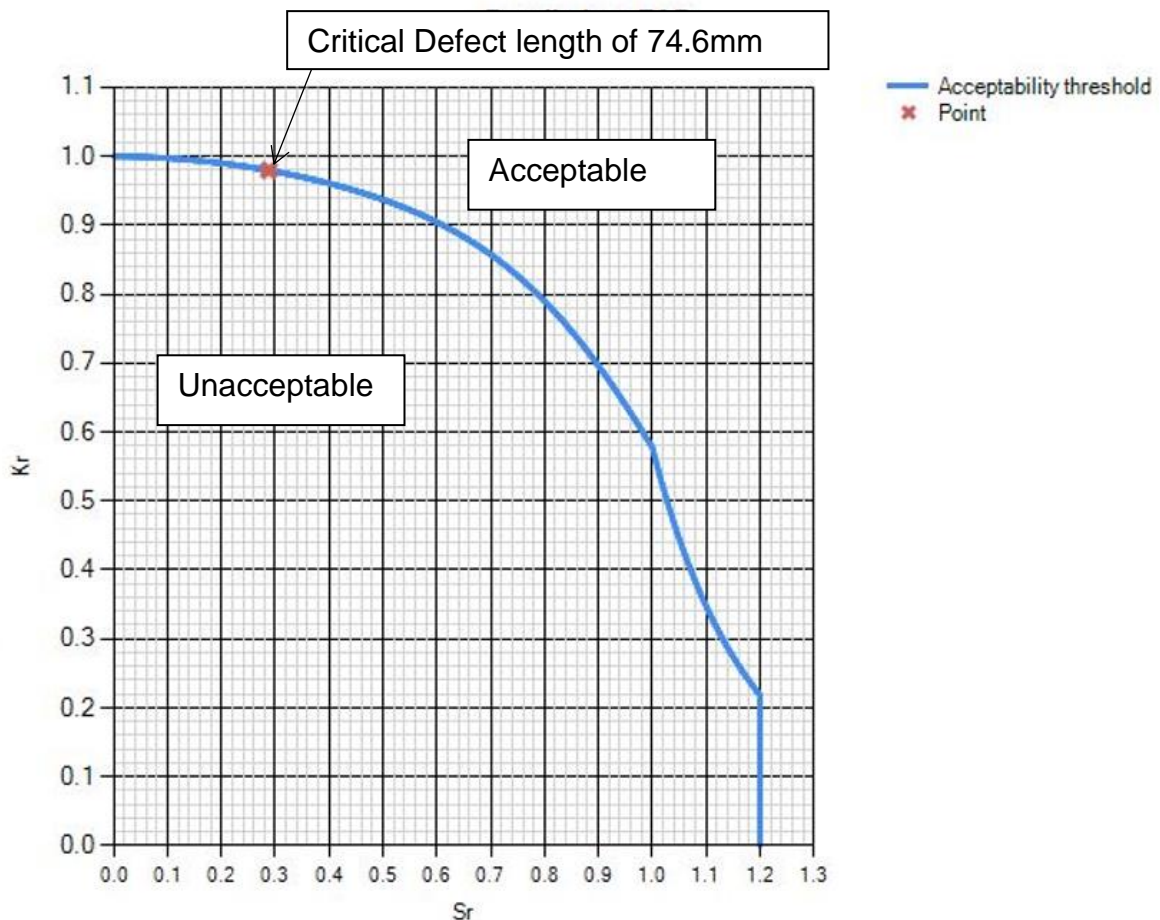
Further analysis was then carried out to determine the length of a through-wall corrosion defect that would be required to put the pipe at risk of structural failure. It was shown that a single defect of 74.6mm, coincident with the maximum point of stress would put the pipe at an unacceptable risk of structural failure.

**FIGURE A4.1 – FAD AT OPERATING PRESSURE WITH FIELD LOADING– CRITICAL LENGTH 74.6MM**

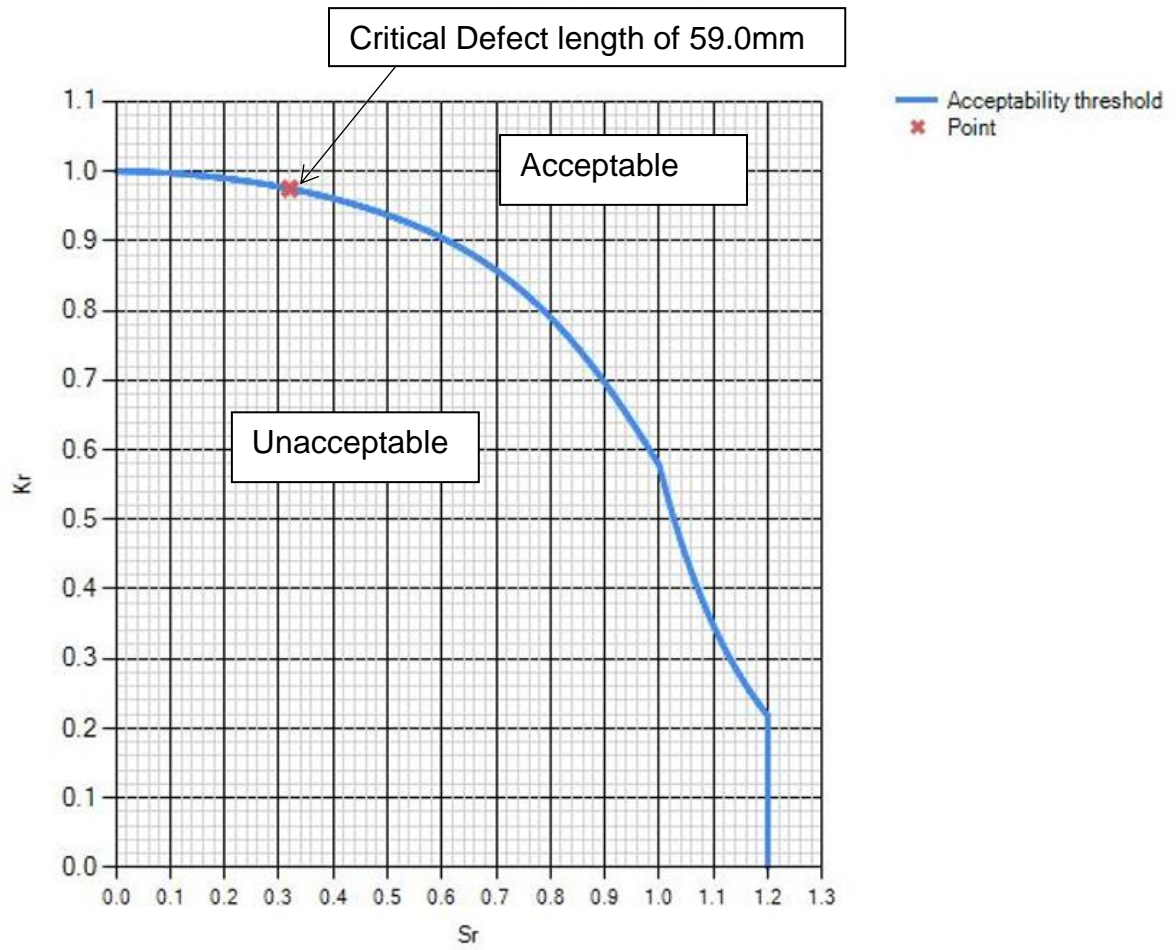
**FIGURE A4.2 – FAD AT SURGE PRESSURE WITH FIELD LOADING – CRITICAL LENGTH 59.0MM**
