Refurbishment & Demolition Survey

**Culls Farm
Dean Street
East Farleigh
Maidstone
ME15 0PS**

SURVEY ISSUE DATE: **17.08.2023**

SURVEY NUMBER: **SAS 6541**

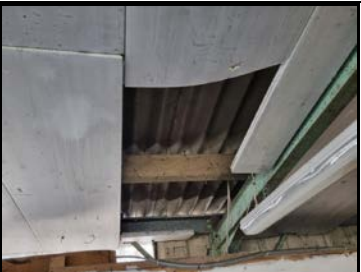
| Location | 005 - Car wash | | Item Description | Roof sheeting | | | Recommendations |
| Condition | 1 | Low damage | Accessibility | 0 | Usually inaccessible | | Risk Assessment Category |
| Surface Treatment | 1 | Enclosed sprays and lagging, asbestos insulating board, asbestos cement etc. | Potential for exposure | 0 | Very low | | D |
| Asbestos Type | 1 | Chrysotile | Maintenance Activity | 0 | Minor Disturbance | | |

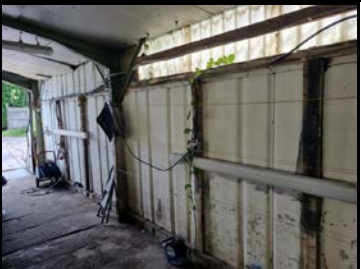
| Location | 005 - Car wash | | Item Description | Wall panels (CEM) | | | Recommendations |
| Condition | 1 | Low damage | Accessibility | 0 | Usually inaccessible | | Risk Assessment Category |
| Surface Treatment | 1 | Enclosed sprays and lagging, asbestos insulating board, asbestos cement etc. | Potential for exposure | 0 | Very low | | D |
| Asbestos Type | 1 | Chrysotile | Maintenance Activity | 0 | Minor Disturbance | | |

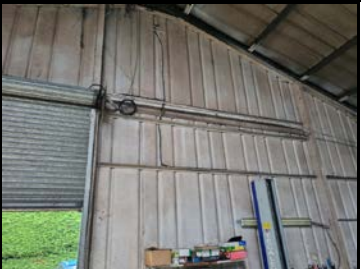
| Location | 007 - MOT area | | Item Description | Wall panels (CEM) | | | Recommendations |
| Condition | 1 | Low damage | Accessibility | 0 | Usually inaccessible | | Risk Assessment Category |

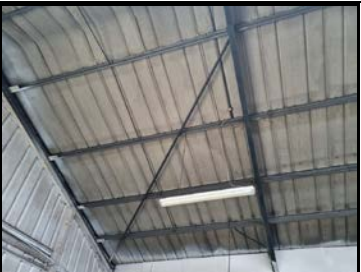
| Floor | Ground Floor | | Item Description | Roof sheeting | | | |
| Location | 007 - MOT area | | Extent | 220m2 | | | |
| Condition | 1 | Low damage | Potential for exposure | 0 | Very low | | |
| Surface Treatment | 1 | Enclosed sprays and lagging, asbestos insulating board, asbestos cement etc. | Maintenance Activity | 0 | Minor Disturbance | | |

| Asbestos Type | 1 | Chrysotile | Recommendations | | Remove | | |

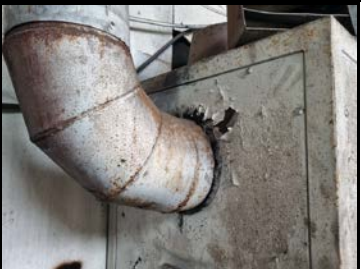
| Floor | Ground Floor | | Item Description | Flue seal | | | |
| Location | 007 - MOT area | | Extent | 1m | | | |
| Condition | 0 | N/A | Potential for exposure | 0 | N/A | | |

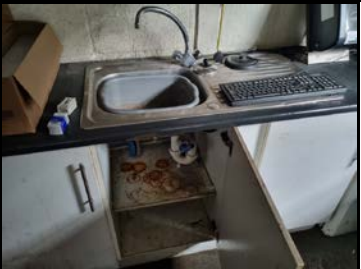
| Floor | Ground Floor | | Item Description | Sink pad | | | |
| Location | 008 - Office | | Extent | 1 unit | | | |
| Condition | 0 | N/A | Potential for exposure | 0 | N/A | | |

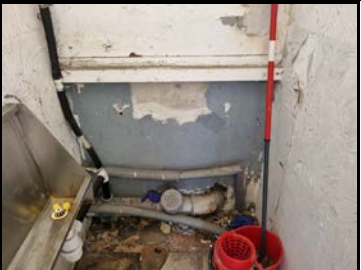
| Floor | Ground Floor | | Item Description | Wall panels (AIB) | | | |
| Location | 009 - W/C | | Extent | 20m2 | | | |
| Condition | 1 | Low damage | Potential for exposure | 0 | Very low | | |
| Surface Treatment | 1 | Enclosed sprays and lagging, asbestos insulating board, asbestos cement etc. | Maintenance Activity | 0 | Minor Disturbance | | |
| Asbestos Type | 2 | Amphibole asbestos excluding crocidolite | D | | | | |

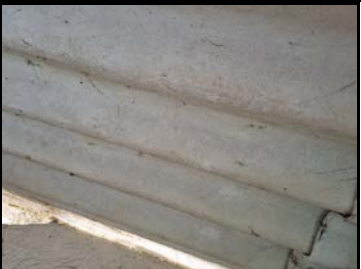
| Floor | Ground Floor | | Item Description | Roof sheeting | | | |
| Location | 009 - W/C | | Extent | 4m2 | | | |
| Condition | 1 | Low damage | Potential for exposure | 0 | Very low | | |
| Surface Treatment | 1 | Enclosed sprays and lagging, asbestos insulating board, asbestos cement etc. | Maintenance Activity | 0 | Minor Disturbance | | |
| Asbestos Type | 1 | Chrysotile | D | | | | |

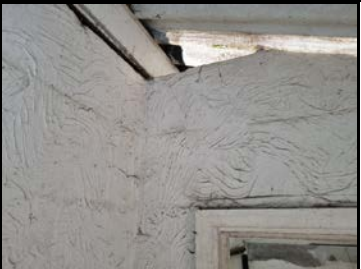
| Floor | Ground Floor | | Item Description | Textured coating to walls | | | |
| Location | 009 - W/C | | Extent | 40m2 | | | |
| Condition | 0 | N/A | Potential for exposure | 0 | N/A | | |

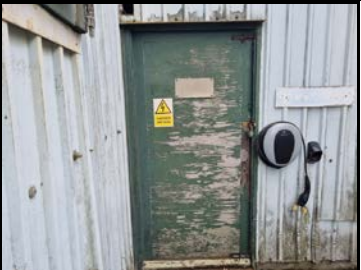
| Building | Culls Farm | | Comments | No Access Gained: No key at time of survey. | | | |
| Location | 010 - Electrical room | | Extent | N/A | | | |

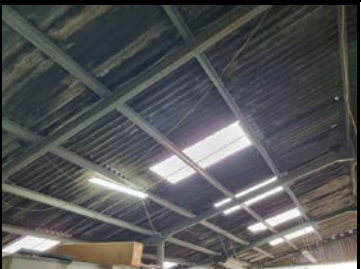
| Building | Floor | Location | Item Description | Risk Assessment Score | Recommendation |
|---|---|---|---|---|---|
| Culls Farm | Ground Floor | 011 - Body repair | Roof sheeting | 4 | Remove |

| Floor | Ground Floor | | Item Description | Roof sheeting | | | |
| Location | 011 - Body repair | | Extent | 240m2 | | | |
| Condition | 1 | Low damage | Potential for exposure | 0 | Very low | | |
| Surface Treatment | 1 | Enclosed sprays and lagging, asbestos insulating board, asbestos cement etc. | Maintenance Activity | 0 | Minor Disturbance | | |
| Asbestos Type | 1 | Chrysotile | D | | | Risk Assessment Category | |

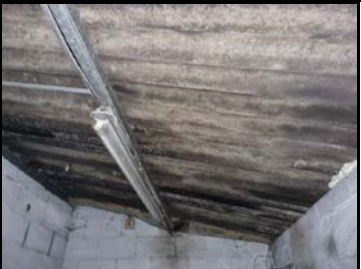
| Floor | Ground Floor | | Item Description | Roof sheeting | | | |
| Location | 016 - Stores | | Extent | 10m2 | | | |
| Condition | 1 | Low damage | Potential for exposure | 0 | Very low | | |

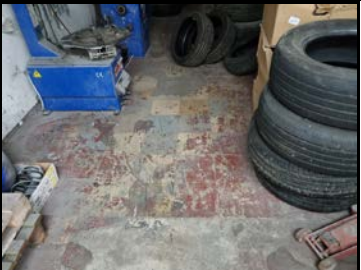
| Location | 018 - Stores | | Item Description | Floor tiles | | Recommendations | |
| Condition | 0 | N/A | Accessibility | 0 | N/A | | |

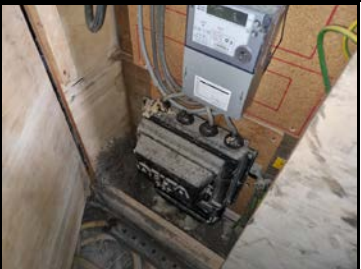
| Building | Culls Farm | | Comments | Presumed rope seals / flash guards. No isolation cert. / electrician present at time of survey. | | | |
| Location | 019 - Compressor room | | Item Description | Electrics | | Recommendations | |
| Condition | 1 | Low damage | Accessibility | 0 | Usually inaccessible | | |
| Asbestos Type | 3 | Crocidolite | Maintenance Activity | 0 | Minor Disturbance | | |

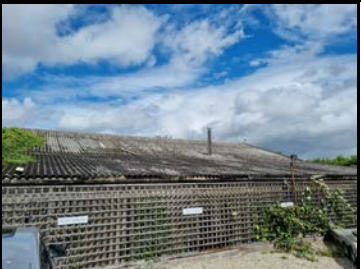
| Location | 001 - External | | Item Description | Corrugated sheeting | | Recommendations | |
| Condition | 1 | Low damage | Accessibility | 0 | Usually inaccessible | | |

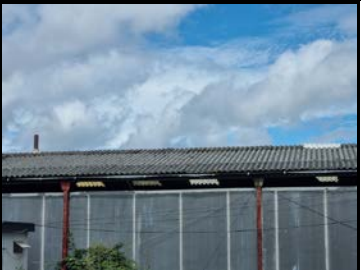
| Location | 001 - External | | Item Description | Corrugated sheeting | | | Recommendations |
| Condition | 1 | Low damage | Accessibility | 0 | Usually inaccessible | | Risk Assessment Category |
| Surface Treatment | 1 | Enclosed sprays and lagging, asbestos insulating board, asbestos cement etc. | Potential for exposure | 0 | Very low | | D |
| Asbestos Type | 1 | Chrysotile | Maintenance Activity | 0 | Minor Disturbance | | |

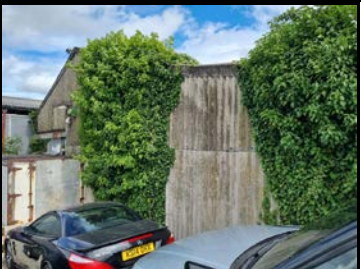
| Location | 001 - External | | Item Description | Corrugated sheeting | | | Recommendations |
| Condition | 1 | Low damage | Accessibility | 0 | Usually inaccessible | | Risk Assessment Category |
| Surface Treatment | 1 | Enclosed sprays and lagging, asbestos insulating board, asbestos cement etc. | Potential for exposure | 0 | Very low | | D |
| Asbestos Type | 1 | Chrysotile | Maintenance Activity | 0 | Minor Disturbance | | |

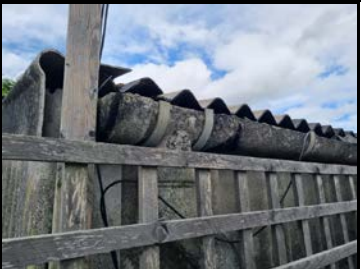
| Location | 001 - External | | Item Description | Rainwater goods | | | Recommendations |
| Condition | 1 | Low damage | Accessibility | 0 | Usually inaccessible | | Risk Assessment Category |

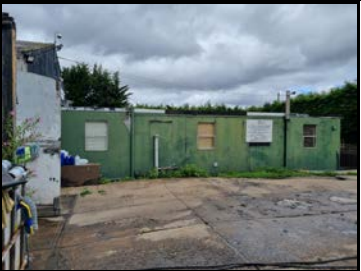
| Floor | External | | Item Description | Render to walls | | Recommendations | |
| Location | 002 - External | | Extent | 120m2 | | | |
| Condition | 0 | N/A | Potential for exposure | 0 | N/A | | |

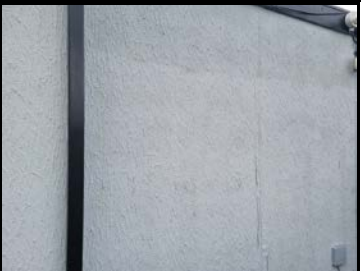
| Floor | External | | Item Description | Render to walls | | Recommendations | |
| Location | 003 - External | | Extent | 160m2 | | | |
| Condition | 0 | N/A | Potential for exposure | 0 | N/A | | |
