# Arboricultural survey, constraints and impact assessment

Client and Address:	c/o Wells Design, Hollywood House,				
	76 Hollywood Lane, Rochester, Kent				
	ME3 8AR				
Inspector:	B.Larkham, Dip.Arb.(RFS),				
	Tech.Cert.(Arbor.A), F.Arbor.A.				
Date of Inspection:	13 <sup>th</sup> May 2023				
Date of Report:	15 <sup>th</sup> May 2023 and 21 <sup>st</sup> June 2023				
Reference no.:	tr-1720-23 AIA

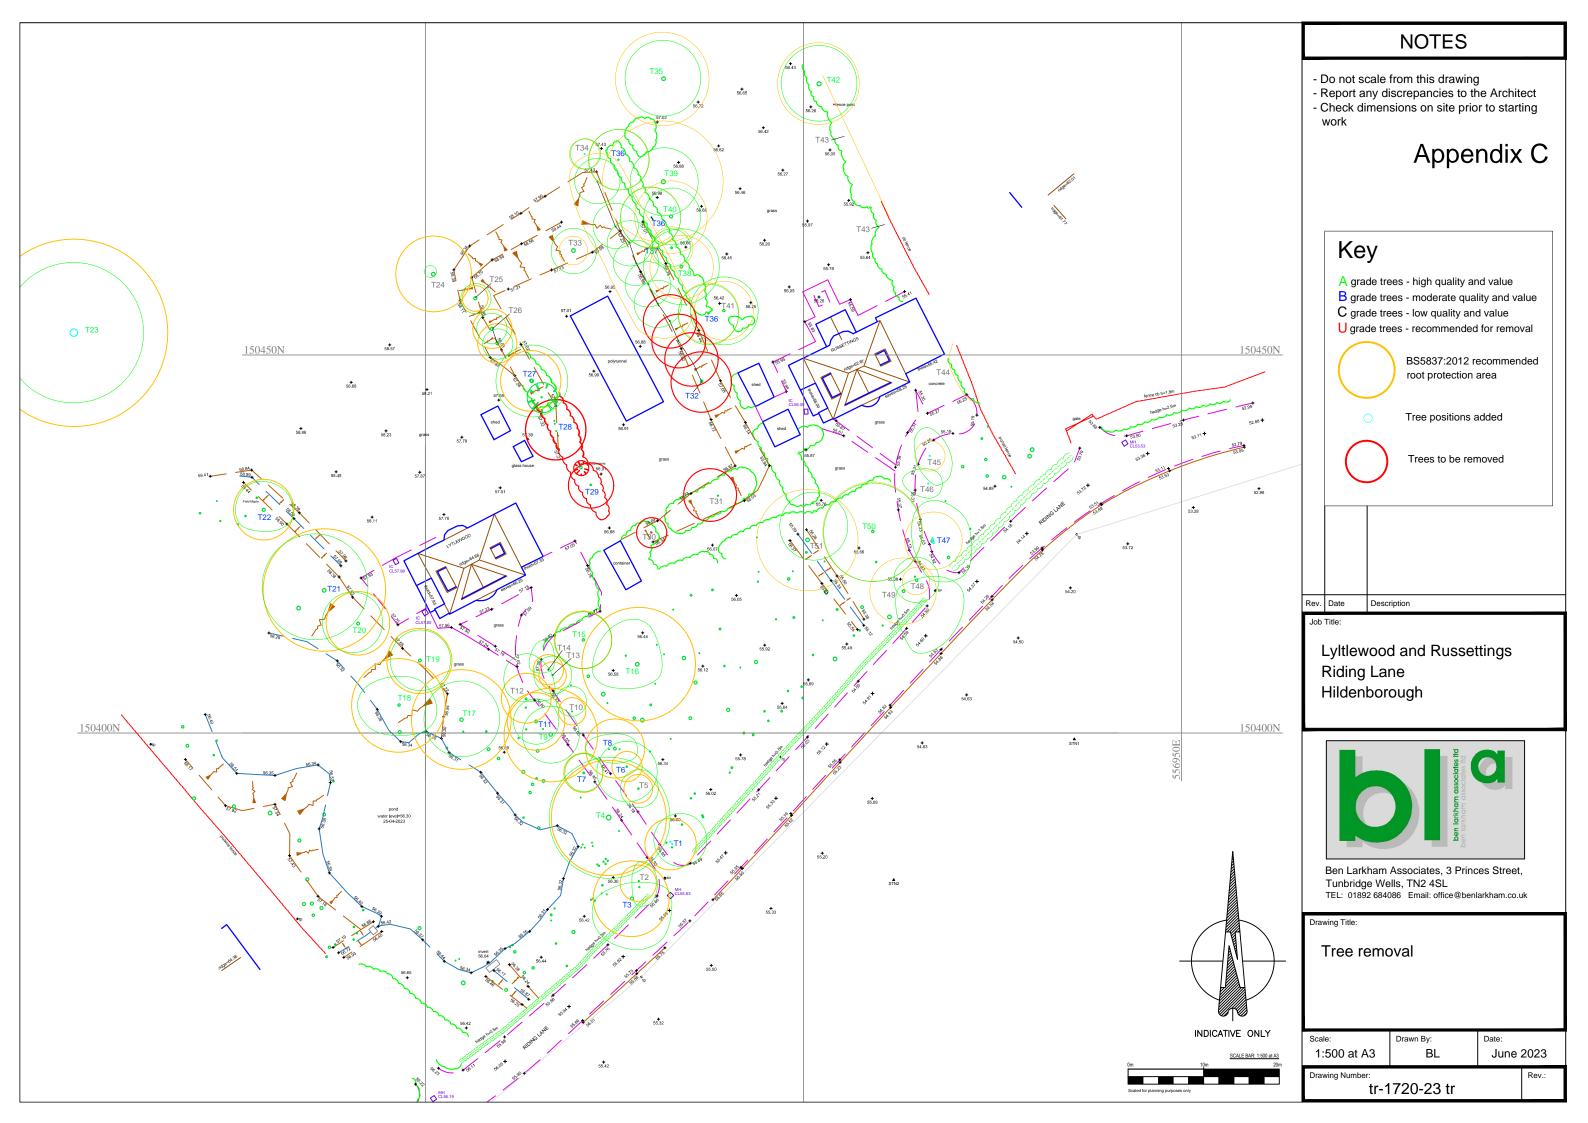
Appendix C – Tree removal

- 7.3 The proposal would require the removal of only four individual trees T28-T31 and four trees from group T32. Tree T28 damson is graded B1/C1, T28 beech B1/C1, tree T30 field maple C1, T31 strawberry tree C1 and four apple trees from group t32 have been graded B2.

- 7.4 Those trees requiring removal are indicated with a red outline at Appendix C based on the proposed new layout. None of the trees to be removed are considered significant in the landscape or important contributors to local amenity. Further shrub planting and hedging would also be removed which is not recorded within the survey.
