Title: BS5837 Tree Report

Site: St Pauls Vicarage,
Boxley Road,
Maidstone
Kent
ME14 2AH

Client: Hill-Wood & Co. (Kent) Limited

Reference: L845AIA

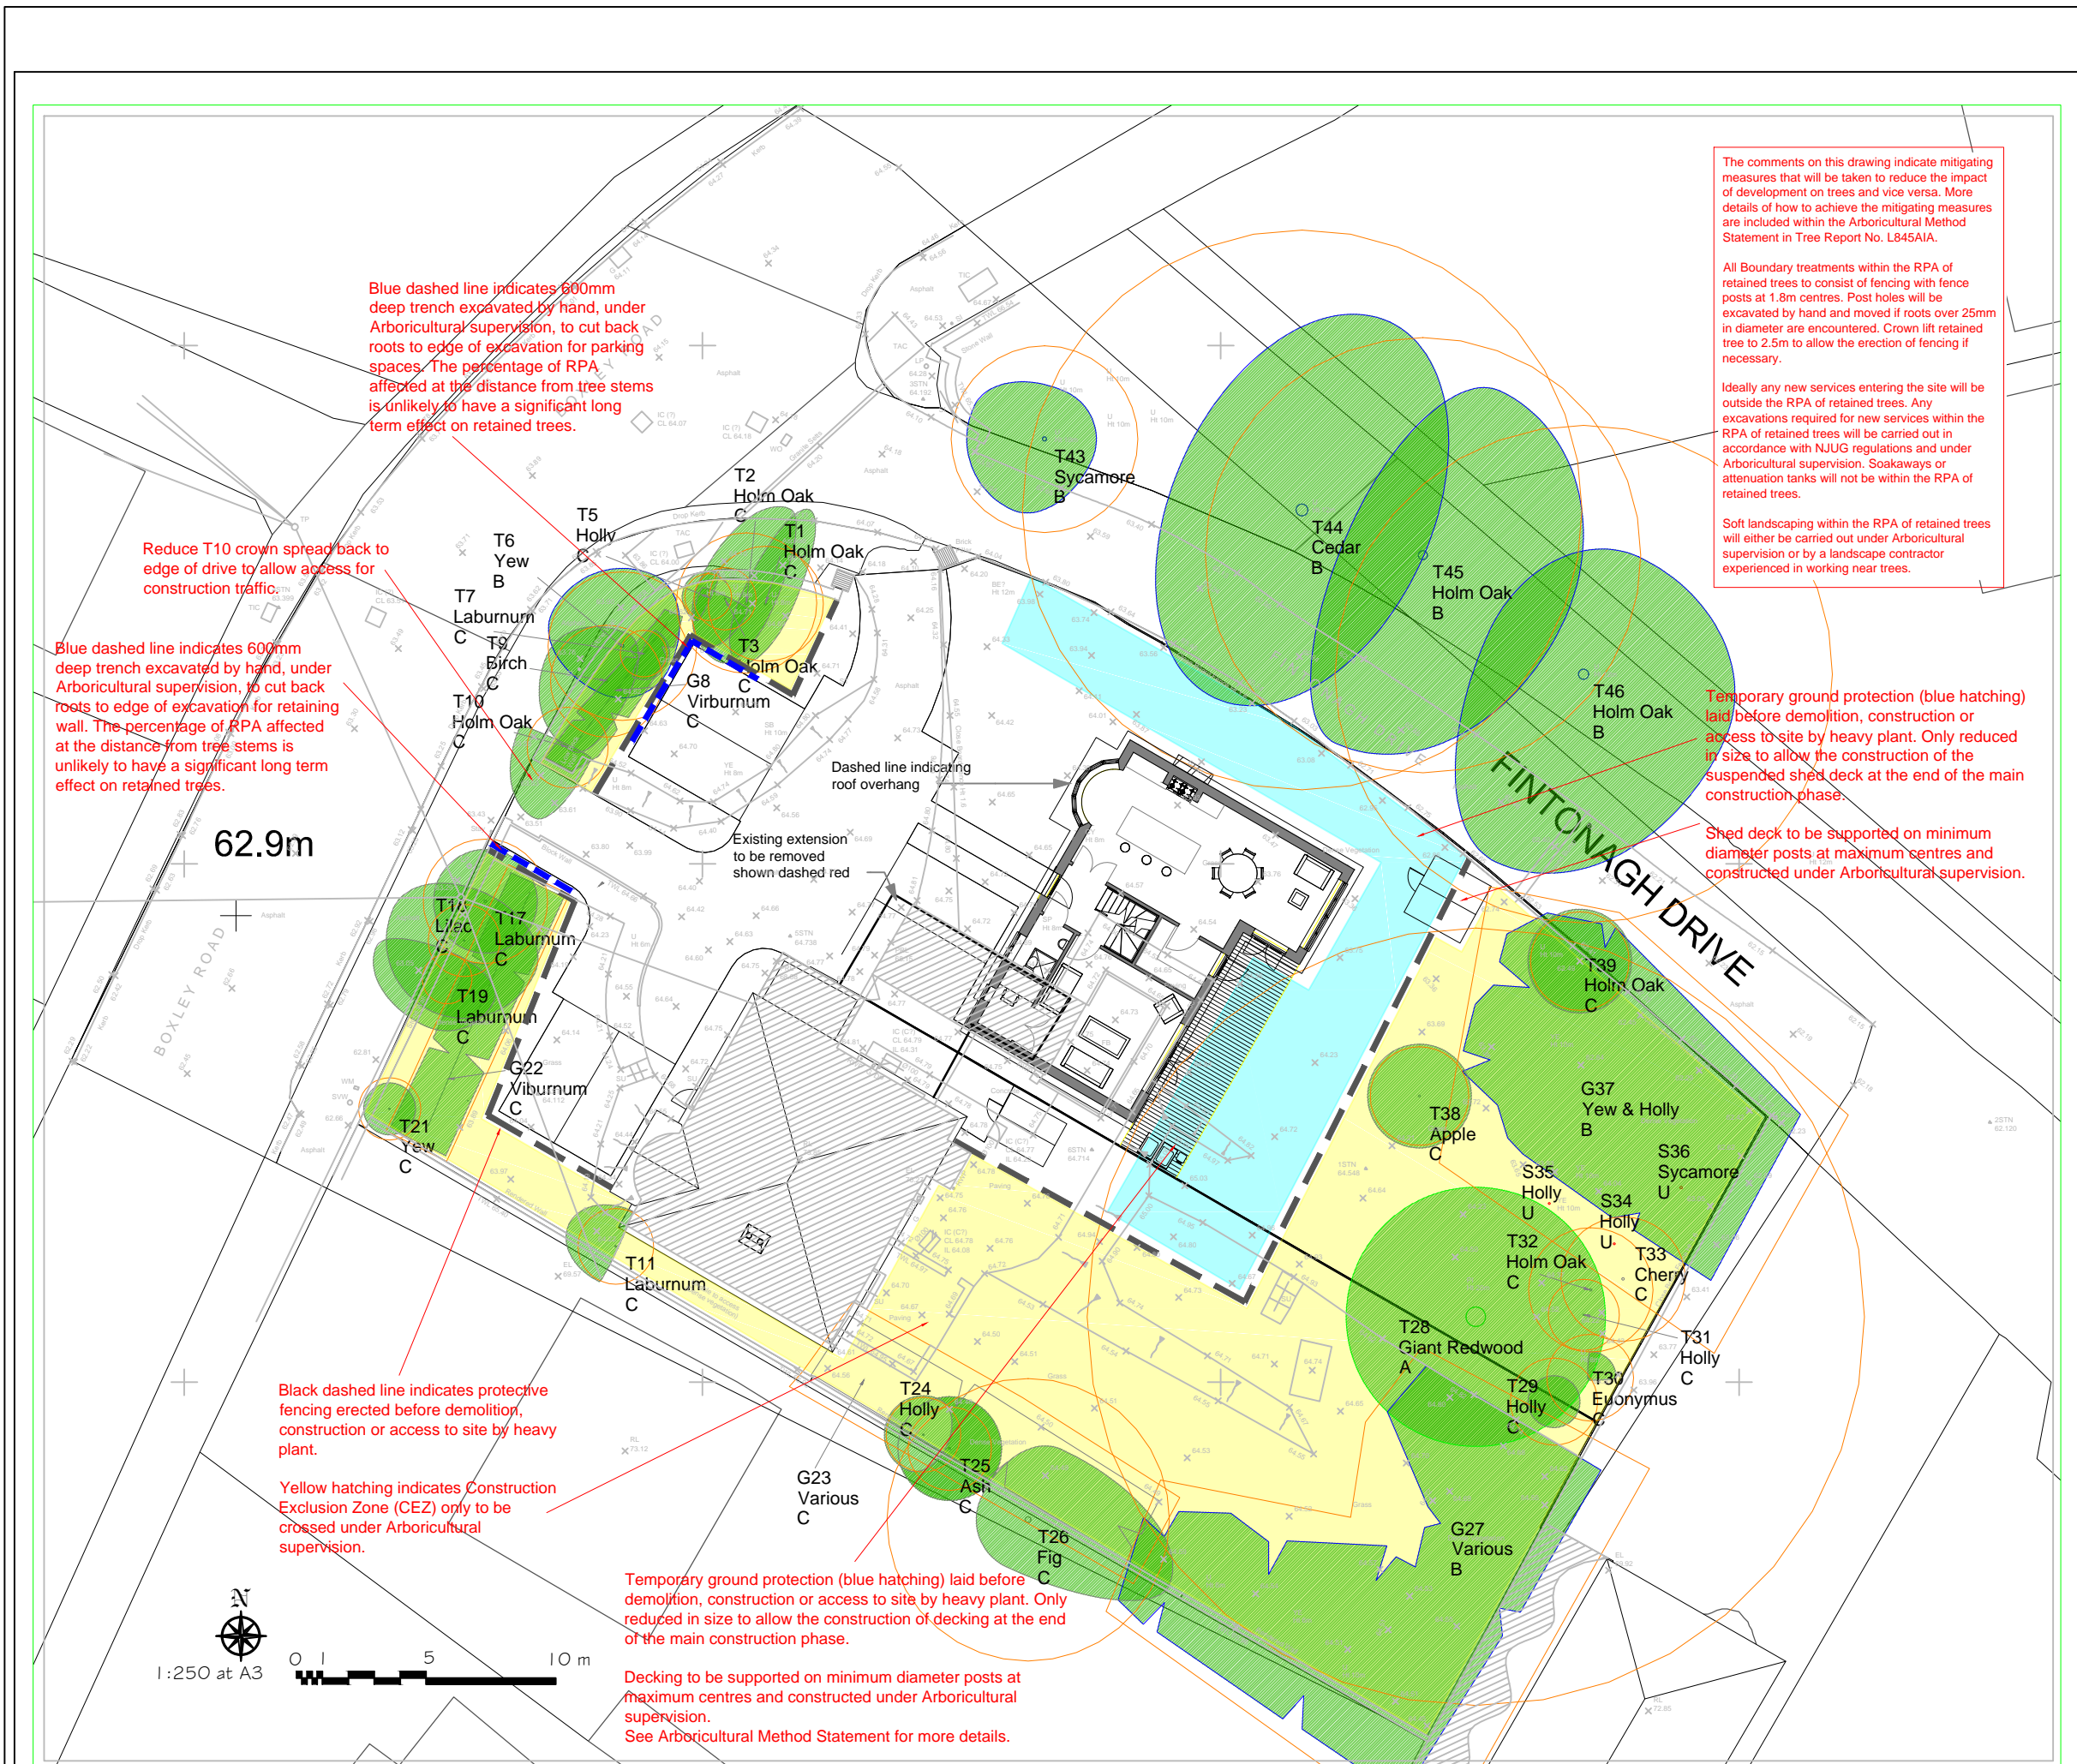
Please see attached drawing L845TPP.

Blue dashed line indicates 600mm deep trench excavated by hand, under Arboricultural supervision, to cut back roots to edge of excavation for parking spaces. The percentage of RPA affected at the distance from tree stems is unlikely to have a significant long term effect on retained trees.

Reduce T10 crown spread back to edge of drive to allow access for construction traffic.
