# Arboricultural Impact Assessment

Land at Burfield Valley  
Reef Way  
Hailsham

4<sup>th</sup> May 2018

PJC ref: 4830/18-02 Rev -

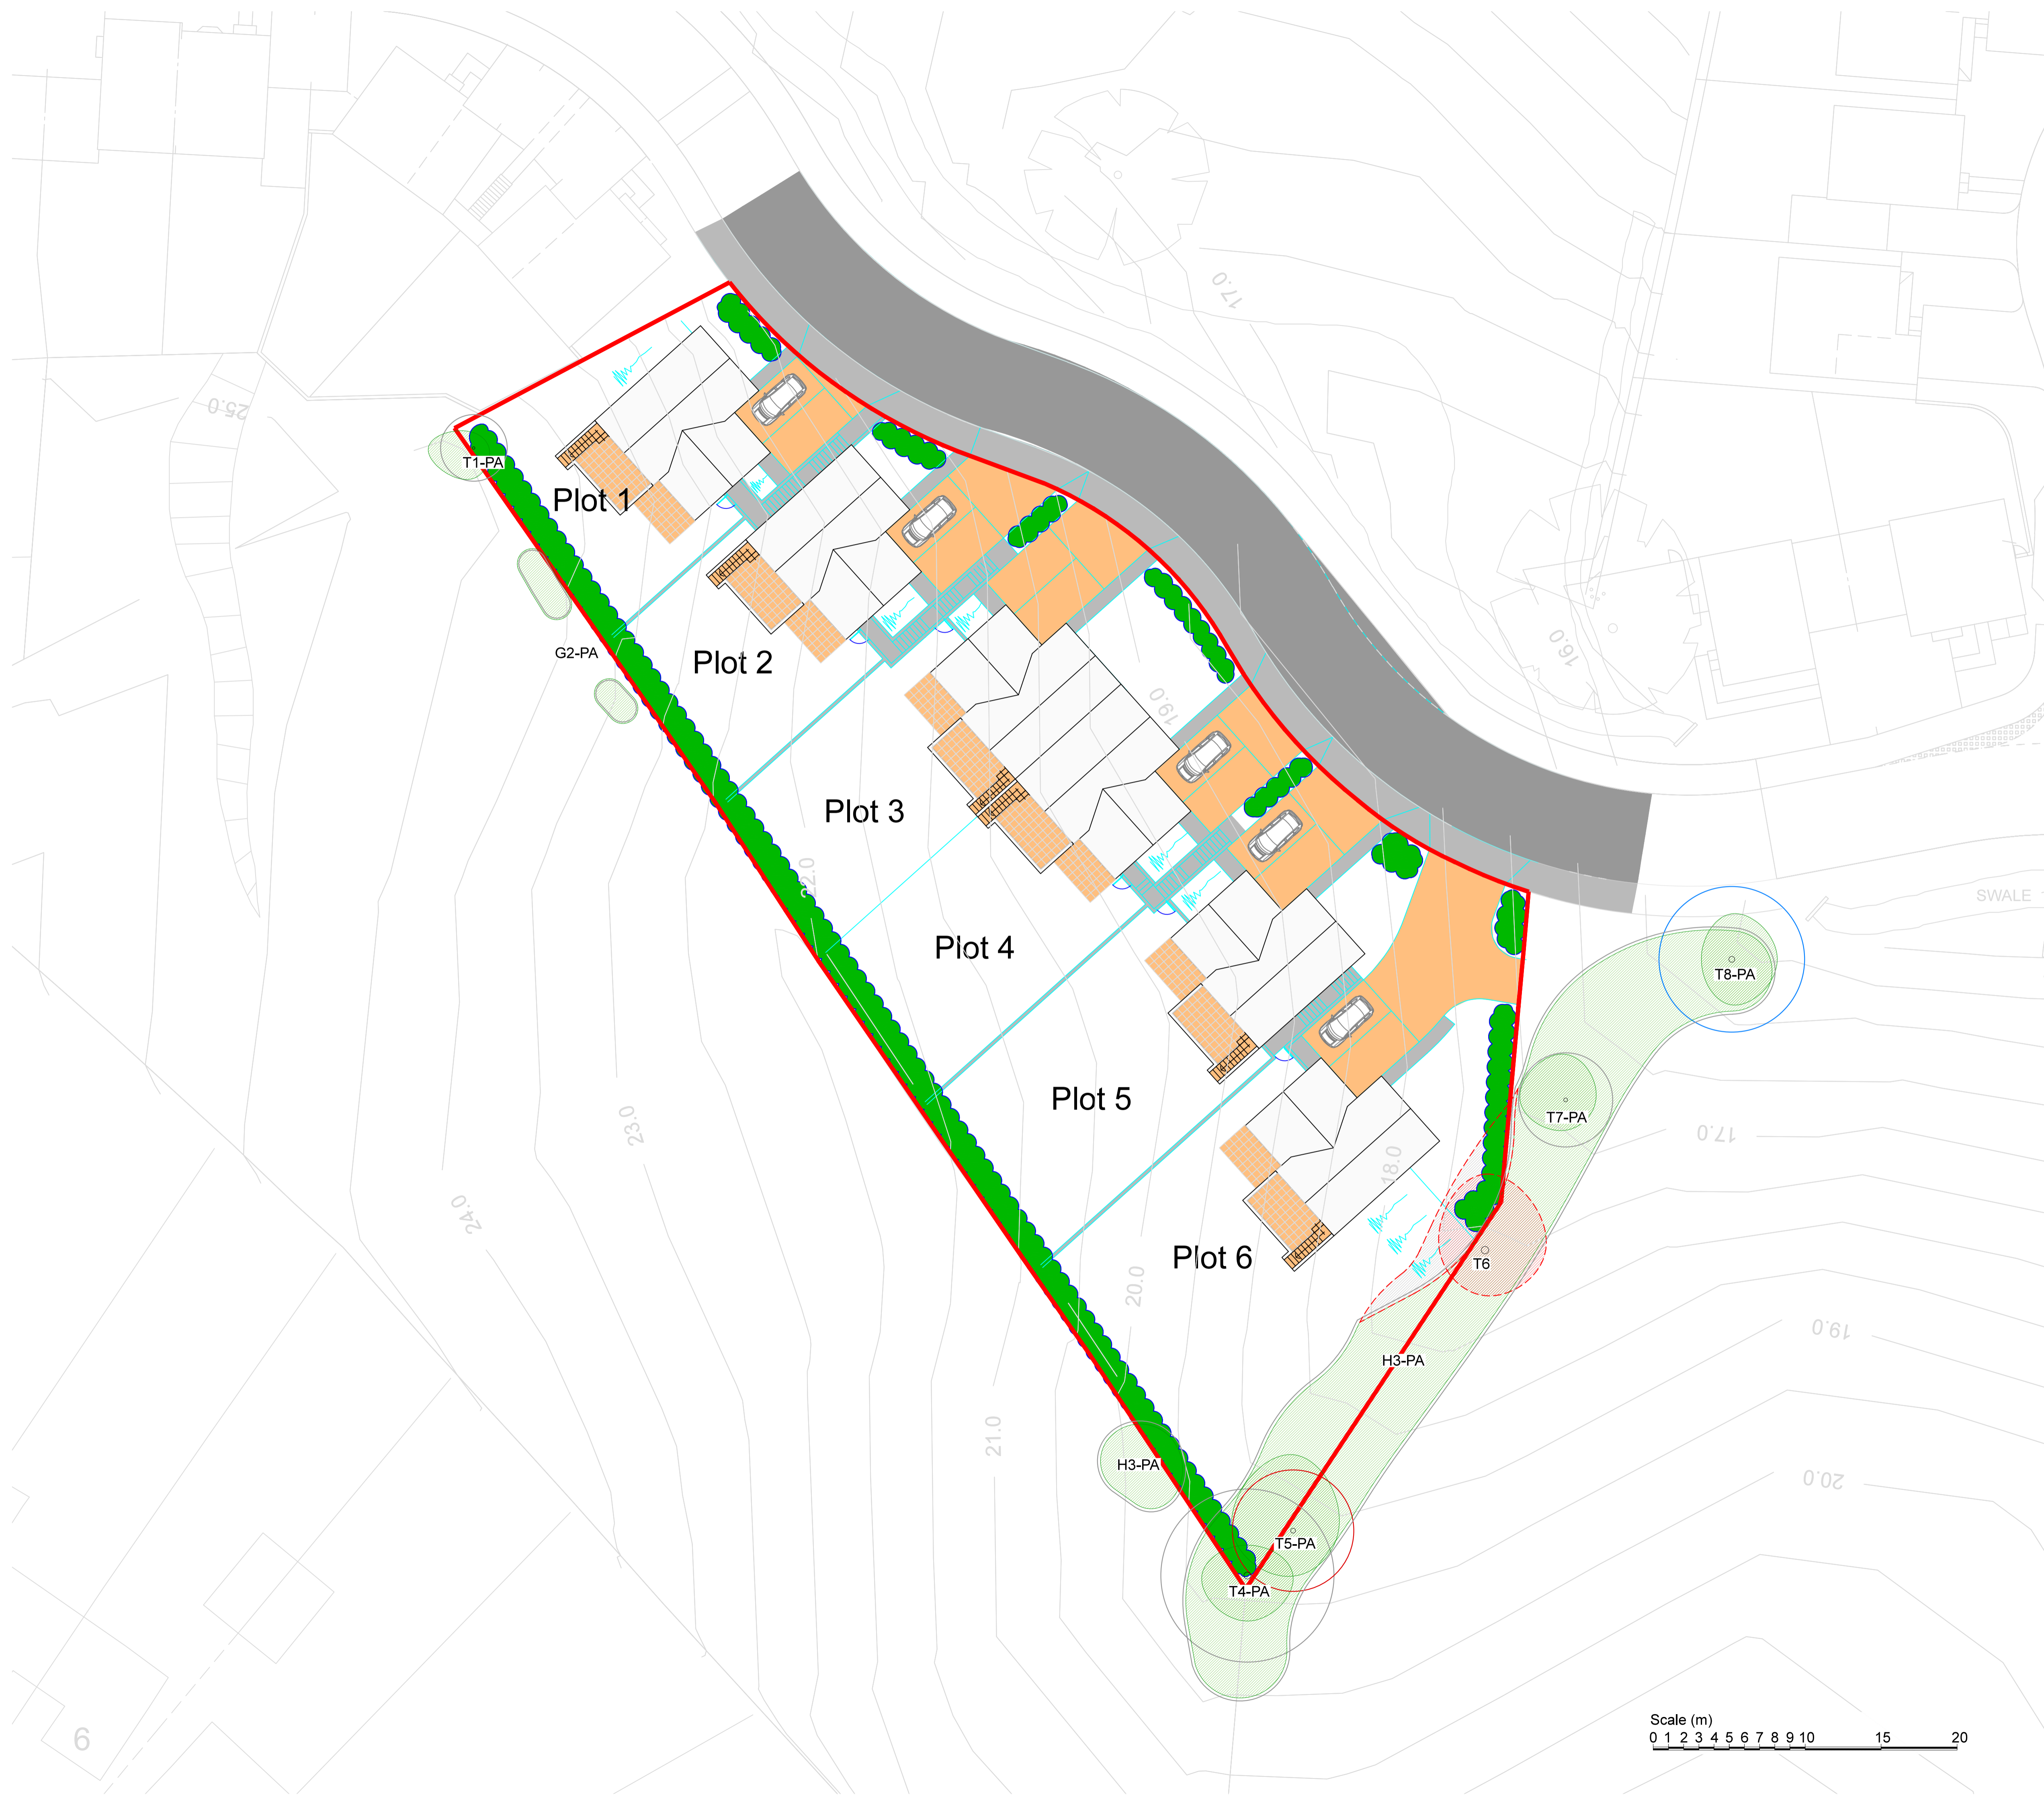
**Drawing title:** Tree Retention Plan

3.1 **Tree removals:** Trees to be removed for the proposed development are shown with dashed outlines on the Tree Retention Plan in Appendix 1 and are shaded to indicate their BS5837 tree category. These comprise H3 (part only) and T6. A summary of the tree removals is shown below.

4.1 Trees requiring removal to facilitate the proposed development comprise T6 (category U sycamore) and a section of hedgerow H3 (mixed native category C hedgerow). The loss of these trees/shrubs should not have a significant detrimental impact on local visual amenity or result in a loss of screening between the development area and the green space to the south.

3.7 **Post development tree pressures and management:** Hedgerow H3 is a broad, unmanaged natural hedgerow adjacent to a ditch. The hedgerow in its current form has ecological benefit (habitat and connectivity) and landscape value (screening) so its long-term protection should be secured. It is recommended that this is achieved by constructing a close board timber fence along the south-east garden boundary of plot 6, to prevent either encroachment into the hedgerow by formal garden practices or the planting of non-native garden plant species.
