Russetings & Lytlewood, Riding Lane, Hildenborough, Kent

Bat Survey and Mitigation Strategy

20th July 2023 / Ref No 2023/03/16

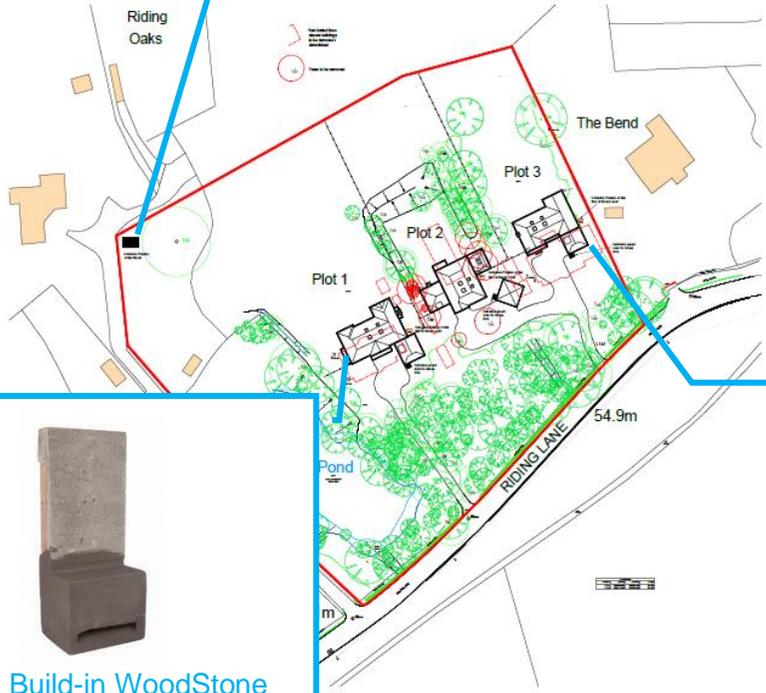
Drawing No			
Site Layout			
Scale	Author	Date	Drawn
1: 500	AT	June 2023	AW
Project	PL/871/01		Rev

Stand Alone Bat Room

No 1 x Build-in WoodStone Bat Box or similar

- Two bat boxes should be installed onto retained trees prior to conversion works starting to provide continued roosting opportunities locally during the works;
- A stand-alone bat room should be created along the north boundary, near trees, away from disturbance and lighting.
- Two ‘Build-in Wood Stone Bat Boxes’ (or similar) should be integrated in the fabric of south elevation of Plot 3 and west elevation of Plot 1 to provide long-term roosting habitat (as high as possible but not directly above windows to avoid droppings).

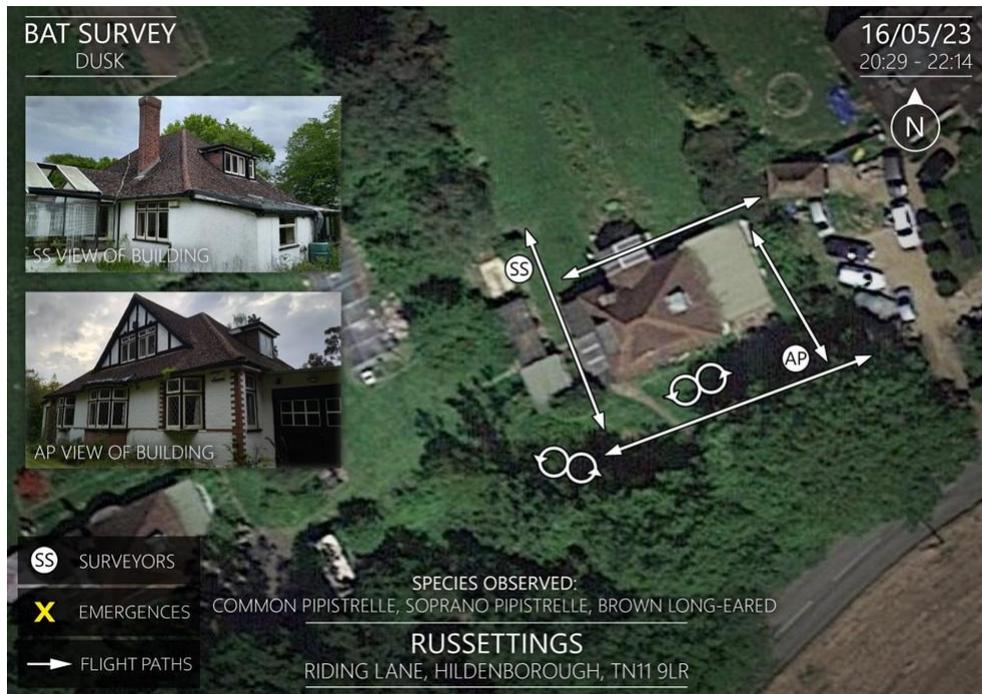
Site Name and Building Number	Russetings, Riding Lane, Hildenborough	Surveyor Name / Equipment	Steve Stanley / Batlogger M2
Weather Conditions	90% Cloud, Wind 1, Rain 0	Date	16th May 2023
Start Time	20:29	Finish Time	22:14
Air Temperature (°C) at Start of Survey	13	Air Temperature (°C) at End of Survey	11
Sunset	20:44	Sunrise	
Position:	NW of building		
Time	Species	Activity*	Comments
21:15	Pip 45	C	Brief pass, not seen.
21:21	BLE	F	Brief F along north side of building, from NE and back again.
21:33	BLE	F	Brief F along north side of building, from NE and back again.
21:43	Pip 45	C	Distant pass, not seen.
21:46	Pip 45	C	From south to north past west side of building.
21:53	Pip 45	F	Brief and distant F, not seen.
*Activity - 'E' = emergence; 'R' = return; 'F' = foraging; 'C' = commuting		*'S' = seen; 'NS' = not seen

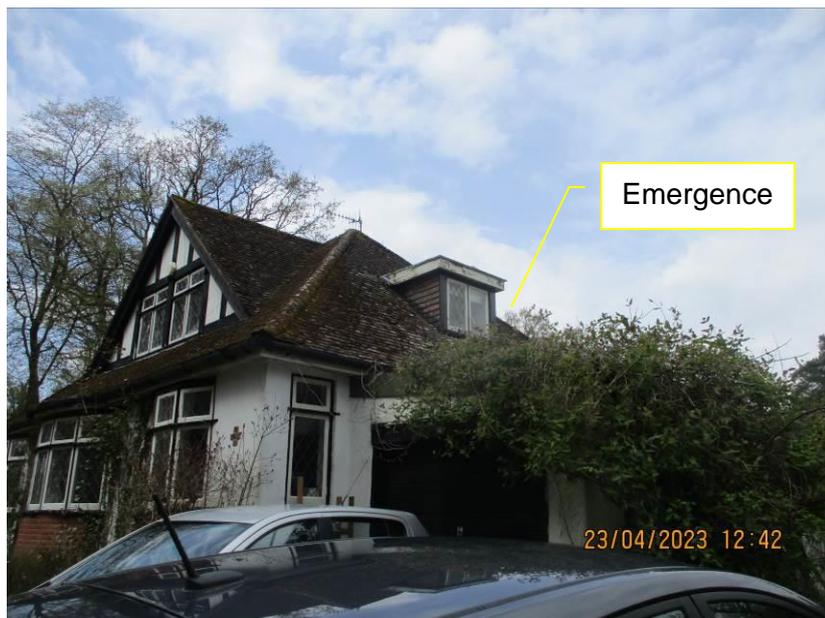
North corner			
Time	Species	Activity*	Comments
21:27	45 pip	E	Emerging from side of dormer window
21:46	45 pip	F	faint audio only
21:52	55 pip	CNS	2 passes, NS
21:56 onwards	55pip	F	West to east then intermittent foraging around garden
22:13	45pip	CNS	1 pass
22:26	BLE	F	East to west, 1 pass

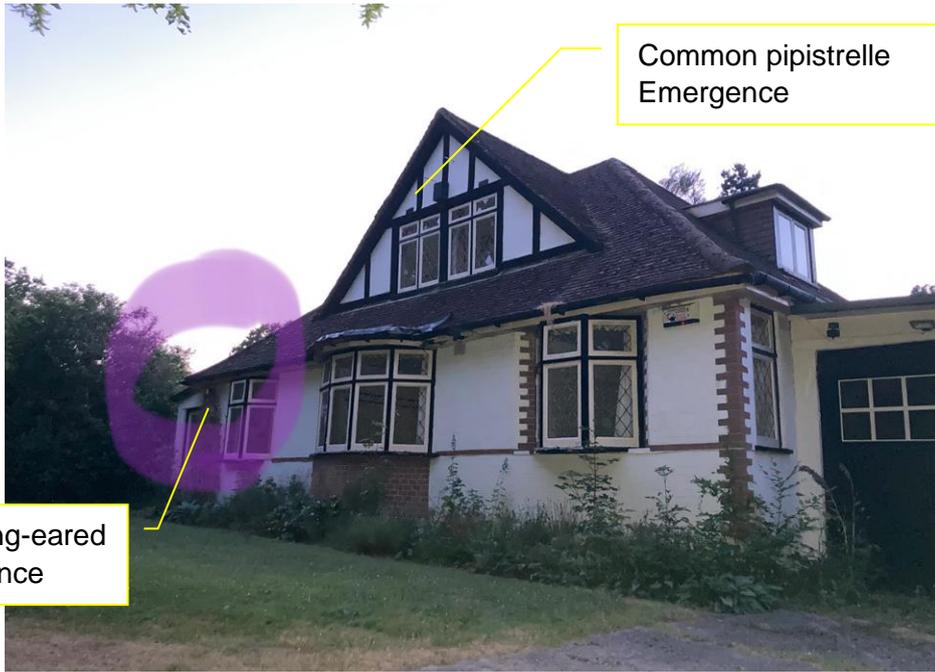
21:25	45 pip	E	emerging from side of front hip see photo
21:28	45 pip	C	from east towards pond
21:29	45 pip	C	from east towards pond
21:42	45 pip	F	foraging 45 pip in front garden/ parking, on and off till 22:23

21:50	BLE	E	2 BLEs emerging from SW corner of house, just above entrance door (cavity present?), then flew along bottom of building towards pond

Common pipistrelle
Emergence

2 x brown long-eared
bats Emergence
