CLIENT WSP GROUP  
 SITE Whitfield  
 DATE 11/02/2016

**Project**  
Whitfield Phase 1

**Job No**  
70012378

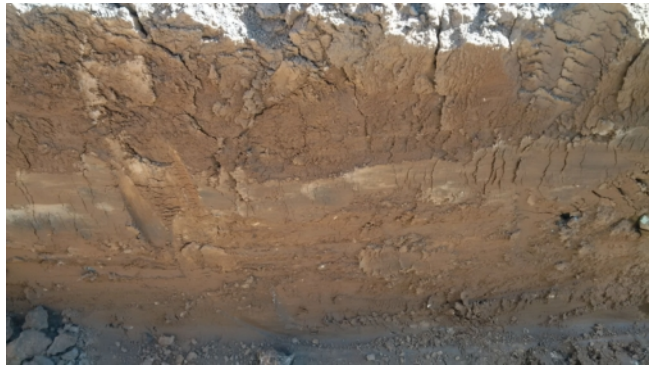
Depth	Type	PID (ppmV)	HSV (kN/m2)	P Pen (kN/m2)	Water	Elev. (mAOD)	STRATA				
							Depth (Thickness)	Description	Legend	Geology	Install / Backfill
0.30							0.30	Firm friable desiccated light brown grey mottled fine sandy slightly coarse gravelly silty CLAY. Gravel is sub angular flint and chalk fragments. [HEAD DEPOSITS]	X O X	HD	
0.70							0.70	Firm light brown grey mottled fine sandy slightly coarse gravelly silty CLAY. Gravel is sub angular flint and chalk fragments. [HEAD DEPOSITS]	X O X	HD	
1.10			93				1.10	Firm light brown grey mottled fine sandy slightly coarse gravelly slightly cobbly silty CLAY. Gravel is sub angular flint and chalk fragments. [HEAD DEPOSITS]	X O X	HD

**General Remarks**  
No groundwater encountered. 600mm plate bearing test completed at 1.1m depth. Set out and backfilled by Contractor on site.  
Plot 18

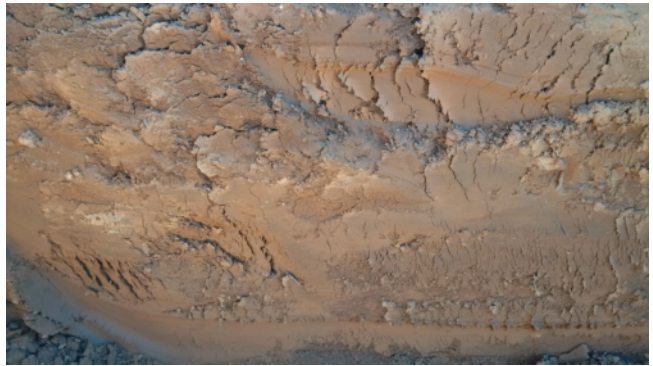
Depth	Type	PID (ppmV)	HSV (kN/m2)	P Pen (kN/m2)	Water	Elev. (mAOD)	Depth (Thickness)	STRATA			
								Description	Legend	Geology	Install / Backfill
							(0.40)	Firm friable slightly desiccated light brown fine sandy slightly fine gravelly silty CLAY. Gravel is sub angular flint fragments. [HEAD DEPOSITS]	[Symbol]	HD	[Symbol]
							0.40				
							(0.70)	Firm friable light brown fine sandy slightly silty CLAY. [HEAD DEPOSITS]	[Symbol]	HD	[Symbol]
							1.10	1.00 - 1.10 m bgl Becomes slightly gravelly with gravel of sub angular flint fragments.	[Symbol]		[Symbol]
			78

**General Remarks**  
No groundwater encountered. 600mm plate bearing test completed at 1.1m depth. Set out and backfilled by Contractor on site.  
Plot 14/15

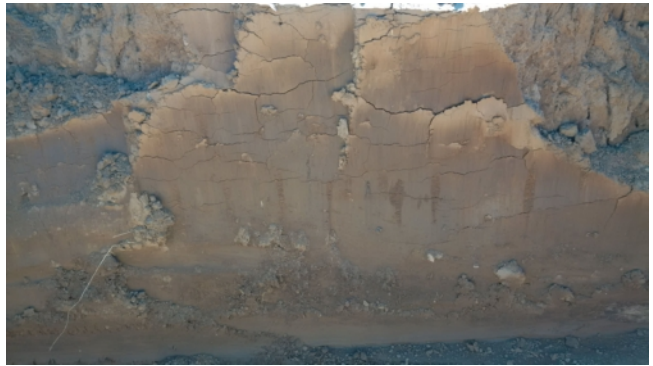
Depth	Type	PID (ppmV)	HSV (kN/m2)	P Pen (kN/m2)	Water	Elev. (mAOD)	STRATA				
							Depth (Thickness)	Description	Legend	Geology	Install / Backfill
0.30							(0.30)	Firm desiccated friable brown fine sandy silty CLAY. Sand content varies from slightly to very sandy. [HEAD DEPOSITS]	[Symbol]	HD	[Symbol]
0.80							(0.80)	Firm friable light brown to light yellow very fine sandy silty CLAY with lenses of 50mm light yellow fine sand. [HEAD DEPOSITS]	[Symbol]	HD	[Symbol]
1.30			71				1.10				
			61				1.30	Firm yellow brown fine sandy CLAY. Small 300mm by 300mm area of organic grey soil and grass. (May have fallen in during excavation). [HEAD DEPOSITS]	[Symbol]	HD	[Symbol]

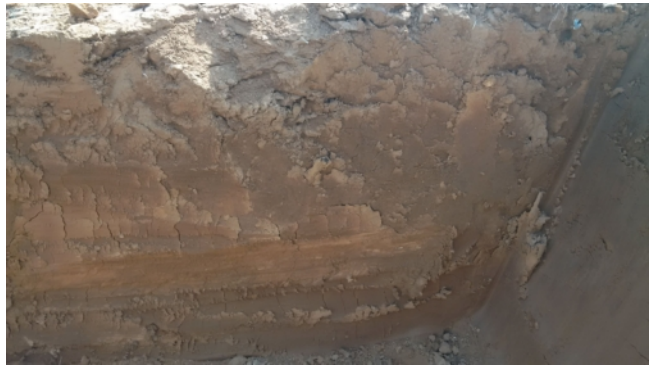
Depth	Type	PID (ppmV)	HSV (kN/m2)	P Pen (kN/m2)	Water	Elev. (mAOD)	Depth (Thickness)	STRATA			
								Description	Legend	Geology	Install / Backfill
							(0.30)	Firm desiccated friable dark grey fine sandy silty CLAY. [TOPSOIL]		TS	
							0.30				
							(0.80)	Stiff friable light brown to brown fine sandy silty CLAY with sub angular flint nodules and dark grey organic streaking. [HEAD DEPOSITS]		HD	
			82				0.70 - 0.80 m bgl	Very fine sandy CLAY			
							1.10

**General Remarks**  
No groundwater encountered. 600mm plate bearing test completed at 1.1m depth. Set out and backfilled by Contractor on site. Plot 41

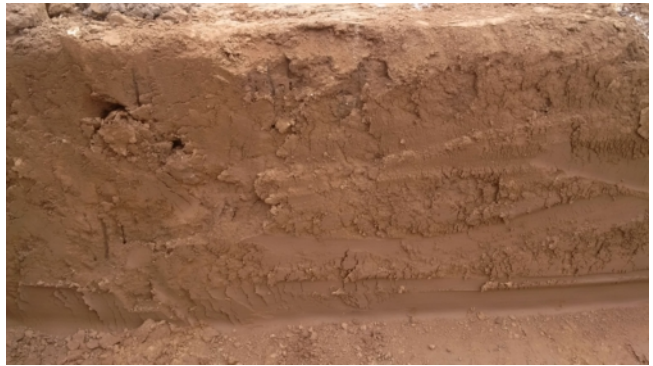
Depth	Type	PID (ppmV)	HSV (kN/m2)	P Pen (kN/m2)	Water	Elev. (mAOD)	Depth (Thickness)	STRATA			
								Description	Legend	Geology	Install / Backfill
								Firm friable reddish brown fine sandy silty CLAY with sub angular flint nodules and dark grey organic streaking. [HEAD DEPOSITS]			
							(1.10)	0.40 m bgl Becomes sandy.		HD	
								0.70 m bgl Becomes dark brown.			
							1.10	0.80 - 1.10 m bgl Becoming slightly sandy with dark brown organic streaks.

**General Remarks**  
No groundwater encountered. 600mm plate bearing test completed at 1.1m depth. Set out and backfilled by Contractor on site.  
Plot 44

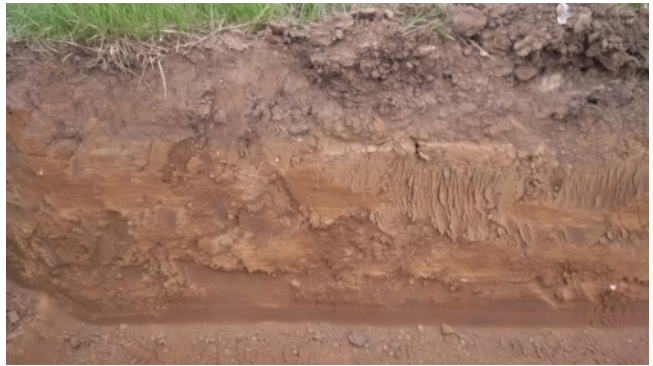
Depth	Type	PID (ppmV)	HSV (kN/m2)	P Pen (kN/m2)	Water	Elev. (mAOD)	Depth (Thickness)	STRATA			
								Description	Legend	Geology	Install / Backfill
							(0.30)	Soft desiccated friable dark grey fine sandy silty CLAY. [TOPSOIL]		TS	
							0.30				
							0.50	Stiff friable light brown to brown fine sandy silty CLAY with sub angular flint nodules and dark grey organic streaking. [HEAD DEPOSITS]		HD	
							0.60	Medium density light brown yellow fine silty SAND. [HEAD DEPOSITS]		HD	
							(0.50)	Stiff friable light brown fine slightly sandy silty laminated CLAY with sub angular flint nodules. [HEAD DEPOSITS]		HD	
			79				1.10	0.80 m bgl. Becoming light brown to yellow.

**General Remarks**  
No groundwater encountered. 600mm plate bearing test completed at 1.0m depth. Set out and backfilled by Contractor on site. Plot 48

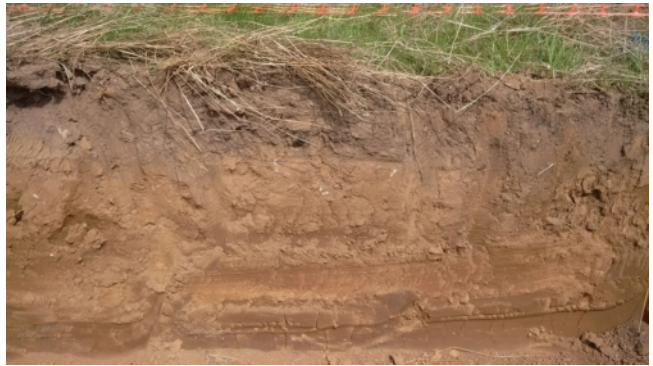
Depth	Type	PID (ppmV)	HSV (kN/m2)	P Pen (kN/m2)	Water	Elev. (mAOD)	Depth (Thickness)	STRATA			
								Description	Legend	Geology	Install / Backfill
							0.20	Soft desiccated friable dark grey fine sandy silty CLAY. [TOPSOIL]		TS	
			82				(0.90)	Stiff friable light brown to brown fine sandy silty CLAY with sub angular flint nodules and dark grey organic streaking. [HEAD DEPOSITS]		HD	
							0.80 m bgl	Becomes brown.			
							1.10	1.00 - 1.10 m bgl	Becomes dark brown.

**General Remarks**  
No groundwater encountered. 600mm plate bearing test completed at 1.1m depth. Set out and backfilled by Contractor on site.  
Plot 51

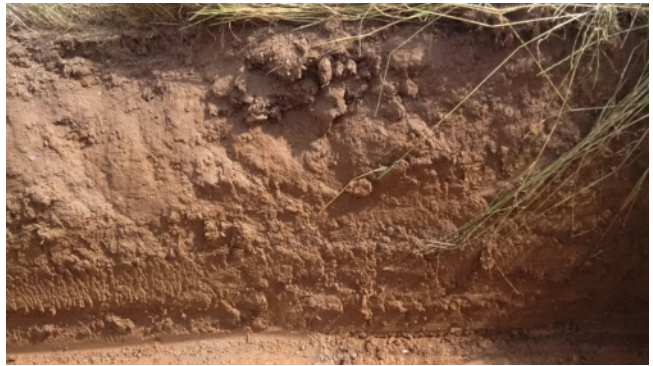
Depth	Type	PID (ppmV)	HSV (kN/m2)	P Pen (kN/m2)	Water	Elev. (mAOD)	Depth (Thickness)	STRATA			
								Description	Legend	Geology	Install / Backfill
							0.20	Soft desiccated friable dark grey fine sandy silty CLAY with roots and nodules of moderate sub angular flint and chalk. [TOPSOIL]		TS	
							(0.90)	0.60 m bgl No longer desiccated		HD	
							0.80 m bgl Becoming stiff.				
			94				1.10

**General Remarks**  
No groundwater encountered. 600mm plate bearing test completed at 1.1m depth. Set out and backfilled by Contractor on site.  
Plot 34

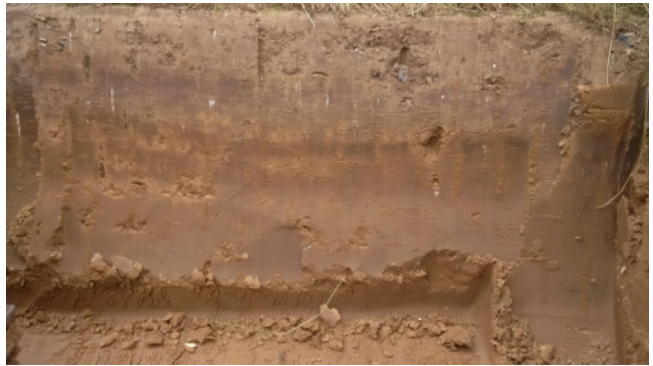
1.10	0.90 - 1.10 m bgl Becomes sandy and dark reddish brown.

**General Remarks**  
 No groundwater encountered. 600mm plate bearing test completed at 1.1m depth. Set out and backfilled by Contractor on site.  
 Plot 53

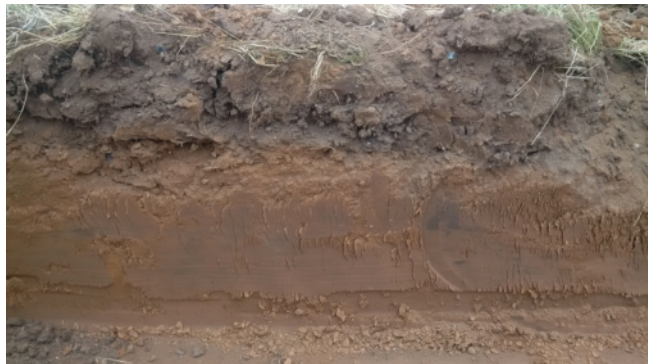
Depth	Type	PID (ppmV)	HSV (kN/m2)	P Pen (kN/m2)	Water	Elev. (mAOD)	STRATA				
							Depth (Thickness)	Description	Legend	Geology	Install / Backfill
0.00 - 0.30							(0.30)	Soft desiccated friable dark grey fine sandy silty CLAY with roots and nodules of medium sub angular flint and chalk. [TOPSOIL]		TS	
0.30 - 0.60							(0.30)	Firm friable reddish brown very fine sandy silty CLAY with sub angular flint nodules and occasional roots. [HEAD DEPOSITS]		HD	
0.60 - 1.10							(0.50)	Stiff friable dark reddish brown very fine sandy silty CLAY with sub angular flint and chalk nodules. [HEAD DEPOSITS]		HD	
1.10 - 1.10			81				1.10

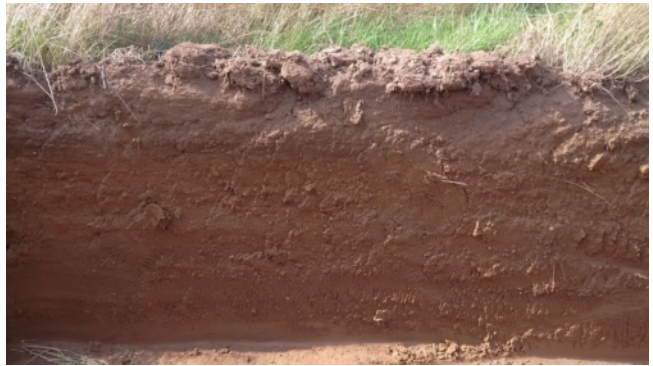
Depth	Type	PID (ppmV)	HSV (kN/m2)	P Pen (kN/m2)	Water	Elev. (mAOD)	Depth (Thickness)	STRATA			
								Description	Legend	Geology	Install / Backfill
							0.20	Soft desiccated friable dark grey fine sandy silty CLAY with roots and nodules of medium sub angular flint and chalk. [TOPSOIL]		TS	
			78				(0.90)	Firm friable reddish brown slightly desiccated very fine sandy silty CLAY with coarse sub angular moderate flint and chalk nodules. 1.1mbgl Becoming sandy. [HEAD DEPOSITS]		HD	
							1.10	0.50 m bgl No nodules below this depth.

**General Remarks**  
No groundwater encountered. 600mm plate bearing test completed at 1.2m depth. Set out and backfilled by Contractor on site. Plot 55

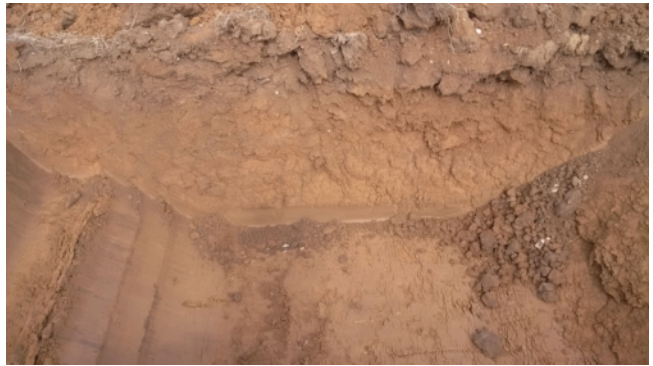
Depth	Type	PID (ppmV)	HSV (kN/m2)	P Pen (kN/m2)	Water	Elev. (mAOD)	Depth (Thickness)	STRATA			
								Description	Legend	Geology	Install / Backfill
							0.10	Soft desiccated friable dark grey fine sandy silty CLAY with roots and nodules of medium sub angular flint and chalk. [TOPSOIL]		TS	
							0.30	Firm friable dark greyish brown slightly desiccated very fine sandy silty CLAY with coarse sub angular medium flint and chalk nodules. [HEAD DEPOSITS]		HD	
							(0.80)	Stiff reddish brown very fine sandy silty CLAY. Sub angular coarse chalk and flint gravel nodules. [HEAD DEPOSITS]		HD	
			74				1.10

**General Remarks**  
No groundwater encountered. No plate load test completed. Set out and backfilled by Contractor on site.  
Plot 57

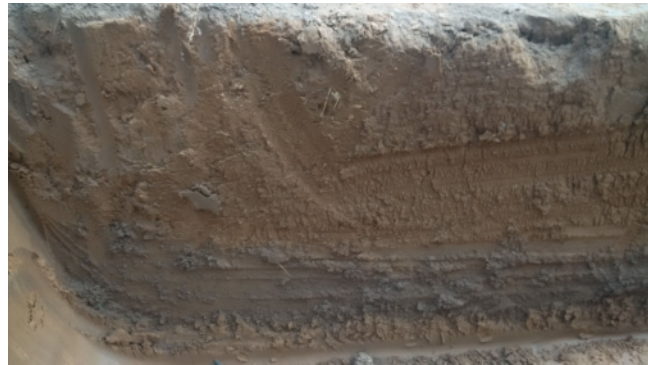
Depth	Type	PID (ppmV)	HSV (kN/m2)	P Pen (kN/m2)	Water	Elev. (mAOD)	Depth (Thickness)	STRATA			
								Description	Legend	Geology	Install / Backfill
							(0.30)	Soft desiccated friable dark grey fine sandy silty CLAY with roots and nodules of medium sub angular flint and chalk. [TOPSOIL]		TS	
							0.30				
							(0.90)	Firm friable reddish brown very fine sandy silty CLAY with sub angular flint nodules and occasional roots. [HEAD DEPOSITS] 0.40 - 0.50 m bgl Slightly gravelly (moderate subangular chalk and flint). 0.70 m bgl Becomes dark reddish brown.		HD	
			81				1.20

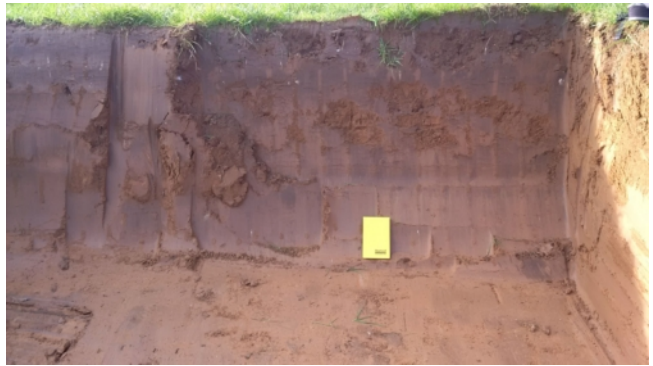
1.20	0.50 m bgl Becoming slightly gravelly. Gravel of fine to coarse sub angular to sub rounded flint and chalk.

**General Remarks**  
 No groundwater encountered. 600mm plate bearing test completed at 1.2m depth. Set out and backfilled by Contractor on site.  
 Plot 61

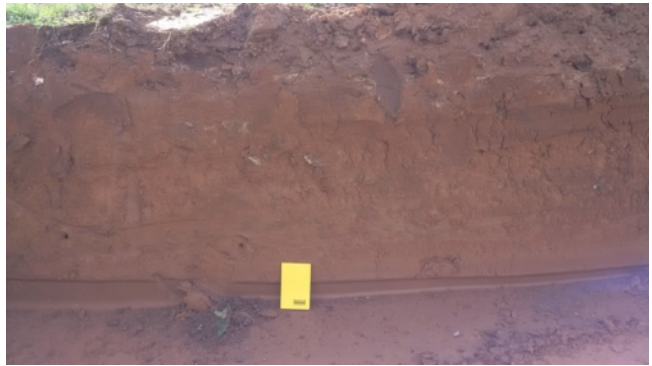
0.25	Firm friable brown very fine sandy slightly coarse gravelly silty CLAY with rootlets. Gravel is sub angular to sub rounded chalk, flint and brick. [REWORKED TOPSOIL]

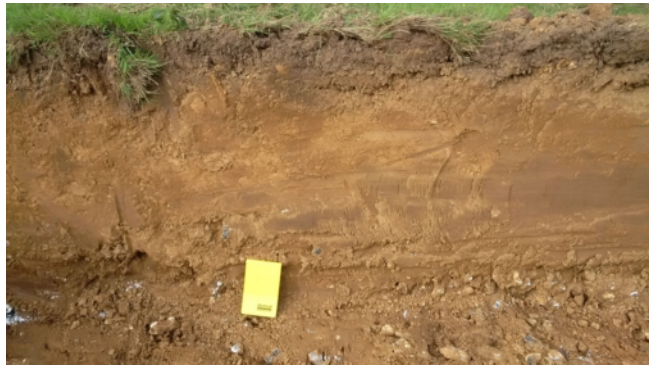
0.55 m bgl	Becoming dark reddish brown and sandy.				
							1.20	0.85 m bgl	Becoming coarse gravelly slightly sandy clay. Gravel is sub angular to sub rounded chalk and flint and appears in lenses. Rare cobbles of sub angular to sub rounded flint.

**General Remarks**  
 No groundwater encountered. 600mm plate bearing test completed at 1.1m depth. Set out and backfilled by Contractor on site. Plot 66

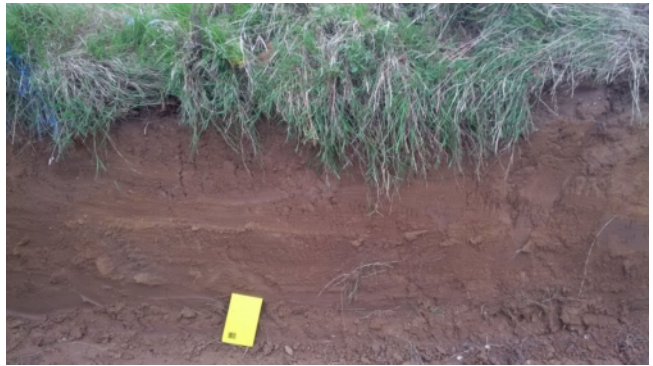
117				1.00	0.90 m bgl Becoming slightly gravelly. Gravel of sub angular to sub rounded flint and chalk

**General Remarks**  
 No groundwater encountered. 600mm plate bearing test completed at 1.1m depth. Set out and backfilled by Contractor on site. Plot 85

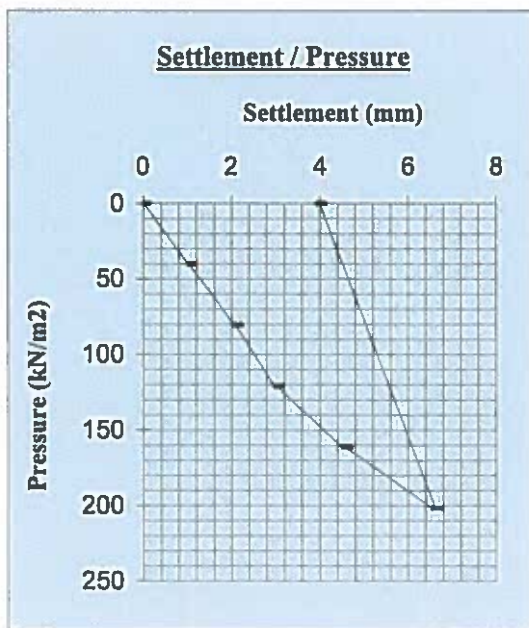
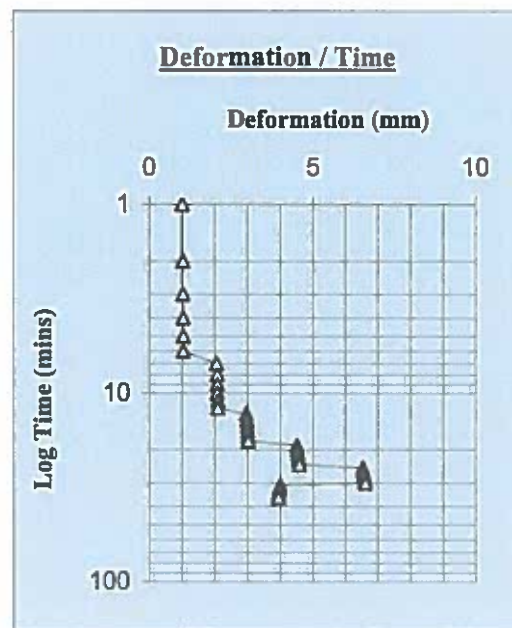
Sample Information			
Test Locations:	Position 501	Lab Reference:	M 24004784
Material Type:	Brown Clay	Temperature (°C):	16
Client Reference:	1	Environmental Conditions:	Sunny

Loading procedure : Incremental  
 In-situ moisture content (%) : 24  
 Test depth (m) : 1000mm Below Ground Level

Maximum Applied Pressure: **201.60 kN/m<sup>2</sup>**

Maximum Deformation: **6.61mm**

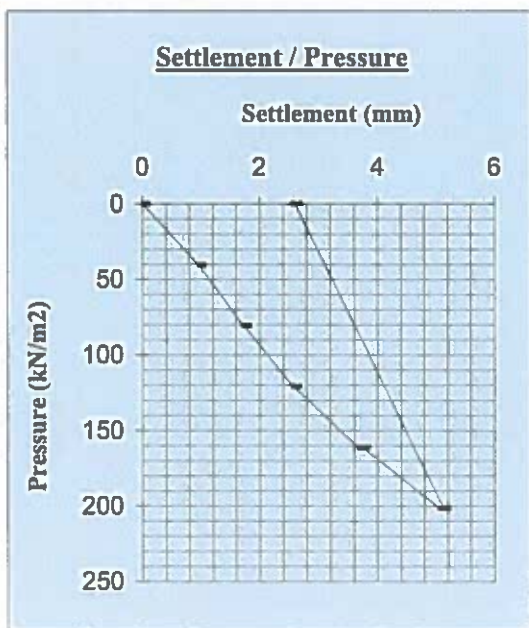
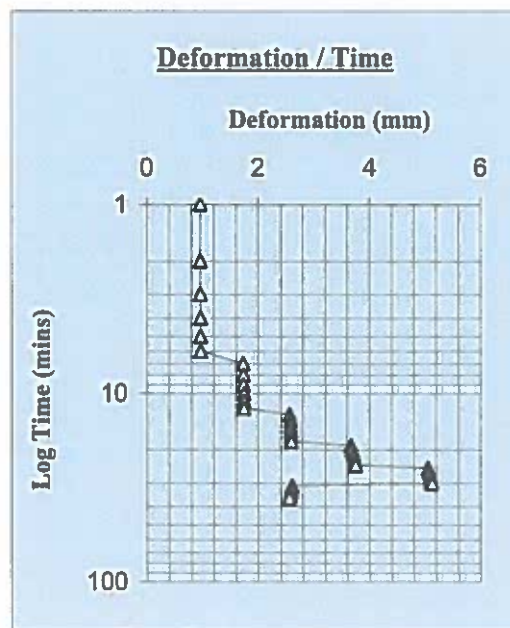
Sample Information			
Test Locations:	Position 502	Lab Reference:	M 24004785
Material Type:	Brown Clay	Temperature (°C):	16
Client Reference:	2	Environmental Conditions:	Sunny

Loading procedure : Incremental  
 In-situ moisture content (%) : 22  
 Test depth (m) : 1000mm Below Ground Level

Maximum Applied Pressure: **201.60 kN/m<sup>2</sup>**

Maximum Deformation: **5.12mm**

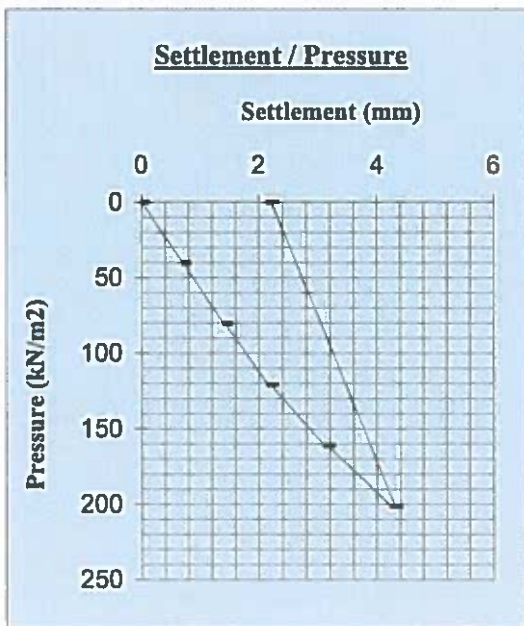
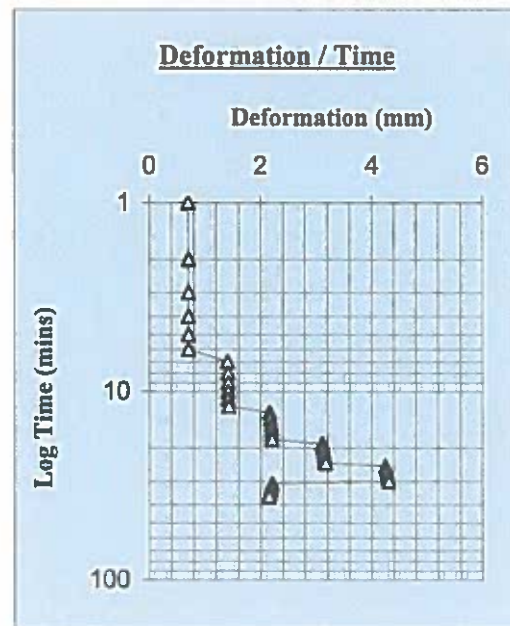
Sample Information			
Test Locations:	Position 503	Lab Reference:	M 24004786
Material Type:	Brown Clay	Temperature (°C):	16
Client Reference:	3	Environmental Conditions:	Sunny

Loading procedure : Incremental  
 In-situ moisture content (%) : 21  
 Test depth (m) : 1000mm Below Ground Level

Maximum Applied Pressure: **201.60 kN/m<sup>2</sup>**

Maximum Deformation: **4.31mm**

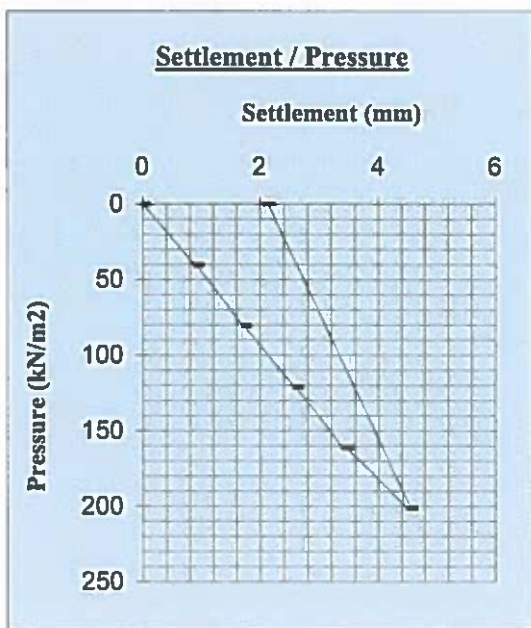
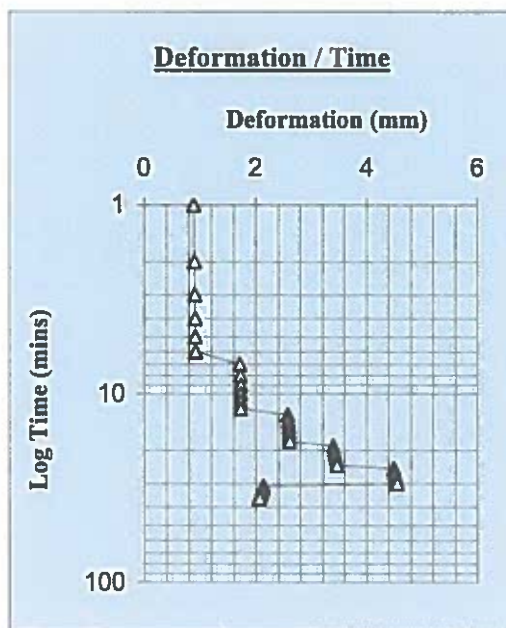
Sample Information			
Test Locations:	Position 504	Lab Reference:	M 24004787
Material Type:	Brown Clay	Temperature (°C):	16
Client Reference:	4	Environmental Conditions:	Sunny

Loading procedure : Incremental  
 In-situ moisture content (%) : 28  
 Test depth (m) : 500mm Below Ground Level

Maximum Applied Pressure: **201.60 kN/m<sup>2</sup>**

Maximum Deformation: **4.55mm**

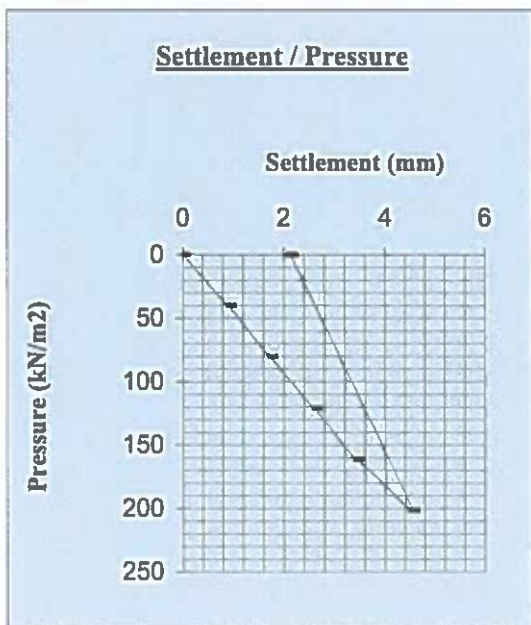
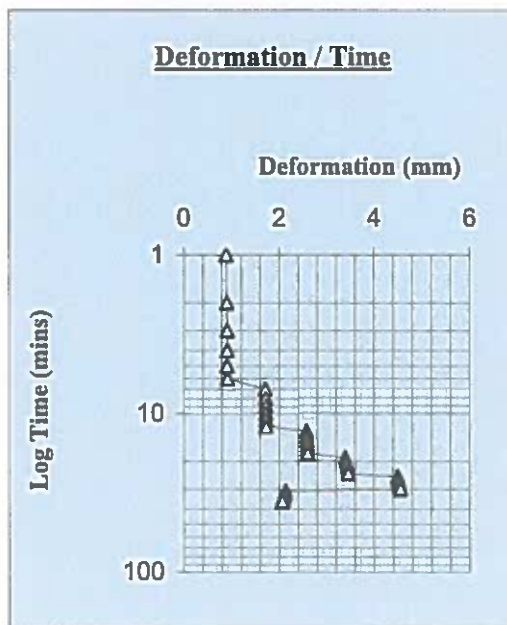
Sample Information			
Test Locations:	Position 504	Lab Reference:	M 24004787
Material Type:	Brown Clay	Temperature (°C):	16
Client Reference:	4	Environmental Conditions :	Sunny

Loading procedure : Continuous  
 In-situ moisture content (%) : 28  
 Test depth (m) : 500mm Below Ground Level

Maximum Applied Pressure: **201.60 kN/m<sup>2</sup>**

Maximum Deformation: **4.55mm**

**Equivalent CBR interpreted from MSR : 4.7 %**  
**Modulus of Subgrade Reaction (MSR) : 37.0 MN/m<sup>2</sup>/m**

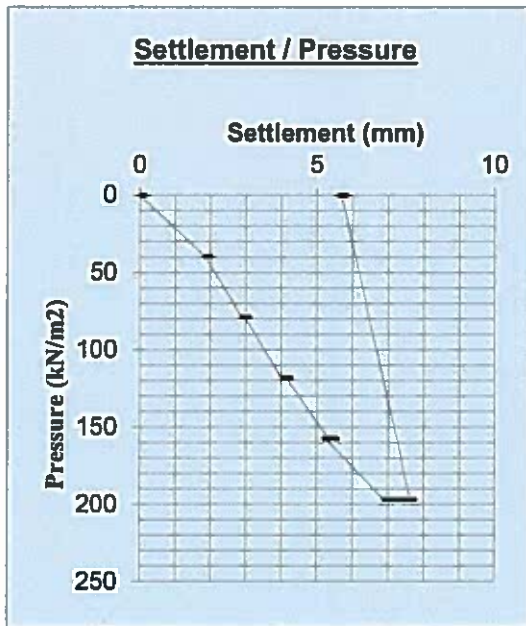
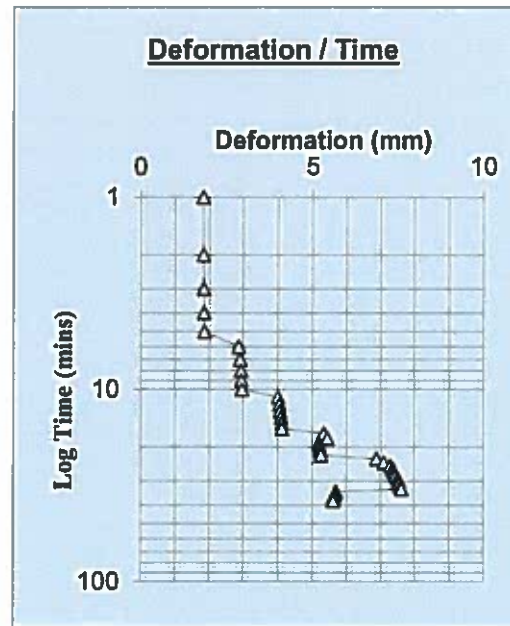
Sample Information	
Test Locations:	1
Material Type:	Brown, Silty Sandy, Gravelly Clay
Client Reference:	1
Lab Reference:	M 24090887
Temperature (°C):	34 - 28.5
Environmental Conditions:	Hot

Loading procedure : Incremental  
 In-situ moisture content (%) : 19  
 Test depth (m) : 1.00

Maximum Applied Pressure: **196.89 kN/m<sup>2</sup>**

Maximum Deformation: **7.62mm**

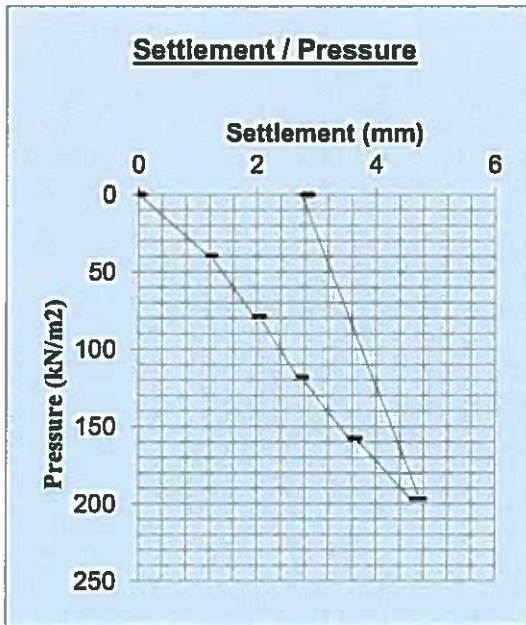
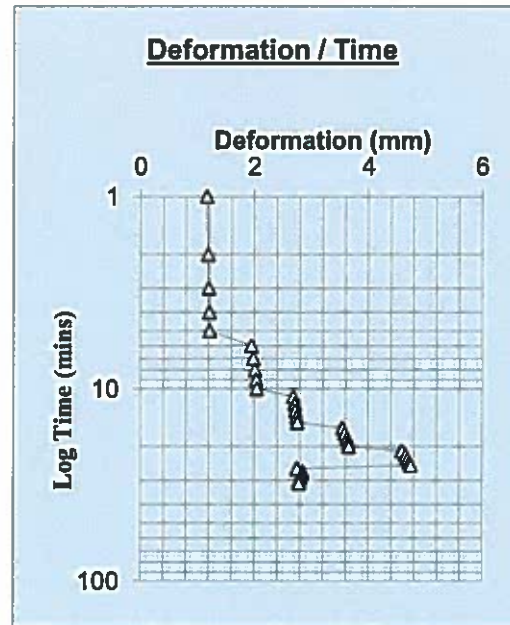
Sample Information			
Test Locations:	2	Lab Reference:	M 24090888
Material Type:	Brown, Silty, Sandy, Gravelly Clay	Temperature (°C):	34 - 28.5
Client Reference:	2	Environmental Conditions:	Hot

Loading procedure : Incremental  
 In-situ moisture content (%) : 17  
 Test depth (m) : 1.00

Maximum Applied Pressure: **196.89 kN/m<sup>2</sup>**

Maximum Deformation: **4.74mm**

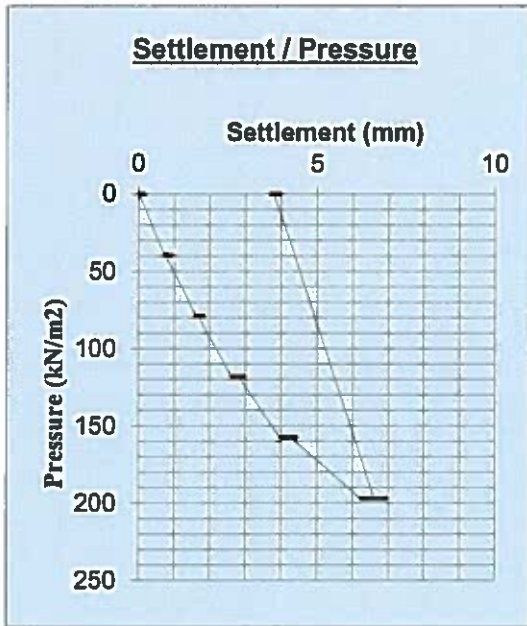
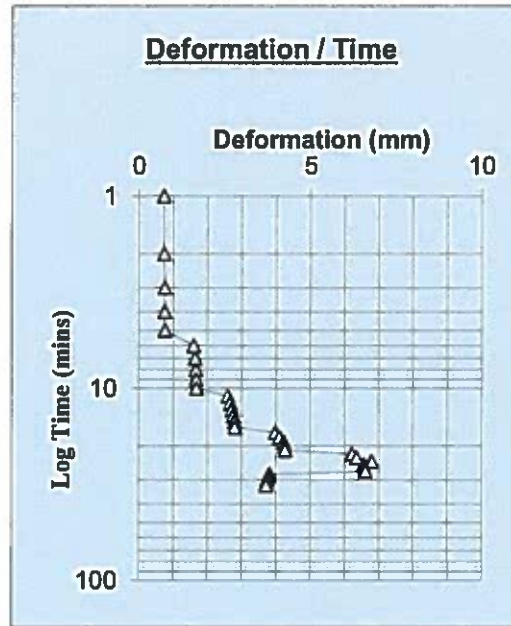
Sample Information			
Test Locations:	3	Lab Reference:	M 24090889
Material Type:	Brown, Silty, Sandy, Gravelly, Clay	Temperature (°C):	34 - 28.5
Client Reference:	3	Environmental Conditions:	Hot

In-situ moisture content (%) : 20

Maximum Applied Pressure: **196.89 kN/m<sup>2</sup>**

Maximum Deformation: **6.79mm**

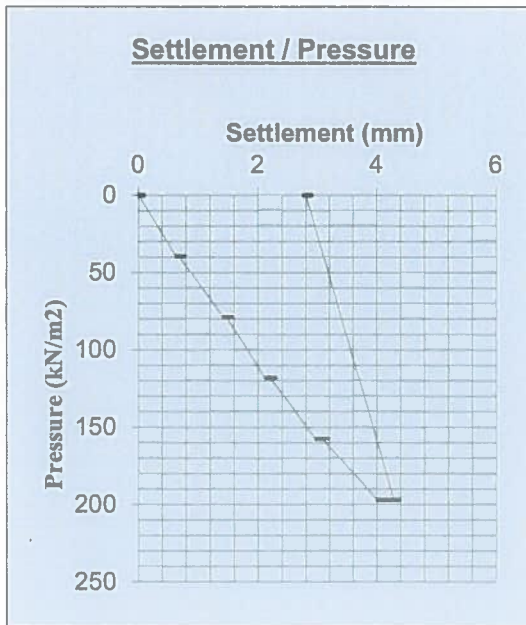
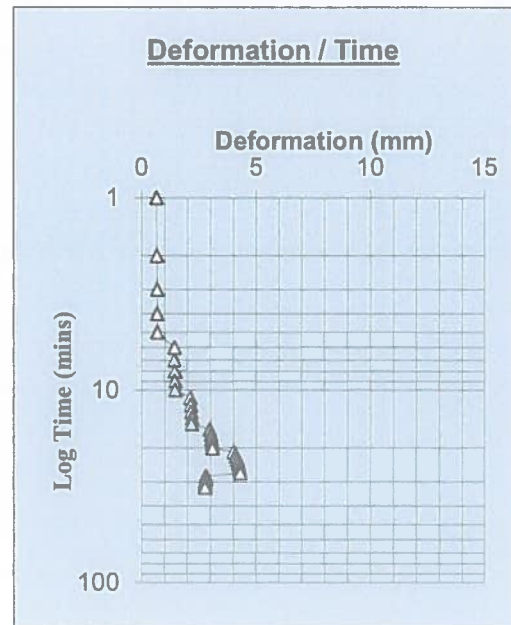
Sample Information			
Test Locations:	5	Lab Reference:	M 24102754
Material Type:	Brown Silty Sandy Gravelly Clay	Temperature (°C):	18-25.6
Client Reference:	1	Environmental Conditions:	Fine/Hot

Loading procedure : Incremental  
 In-situ moisture content (%) : 21  
 Test depth (m) : 1.00

Maximum Applied Pressure: **196.89 kN/m<sup>2</sup>**

Maximum Deformation: **4.29mm**
