A GROUND GAS RISK ASSESSMENT FOR:

PHASE 1B OF A RESIDENTIAL DEVELOPMENT AT WHITFIELD, DOVER, KENT

CLIENT:	Halsbury Homes (South East) Limited
REFERENCE :	JAH/18.185/GGRA
DATE:	6 June 2019

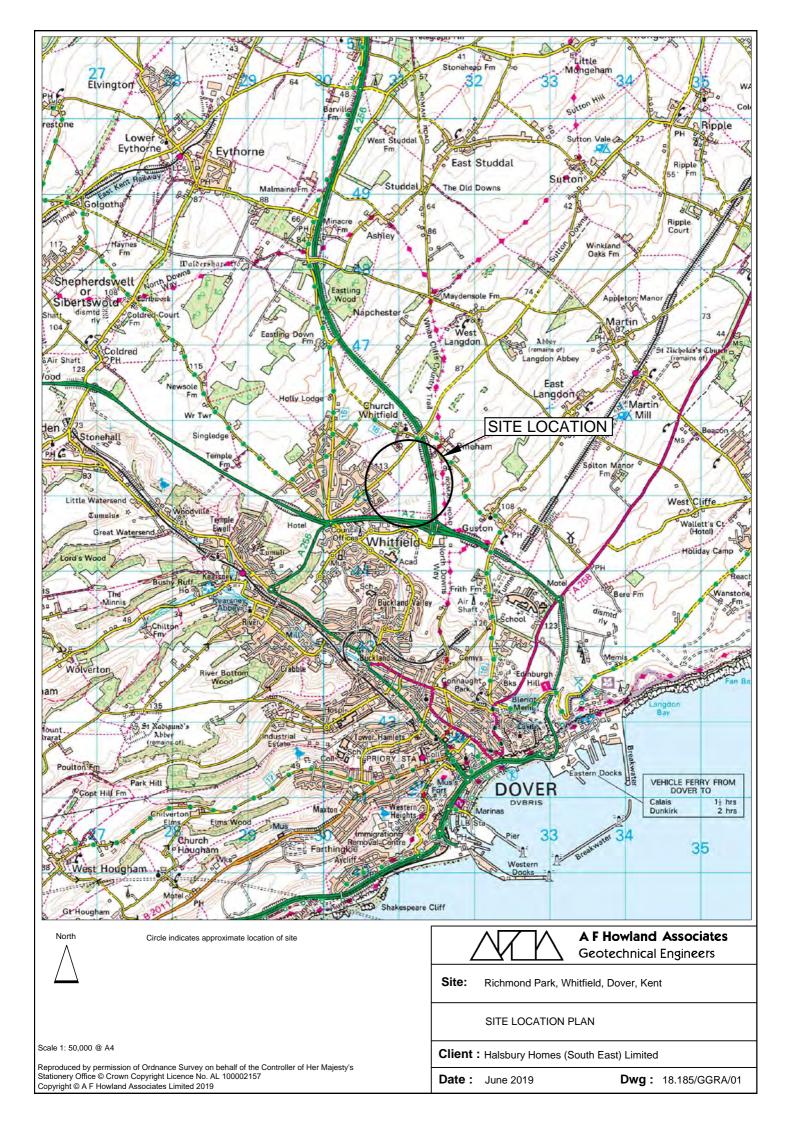
Drawing 18.185/GGRA/01	Site Location Plan
Drawing 18.185/GGRA/02	Exploratory Hole Location Plan
Drawing W1C-01a	Halsbury Homes (South East) Limited – Proposed Site plan

It is proposed to develop Phase 1B of the wider residential development at Whitfield, Dover, Kent (Fig. 18.185/GGRA/01) for residential end use. At the instruction of Halsbury Homes (South East) Limited (the "Client"), an investigation was carried out to provide information on the subsoil conditions to enable an assessment of the potential ground gas risks.
