# LAND TO THE EAST OF NORTH DANE WAY, MEDWAY, KENT

## Geoarchaeological Fieldwork Report

**Date:** 14<sup>th</sup> February 2020

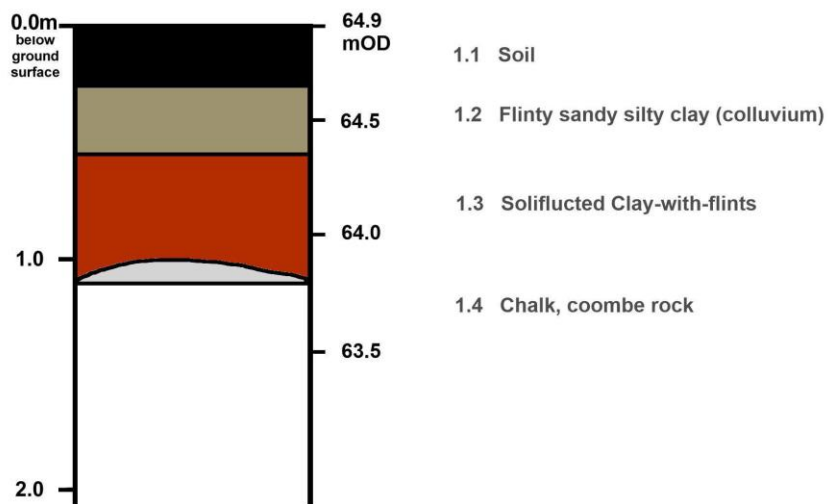
Figure 3: QTP1 stratigraphic log.

Unit	m bgs	m OD	Thickness (m)	Description	Stratigraphic Unit
1.1	0.0 – 0.25	64.9 – 64.65	0.25	Soil.	MODERN SOIL
1.2	0.25 – 0.55	64.65 – 64.35	0.30	Sandy silty clay, frequent flints up to 5 cm, some chalk clasts.	COLLUVIUM/ HEAD
1.3	0.55 – 1.1	64.35 – 63.8	0.55	Large flints in silty clay yellowish red-(5YR5/8 to 2.5YR4/8) silty clay matrix. Flints up to 10 cm, black, rounded with white cortex if whole, angular if broken.	SOLIFLUCTED CLAY-WITH-FLINTS
1.4	1.1 +	>63.8		Broken chalk, clasts up to 5 cm, angular, mostly clast supported within a silty chalk matrix.	COOMBE ROCK

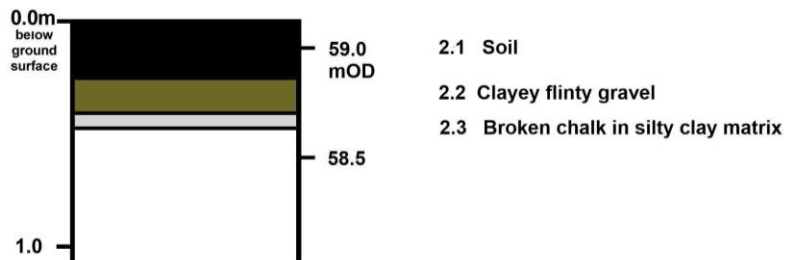
Figure 5: QTP2 stratigraphic log.

Unit	m bgs	m OD	Thickness (m)	Description	Stratigraphic Unit
2.1	0.0 – 0.25	59.1 – 58.85	0.25	Soil.	MODERN SOIL
2.2	0.25 – 0.55	58.85 – 58.7	0.15	Clayey gravel with sub-angular flints up to 6 cm.	COLLUVIUM/ HEAD
2.3	0.55 +	>58.7		Broken chalk, clasts up to 5 cm, angular, mostly clast supported within a silty chalk matrix. Coombe rock.	COOMBE ROCK

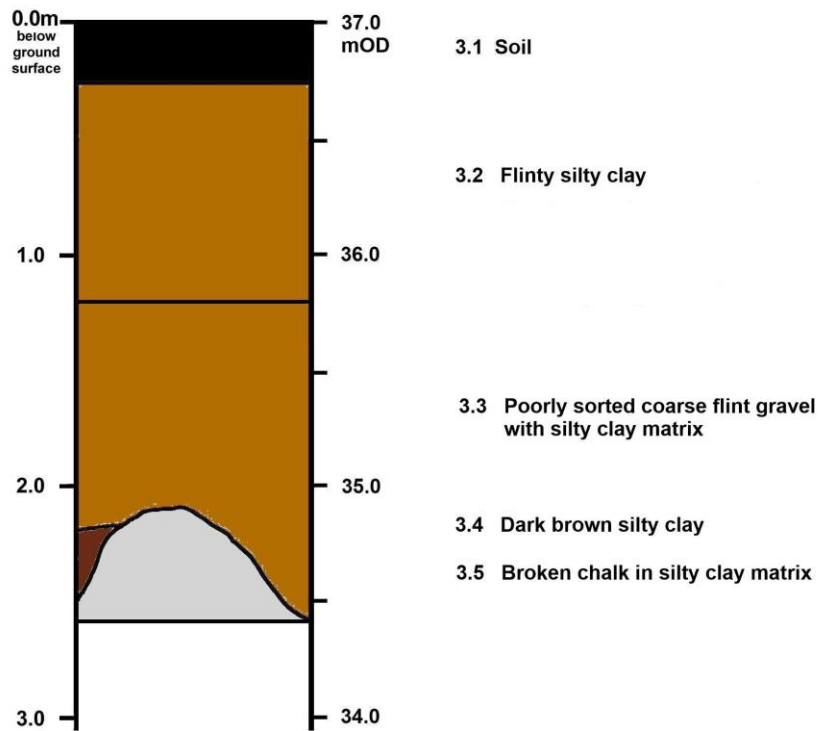
Figure 7: QTP3 stratigraphic log.

Unit	m bgs	m OD	Thickness (m)	Description	Stratigraphic Unit	Samples
3.1	0.0 – 0.25	37.0 – 36.75	0.25	Soil.	MODERN SOIL	
3.2	0.25 – 1.2	36.75 – 35.8	0.95	Flinty sandy silty clay, flints mostly sub-angular with white patina, up to 2-3 cm. Colluvium.	COLLUVIUM/ HEAD	Bags, 2 x c.10L, collected from each of 0.55, 1.0 mbgs

3.3	1.2 – 2.25 to 2.5	35.8 – 34.75 to 34.5		Flints, often with white patina, and chalk clasts, within a brown silty clay matrix, flint modal size of 5 cm but examples up to 16 cm. Unit as a whole shows a sub-horizontal breakage pattern, suggesting deposition by aggradation.		Bags, 2 x c.10L, collected from 1.3 m bgs.

3.4	2.25 – 2.50	34.75 – 34.5	0.25	Dark brown silty clay, brecciated; lies beside coombe rock. ?Residue from dissolution of coombe rock.	COOMBE ROCK	
3.5	2.5 +	>34.5		Irregular chalk surface. Broken chalk, clasts, sub-angular, mostly clast supported within a silty chalk matrix.

<b>Soil</b>	<i>Units</i> 3.1, 4.1, 5.1
Silt with chalk granules	4.2
Sandy silt	4.3
<b>Silt clay with a minor amount of flint</b>	3.2, 4.4, 5.2
<b>Coarse flint gravel with silty-clay matrix</b>	3.3, 4.5, 5.3
Brown clay	4.6
Dark brown clay	3.4
<b>Coombe rock</b>	3.5, 4.6, 5.4

**Coarse flint gravel** – shows flints tending towards the horizontal and the pit face showing a horizontality, suggesting deposition by aggradation. Given the size of the flints, up to 16 cm or more, the deposit is considered to have been created by major movements of surface material from the adjacent slope to the valley bottom during thaw periods within a periglacial environment.

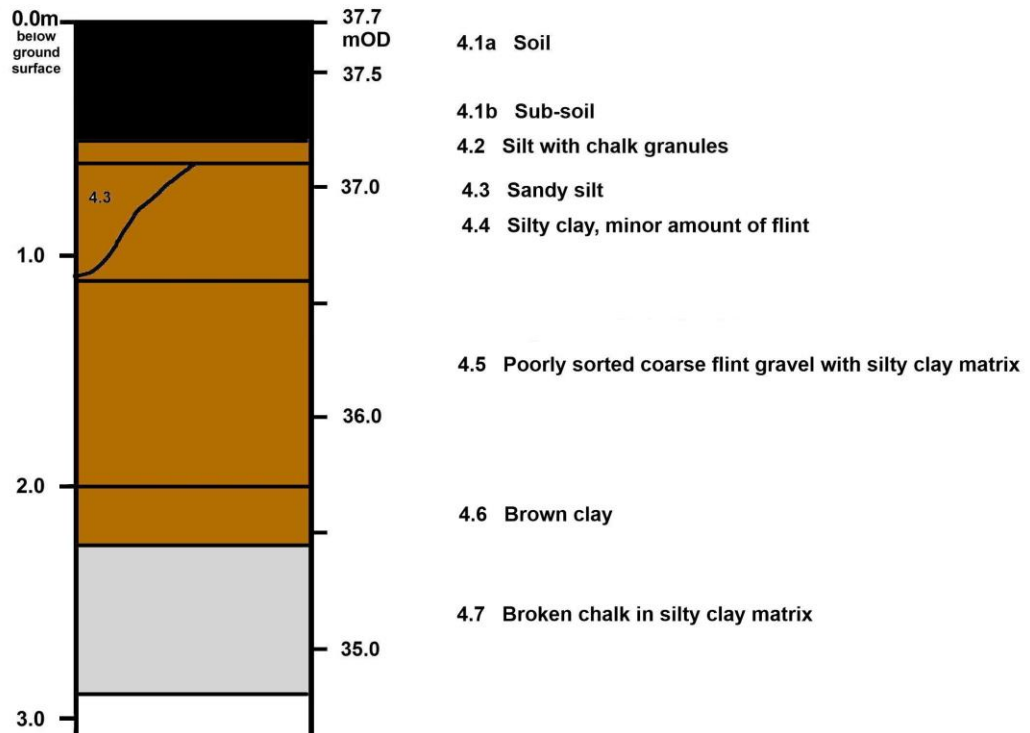
Figure 9: QTP4 stratigraphic log.

Unit	m bgs	m OD	Thickness (m)	Description	Stratigraphic Unit
4.1	0.0–0.5	37.7–37.2	0.5	Soil, grey-brown, darker at surface (4.1a), lighter with depth (4.1b)	MODERN SOIL

4.2	0.5–0.6	37.2–37.1	0.1	Silt with chalk granules. ?Loessic (wind-blown)	LOESS
4.3	0.6–1.1	37.1–36.6	0.5	Brown stoneless sandy silty clay, lying to the side of, channelled into. Unit 4.4.	COLLUVIUM/ HEAD

4.4	0.6–1.1	37.1–36.6	0.5	Flinty brown sandy silty clay, flints mostly granular, sub-angular, white patina.	
4.5	1.1–1.9	36.6–35.8	0.8	Flints, with white patina, and chalk clasts, within a brown silty clay matrix, flint modal size 5 cm but examples up to 20 cm occur. Unit as a whole shows a sub-horizontal breakage pattern, suggesting deposition by aggradation.

4.6	1.9–2.15	35.8 – 35.55	0.25	Brown silty clay, brecciated. ?Residue from dissolution of coombe rock.	COOMBE ROCK
4.7	2.15 +	>35.55		Irregular chalk surface. Broken chalk, clasts, sub-angular, mostly clast supported within a clay-chalk matrix.

**Sandy silt** – this is incised into the silty clay and may be occupying a channel cut by a minor surface stream or rill.

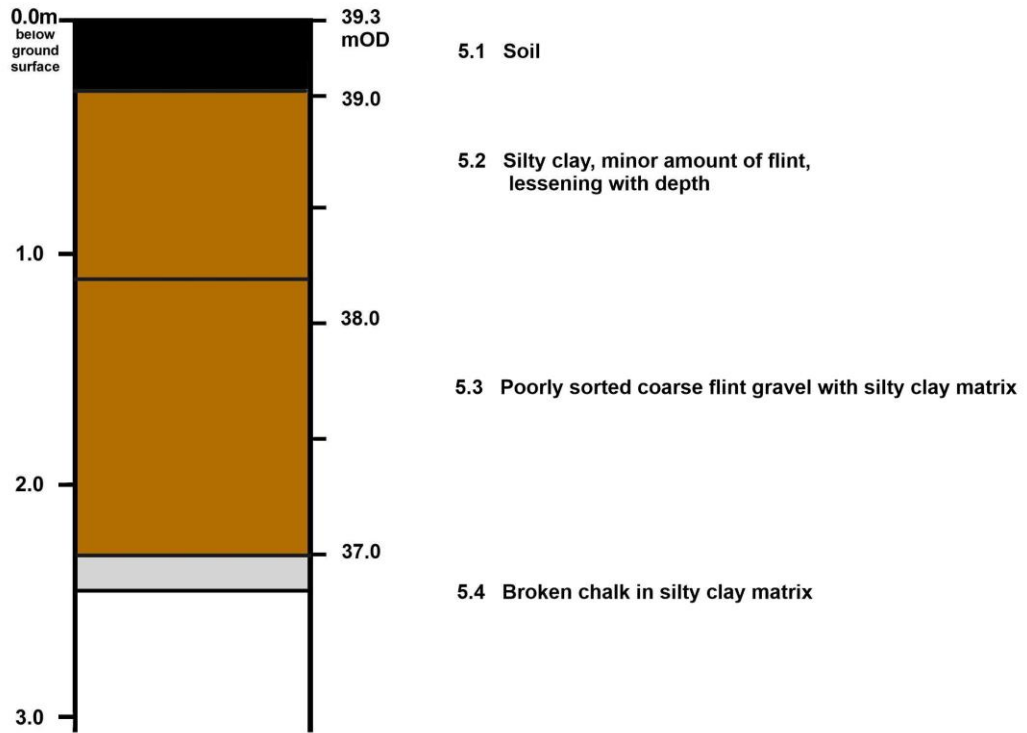
Figure 11: QTP5 stratigraphic log.

Unit	m bgs	m OD	Thickness (m)	Description	Stratigraphic Unit	Sample
5.1	0.0 – 0.3	39.3 – 39.0	0.3	Soil.	MODERN SOIL	
5.2	0.3 – 1.1	39.0 – 38.2	0.8	Sandy silty clay, flints mostly granular, but some up to 1 cm, mostly sub-angular with white patina.	COLLUVIUM/ HEAD	
5.3	1.1 – 1.8	38.2 – 37.5	0.7	Flints within a brown silty clay matrix. Flints in basal area have modal size of 5 cm but examples up to 12 cm occur. Unit as a whole shows a sub-horizontal breakage pattern, suggesting deposition by aggradation.		Bags, 2 x c.10L, collected from each of 1.45 and 1.8 m bgs
5.4	1.8 – >2.3	>37.5		Irregular chalk surface. Broken chalk, sub-angular, mostly clast supported within a silty chalk matrix. Coombe rock.	COOMBE ROCK

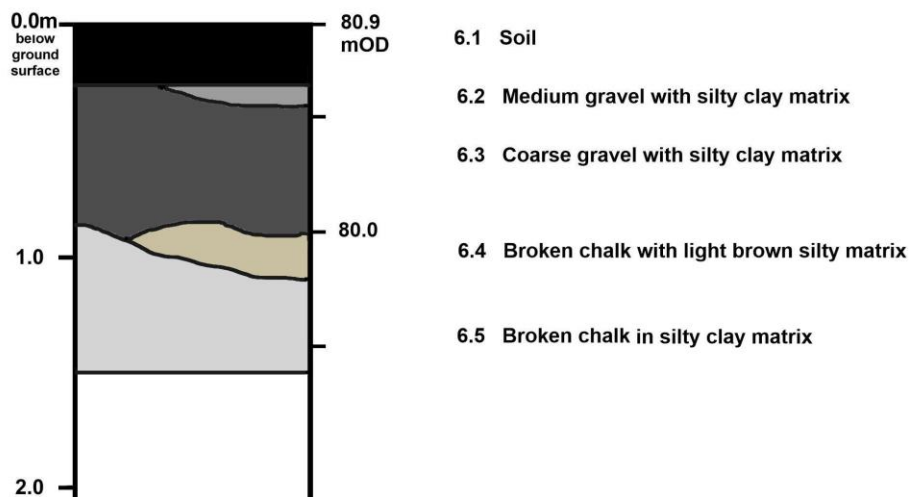
Figure 13: QTP6 stratigraphic log.

Unit	m bgs	m OD	Thickness (m)	Description	Stratigraphic Unit
6.1	0.0 – 0.25	80.9 – 80.65	0.25	Soil.	MODERN SOIL
6.2	0.25 - 0.35	80.65 – 80.5	0.15	Poorly sorted medium gravel, rounded and sub-angular flint, up to c.5 cm. No overt bedding, clasts at various angles.	COLLUVIUM/ HEAD
6.3	Side face 0.35 – 0.75 End face 0.35 – 1.5	80.5 – 80.1	0.4	Side face. Coarse poorly sorted gravel, rounded and sub-angular flints, often with white cortex, in red-brown clayey matrix. Reworked Clay-with-flints.  End face Seen to lie with in solution hollow in coombe rock (Figure 14b).	
6.4	0.75 – 0.95	80.1 – 79.9	0.2	Broken chalk; sub-angular clasts up to c.7 cm in light brown silty matrix.	COOMBE ROCK
6.5	0.95 – 1.5	79.9 – 79.4	0.55	Broken chalk, sub-angular, mostly clast supported within a silty chalk matrix.

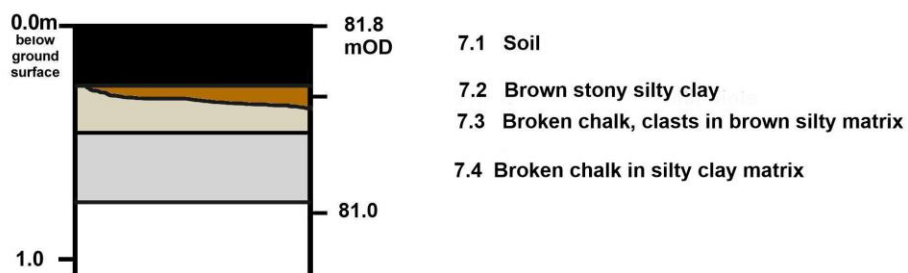
Figure 15: QTP7 stratigraphic log.

Unit	m bgs	m OD	Thickness (m)	Description	Stratigraphic Unit
7.1	0.0 – 0.25	81.8 – 81.55	0.25	Soil.	MODERN SOIL
7.2	0.25 – 0.40	81.55 – 81.40	0.15	Brown stony silty clay; flints 2 – 3 cm, sub-angular and rounded.	COLLUVIUM/HEAD
7.3	0.40 – 0.50	81.40 – 81.30	0.1	Broken chalk; sub-angular clasts up to c.7 cm in light brown silty matrix.	COOMBE ROCK
7.4	0.50 – >0.75	81.30 – <81.05	0.25+	Broken chalk, sub-angular, mostly clast supported within a silty chalk matrix.
