5. DISCUSSION, CONCLUSIONS & RECOMMENDATIONS

Project name LAND TO THE EAST OF NORTH DANE WAY, MEDWAY, KENT

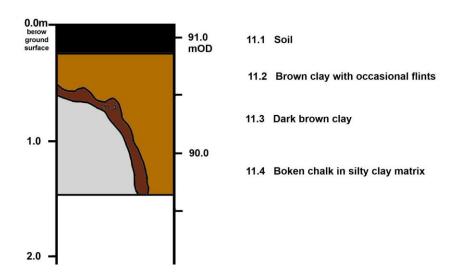
Figure 23: QTP11 stratigraphic log.

Table 12: QTP11 descriptive log. Ground Surface 91.1m OD. Beds horizontal but of variable thickness.

Unit	m bgs	m OD	Thickness (m)	Description	Stratigraphic Unit
11.1	0.0 – 0.25	91.1 – 90.85	0.25	Soil	MODERN SOIL
11.2	0.25 – 0.55 to 1.45	90.85 - 90.55 to 89.65	0.3 to 1.2	Brown stony silty clay; flints 2 – 3 cm, sub-angular and rounded, occupying top part of a solution hollow in the coombe rock.	COLLUVIUM/ HEAD
11.3	0.55 to 1.45 – 0.65to 1.45	90.55 to 89.65 - 90.45 – 89.65	0.1	Dark brown clay, brecciated, occupying top part of a solution hollow in the coombe rock. ?Residue from dissolution of coombe rock.	CLAY-WITH- FLINTS
11.4	0.65 – 1.45	90.45 – 89.65		Broken chalk, sub-angular, in silty-clayey chalk matrix.	COOMBE ROCK

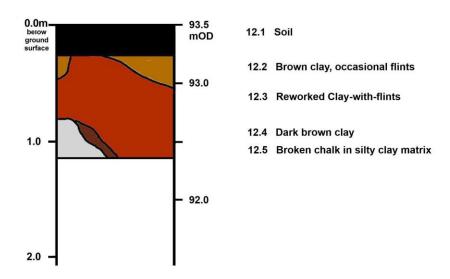
Figure 25: QTP12 stratigraphic log.

Table 13: QTP12 descriptive log. Ground Surface 93.5m OD. Beds horizontal but of variable thickness.

Unit	m bgs	m OD	Thickness (m)	Description	Stratigraphic Unit
12.1	0.0 – 0.25	93.5 – 93.25	0.25	Soil.	MODERN SOIL
12.2	0.25 – 0.85 to 1.15	93.25 – 92.65 to 92.35	0.6 to 0.9	Coarse poorly sorted gravel, rounded and sub-angular flints, often with white cortex, in red-brown clayey matrix. Clasts disorganised, at various angles.	COLLUVIUM/ HEAD
12.3	0.85 – >1.15	92.65 - 92.35	0.3	Dark brown clay, brecciated, lies to side of 12.4. ?Residue from dissolution of coombe rock.	CLAY-WITH- FLINTS
12.4	0.85 – ?1.15	92.65 – 92.35	0.3	Broken chalk, as above but in silty-clayey chalk matrix.	COOMBE ROCK
