Bat Emergence/Re-entry surveys

Stonehouse Farm, Frindsbury ME3 8EN

Clients Name: St Sepulchre (Finsbury) United Charities

Date of Completion: 24/08/20 (Revised version 02/09/21)

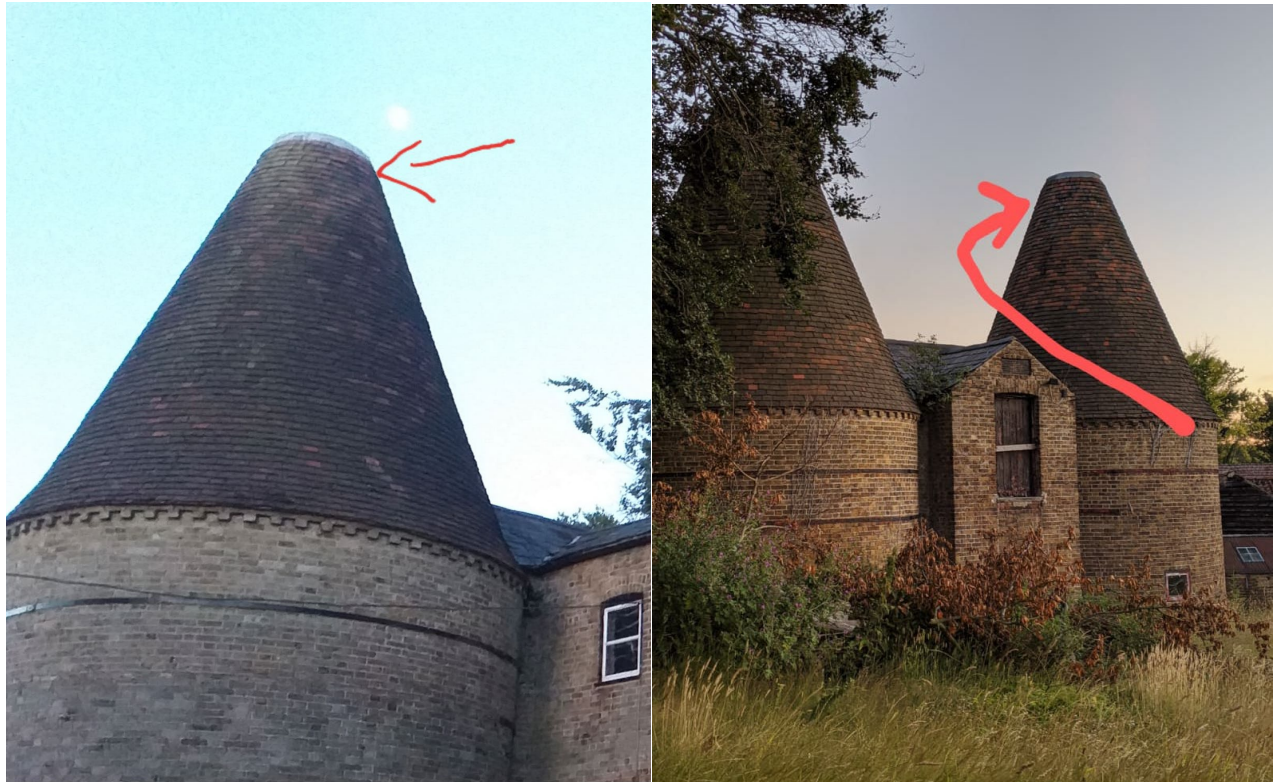
Figure 3: surveyors' photos indicating roost access point for common pipistrelle in B1 oast roundel

- An individual common pipistrelle bat was observed returning to the easternmost roundel of B1 oast during the dawn survey of the building on 11/07/20. A second incidental observation of one individual common pipistrelle returning to the same access point in B1 oast was made during the dawn survey of B2 small barn on 17/06/20.

- The survey undertaken shows a small number of common pipistrelle bats (one individual) were using the easternmost roundel of B1 oast as a place of rest or shelter.
- An internal inspection of B1 oast found feeding remains and droppings consistent with those of brown long eared bat in multiple locations on the ground floor of B1 the oast. The evidence indicates that the building is used for the purpose of feeding by this species.
- The survey undertaken shows a small number of brown long eared bats (one individual) were using B3 large barn for roosting. Some sporadic feeding remains of the prey species of brown long eared bat were found internally. The evidence indicates the building offers both a place of rest or shelter and feeding perches for this species.

- The development proposal is understood to include removal of the tiles hanging on the oast roundels to insulate the roof. Cows are also to be reinstated to the roundels.
- The internal areas used by the long eared bat(s) are to be redeveloped to provide accommodation.

- species appropriate bat boxes in trees.
- Destruction of the areas containing bats carried out by hand (soft strip) under supervision by a licensed bat worker.
- mitigation woven into the structural design of the new structure ie bat bricks, bat access tiles to parts of the roof that will not suffer human interference/disturbance.

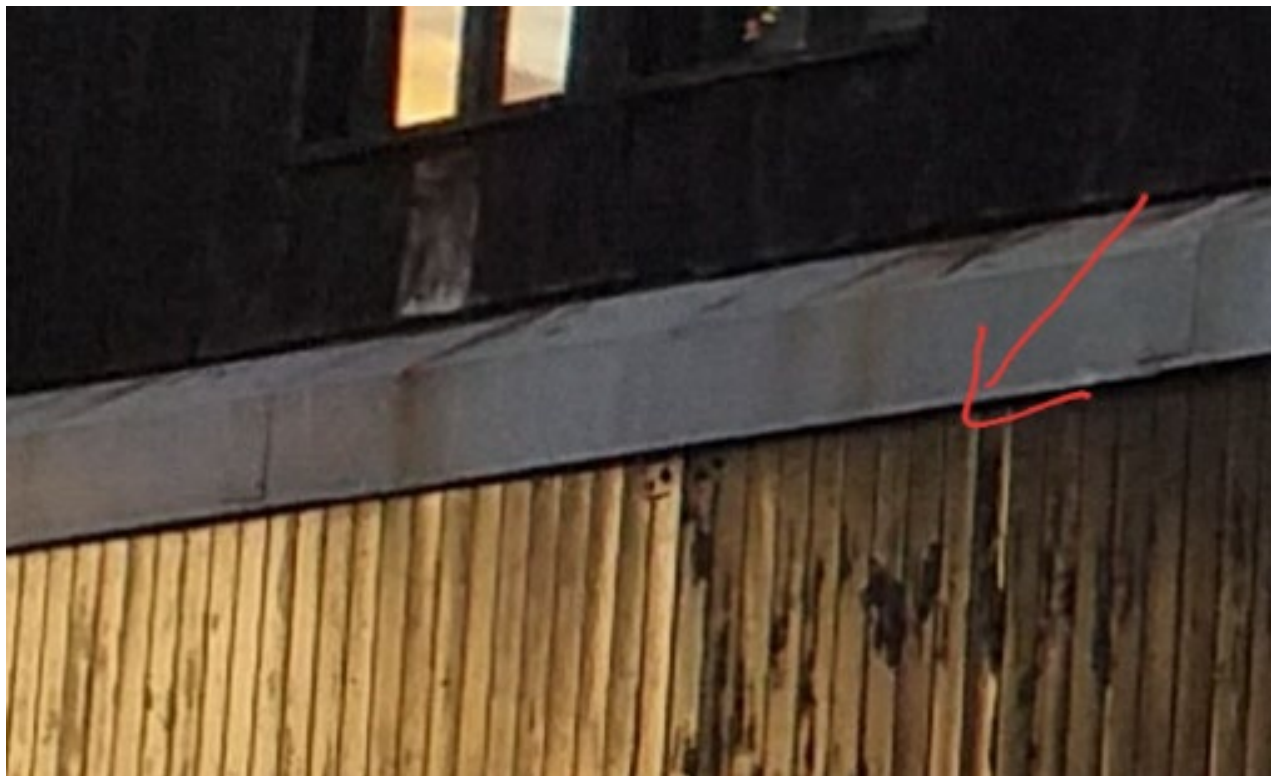
Figure 4: Surveyor's photo of brown long eared bat exit point in B3 large barn

- A single brown long eared bat was observed emerging from B3 large barn at 21:47 during the second survey of the building on 10/07/20.
- At no other time were bats observed emerging from or returning to the structures. All results data can be viewed in full in the survey results forms appended to this document.
