Title: BS5837 Tree Report

Site: St Pauls Vicarage,
Boxley Road,
Maidstone
Kent
ME14 2AH

Client: Hill-Wood & Co. (Kent) Limited

Reference: L845AIA

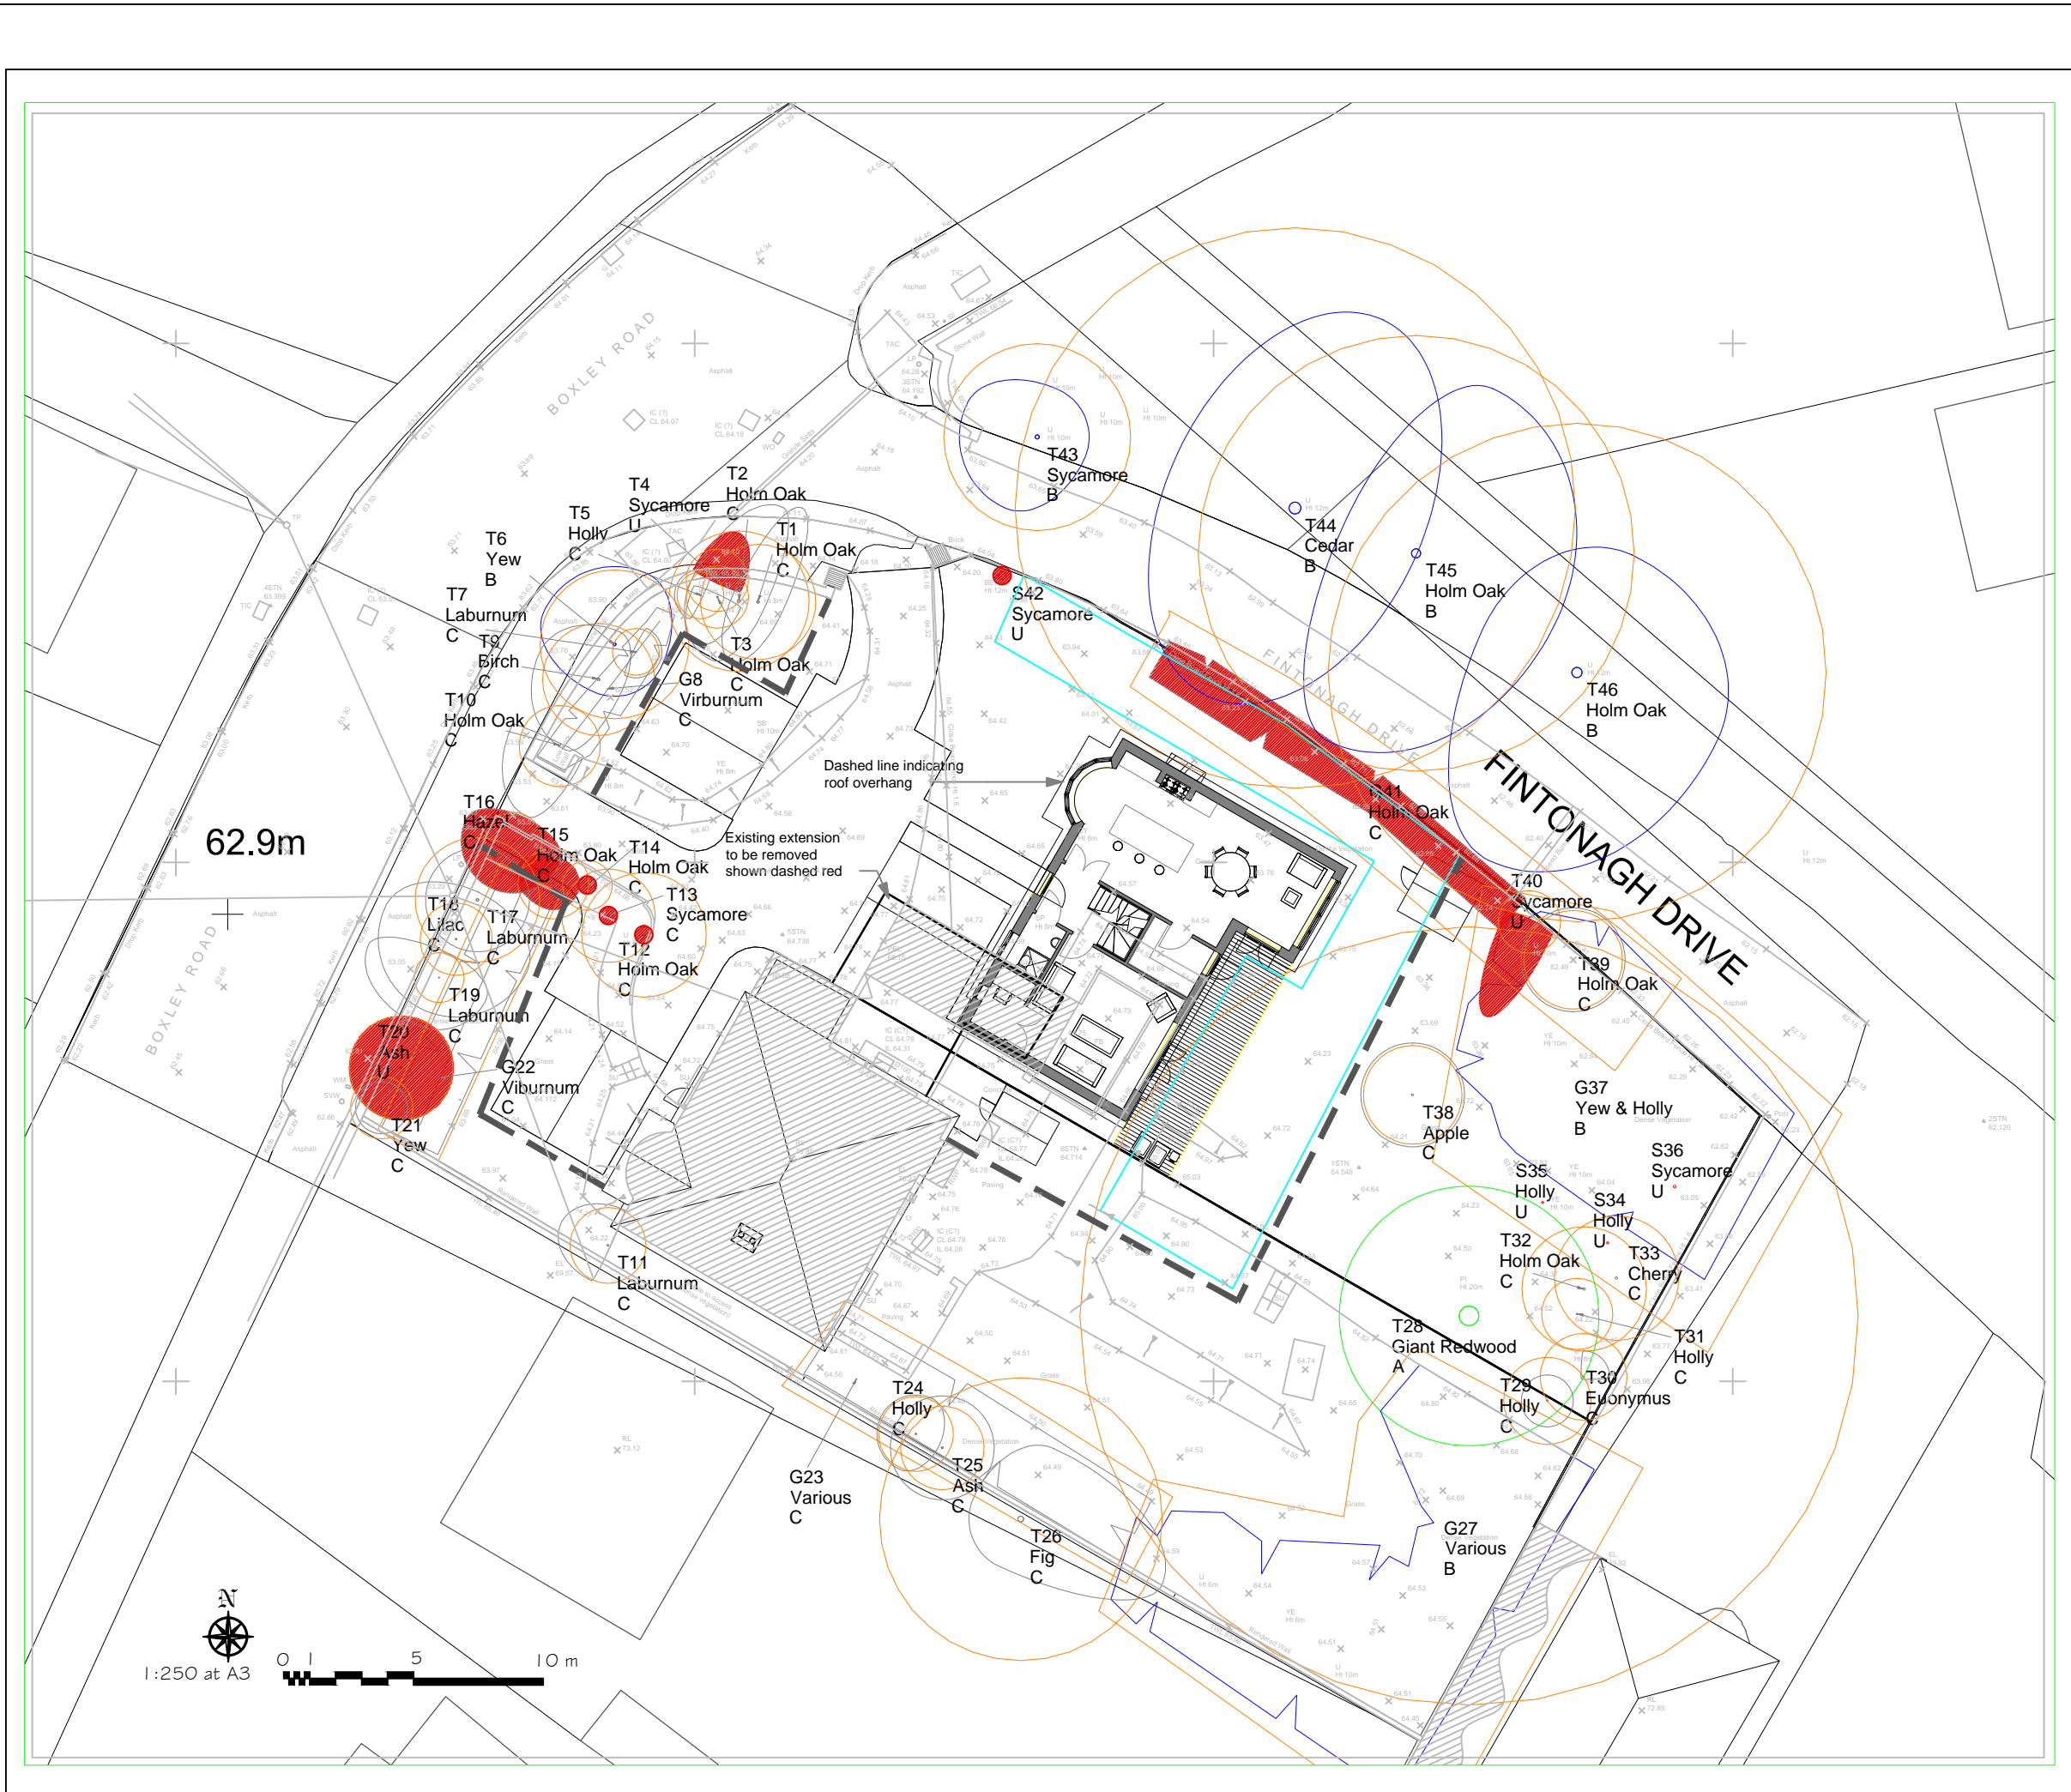
Appendix 8
Tree Removal Plan L845TRP

- 3.3 There will be 3 No. U category trees (T4, T20 and T40) and 1No. partial stump (S42) to be removed within the site boundaries. **Mitigation: Due to their poor quality or the damage they are likely to cause in the next ten years these trees are likely to have been removed irrespective of development.**
