Desk Study & Preliminary Site Investigation Report

Site: Land off Shawstead Road, Hale, Kent, ME5

Report Date: October 2018

Project Reference: J13752

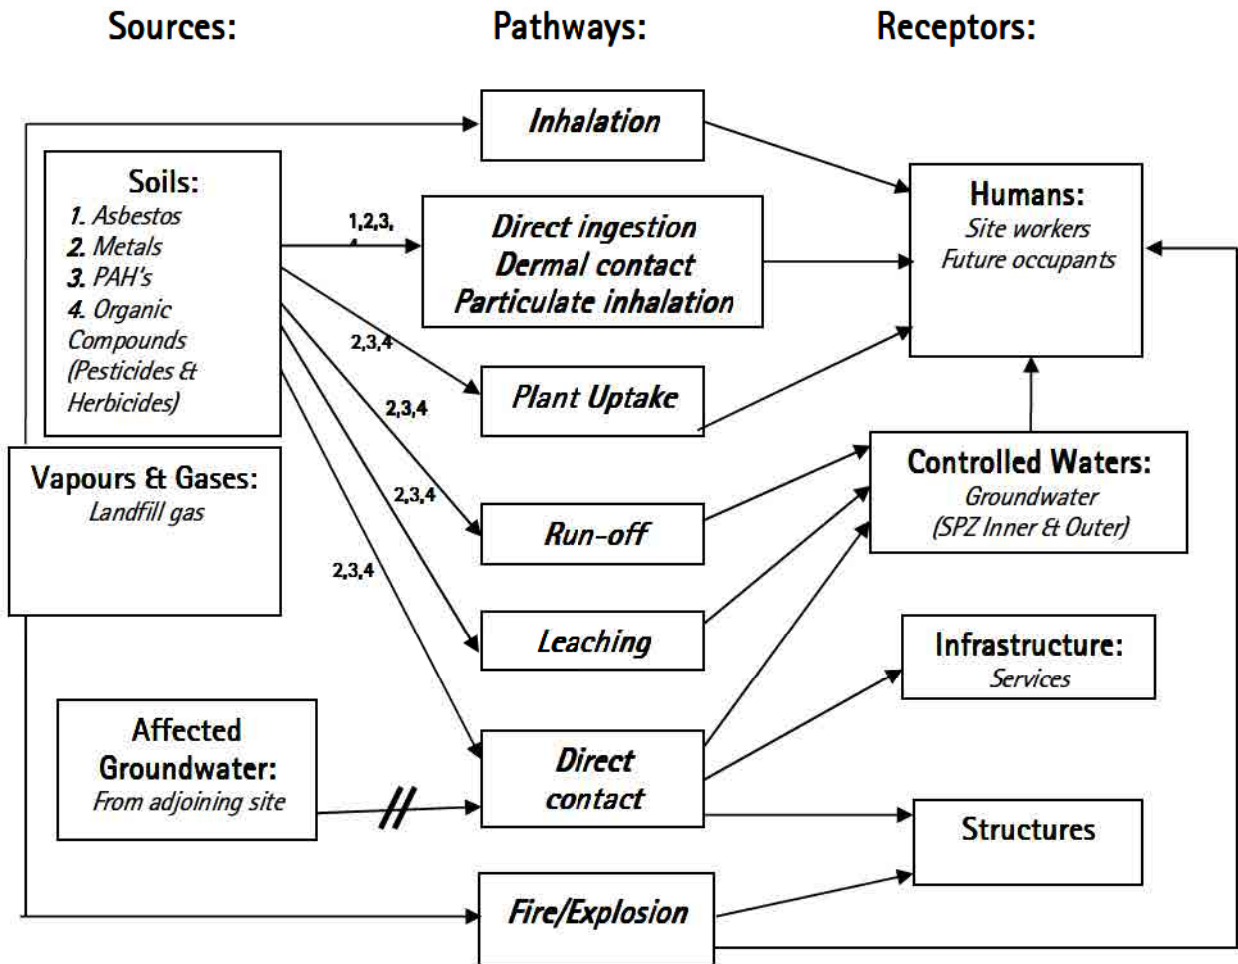
10 Pollutant Linkages and Model Summary

The following diagram shows the potential pollutant linkages identified for the site and summarises the preliminary conceptual model.

// Denotes potential pollutant linkage not complete
