Advanced Blockage Clearance Ltd

CCTV DRAINAGE REPORT

Client : Artemis Build
Location : Ashwood Nursing Home Heathfield Road Burwash Common
Date : 16th February 2021
Order no : Email Nick

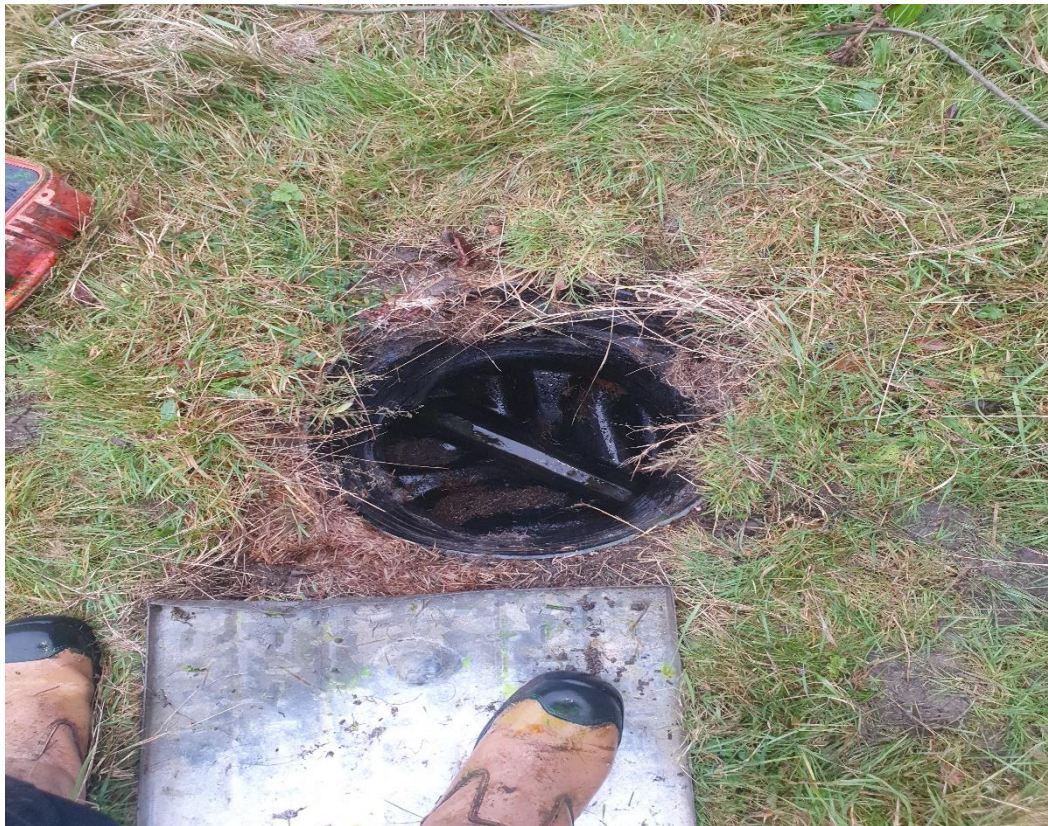
Manhole 1

Green dye can be seen in this run from rain water drain
0.00m Survey starts downstream
2.60m Pipework heavily cracked/broken
3.50m Pipework heavily dis-jointed
7.30m Enters Manhole in road (Southern Water Manhole)

This is last Manhole on site before leaving site Manhole Photo Below

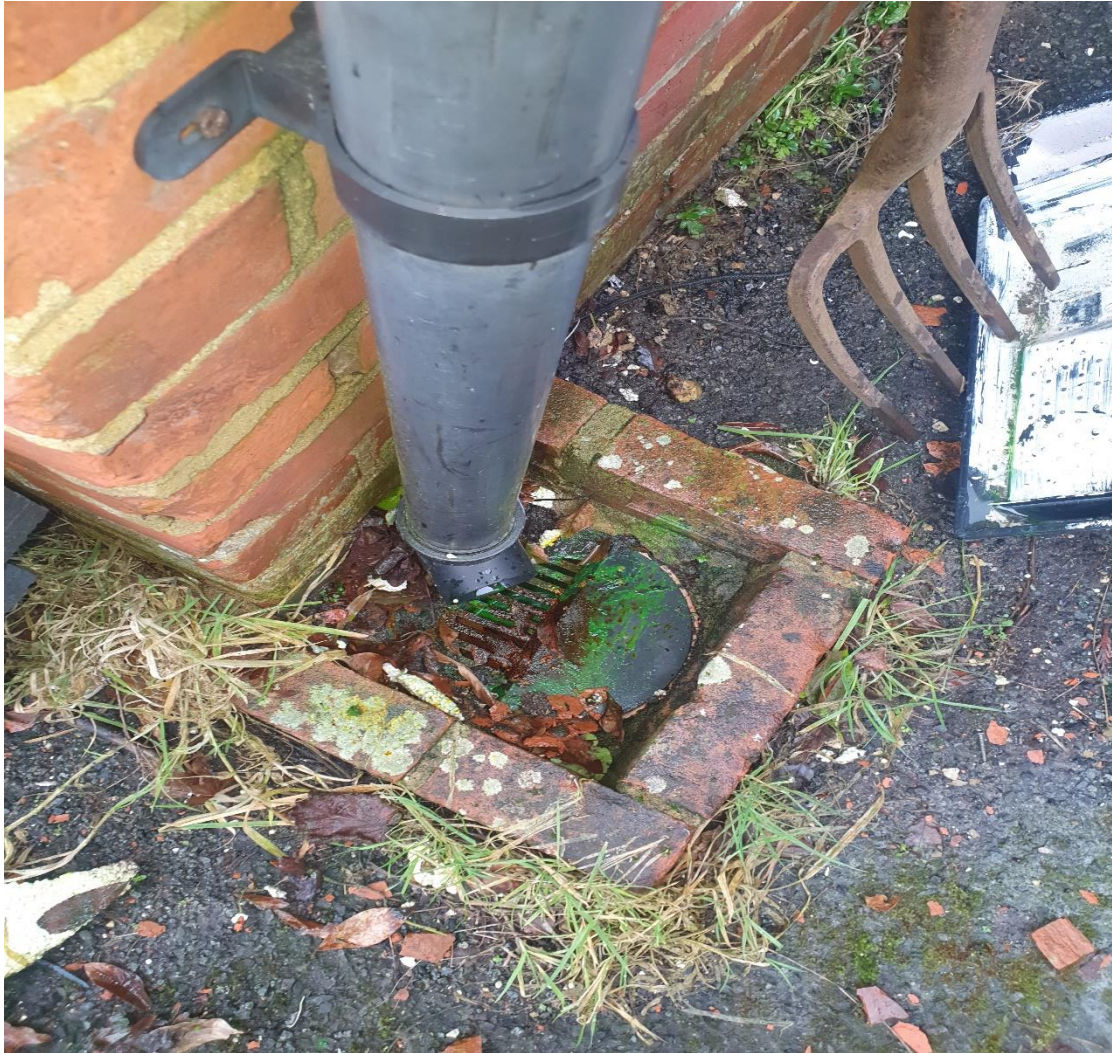
Green dye can be seen in this run from rain water drain
Survey starts upstream

Enters Manhole 2
Green dye flowing through Manhole from Rain Water shown in
Photo Below.

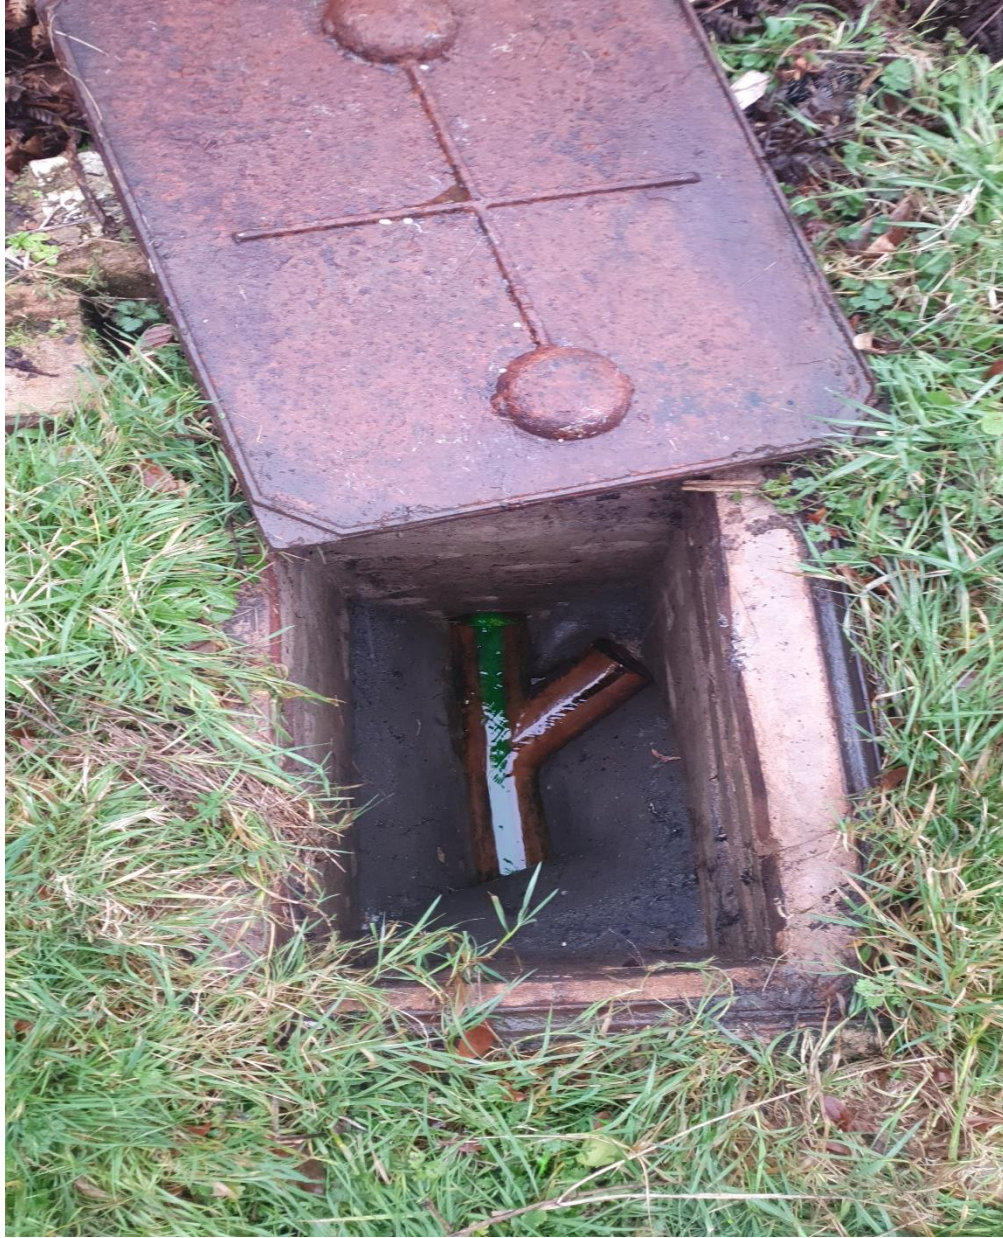
In Photo Above this is Manhole 2 showing the green tracing dye which was used in the Rain water gully flowing into the foul system.
